Evaluation Report

138

Sperry New Holland 1033 Automatic Bale Wagon

SPERRY NEW HOLLAND 1033 AUTOMATIC BALE WAGON

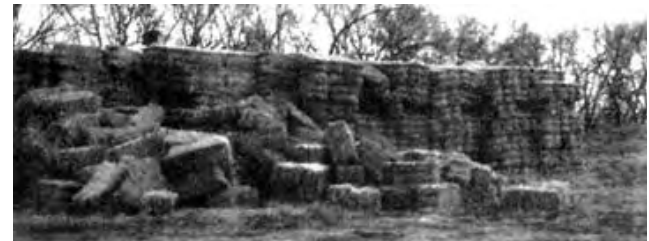
FIGURE 4. Poor Site Selection, Poor Bale Quality, or Careless Unloading Usually Resulted in Stack Collapse.

Stack Quality: Stack quality and durability depended on operator care, operator experience, bale quality, bale uniformity and selection of a suitable stack site. With proper care in baler operation, site selection and unloading, solid, durable stacks (FIGURE 3) were formed. If bales were of poor or variable quality, or if care was not taken in selecting a good stack site and in properly positioning bale loads within the stack, the stack usually collapsed within several days (FIGURE 4).

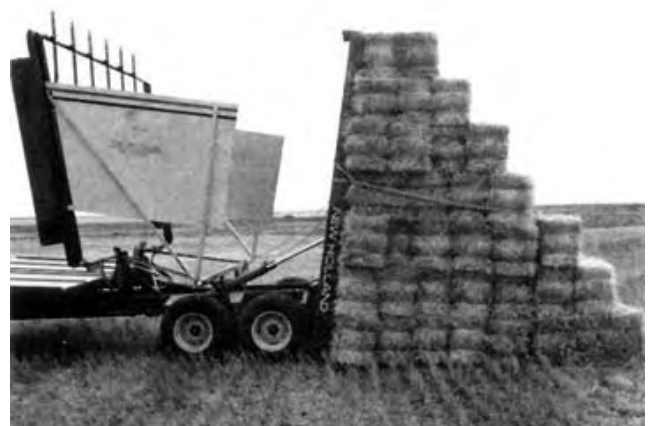
FIGURE 5. Suitable Backstop Formed by Rearranging a Full Load by Hand.

An adequate backstop was needed to start a stack. Full loads, which were rearranged by hand, as shown in FIGURE 5, formed a good backstop. Placing a full load against a fence, or placing props against the first load, usually was inadequate and lead to stack collapse. Partial loads from field cleanup had to be unloaded by hand and could sometimes be used to finish a stack and stabilize its end.

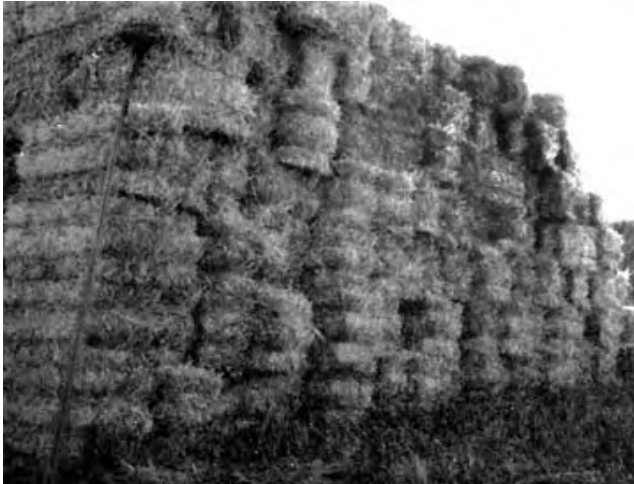
FIGURE 6. Non-Uniform Right Stack Side Resulting from Bale Length Variations.

Good quality, durable stacks required dense, well-formed, uniform bales. Stack durability was greatly influenced by baler performance. Poorly formed bales on the bottom, usually settled, resulting in collapse. Non-uniform bale lengths resulted in reduced stability and unsightly appearance on the right stack side, since all the bale length variations accumulated on this side (FIGURE 6).
