Evaluation Report

548

Knudson Square Bale Stacker and Mover

KNUDSON SQUARE BALE STACKER AND MOVER

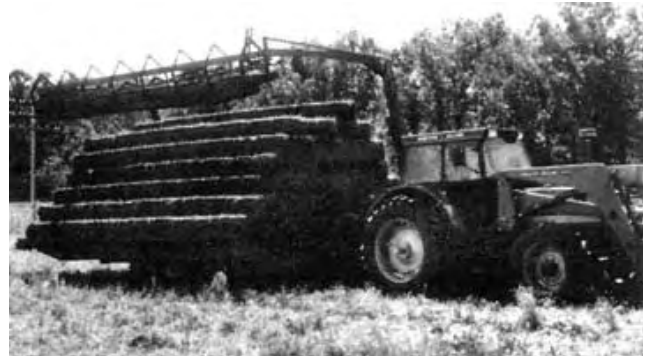
The Knudson bale stacker arranged the bales in layers on the deck of the wagon forming a prism (FIGURE 2). The deck was capable of holding 310 bales, 34 in (864 mm) or 285 bales, 40 in (1016 mm) in length. With an average weight of 70 lb (32 kg) per bale, the stacker deck was capable of supporting 10.8 tons (9.8 t) of crop. For eight 7.50-16 tires inflated to a maximum pressure of 36 psi (248 kPa), the maximum load is 9 ton (8.1 t) according to standards of the Tire And Rim Association. A fully loaded Knudson stacker would exceed this load limit by 1.8 tons (1.6 t).

FIGURE 2. Bale Arrangement On Deck.

Quality of work was good, as the Knudson stacker did not impart any aggressive action on the crop. The bales were stacked in a prism shape, with their longitudinal axes all running the same direction. The stack was constructed in layers, with each ascending layer containing six or seven less bales (one row) than the preceding layer. The exposed surface area per ton of hay was high in comparison with round bales or other automatic square bale stackers. No long term study was conducted to determine the weatherability of stacking hay in this fashion. The resulting stack was stable and required no poles or other means of support.

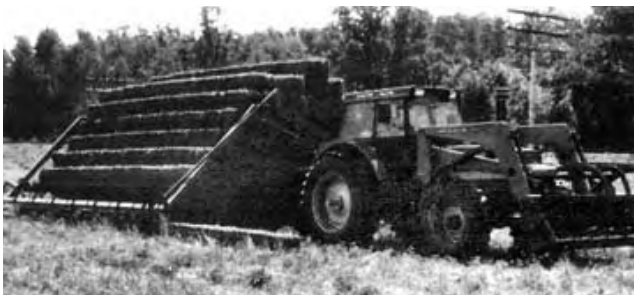
Loading: The Knudson stacker was placed in field position by hydraulically lifting the pickup from its transport position and placing the arm stops in the field position on the front and rear of the frame (FIGURE 4). The train of bales were approached and the pickup guided to slide over the bales. When the first bale into the pickup reached the rear, it tripped a trigger that closed the pickup on the train of bales (FIGURE 5).

FIGURE 4. Pickup in Field Position.

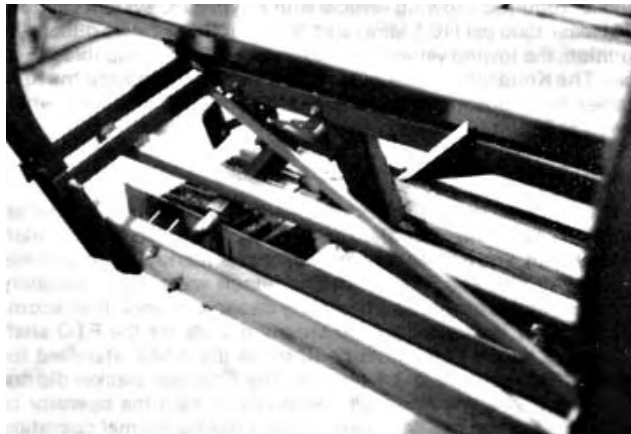
FIGURE 5. Trigger for Closing Pickup.
