Evaluation Report

Co-op Implements 9600 Pull-Type Combine

CO-OP IMPLEMENTS 9600 PULL-TYPE COMBINE

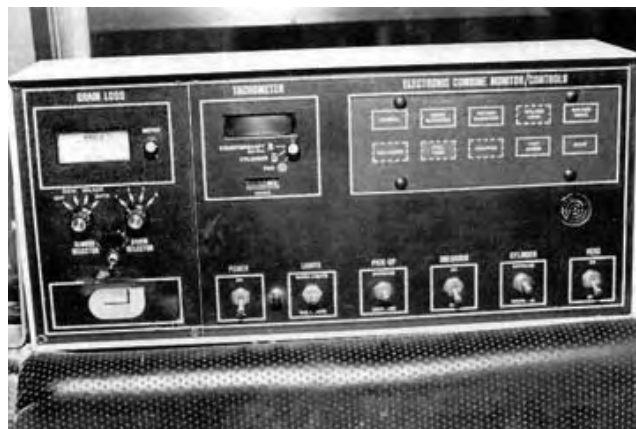
FIGURE 2. Electric Monitor/Control Box.

Electronic Monitor/Control Box: In addition to the electric controls, the monitor contained an hour meter, a grain loss monitor, a shaft speed monitor and a digital tachometer, which displayed either the primary counter shaft speed cylinder speed or fan speed.

Grain Loss Monitor: The grain loss monitor readout and controls were located in the combine monitor/control box (FIGURE 2). Grain loss was sensed by four pad sensors; two located behind the shoe and two behind the straw walkers.

When the monitor/control box was mounted for convenient access to the control switches, loss monitor meter visibility was restricted. The meter was difficult to read due to its small size and poor contrast between the needle and meter face. Meter illumination provided good night visibility, but did not improve readability.

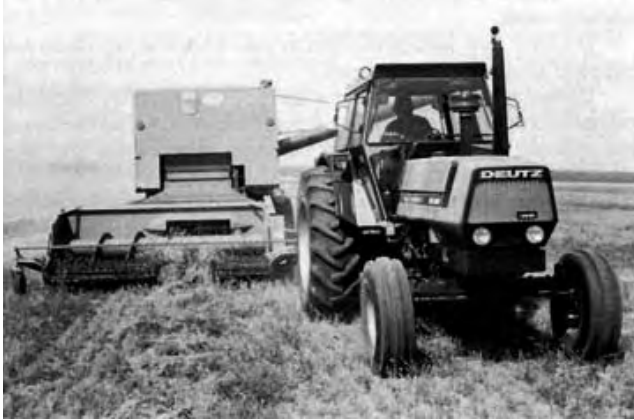
FIGURE 3. In-Line Feeding of Windrow.

Maneuverability: The CI 9600 was very maneuverable and easily picked most windrow corners. The pickup, header and drawpole position allowed windrows to be fed directly in line with the feeder house opening (FIGURE 3). A maximum outside tractor wheel width of 2440 mm (96 in) allowed direct feeding of fluffy windrows. The minimum windrower width to permit passing between windrows was 4880 mm (16 ft) with a 2440 mm (96 in) tractor width (FIGURE 4).

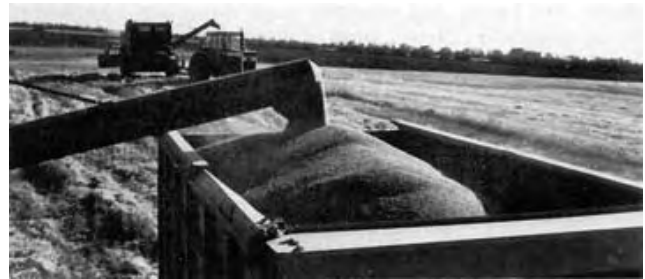
FIGURE 5. Unloading Auger Clearance.

The unloading auger had ample reach for easy on-the-go unloading, but clearance was marginal when unloading into trucks with high boxes or box extensions (FIGURE 5). The auger delivered an even compact stream of grain and unloaded a full tank of dry wheat in 109 seconds. The empty unloading auger continued to turn for several seconds after it was disengaged.

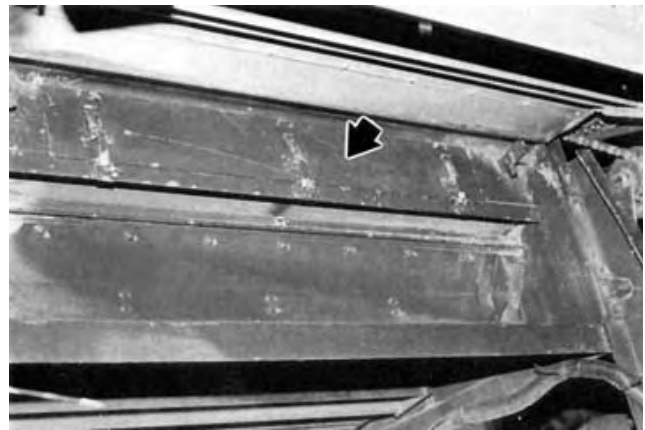
FIGURE 6. Stone Trap Clean-Out Door.

Stone Protection: The stone trap, located in front of the cylinder, quickly filled with chaff and grain, but trapped most stones and roots. The trap was quite accessible (FIGURE 6), but dirty and inconvenient to clean, as cleaning required hand removal of foreign objects. The entire stone trap assembly was removable to provide access to the cylinder.

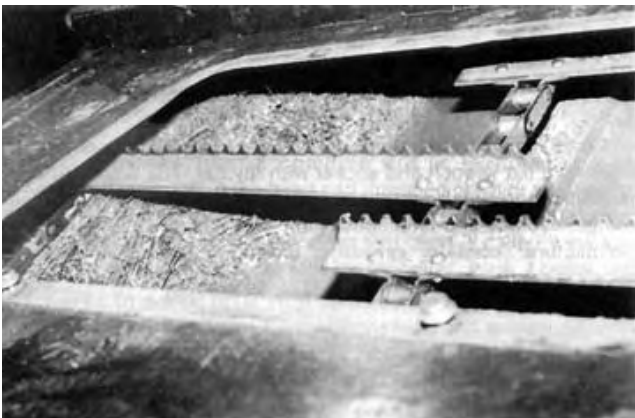
FIGURE 8. Flax Straw Bunching in Feeder Housing.

The feeder had high capacity in most crops. In flax, however, straw bunched on the top side of the feeder housing behind the carrier slats (FIGURE 8), causing excessive chain tension. It is recommended that the manufacturer consider modifications to reduce feeder plugging in flax straw.

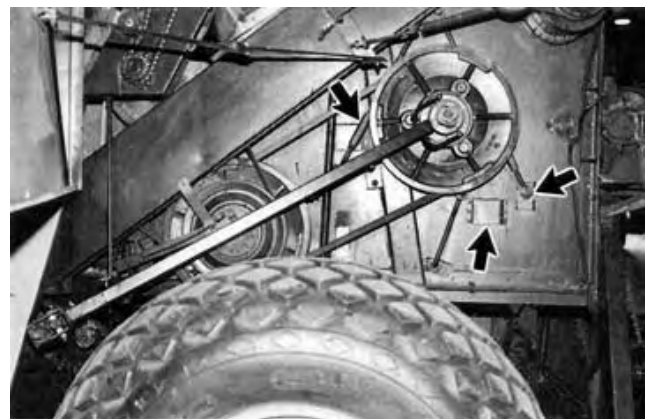
FIGURE 10. Concave Levelling and Inspection.

Concave Adjustment: The CI 9600 had a single segment high wrap concave. The concave could be levelled with front and rear eyebolts. Front and rear concave clearances were gauged through inspection holes (FIGURE 10). Once the concave had been initially set, clearances were changed by unlocking and rotating the adjusting bolt (FIGURE 11). The control linkage was designed so the leading concave bar opened at five times the rate of the trailing bar.

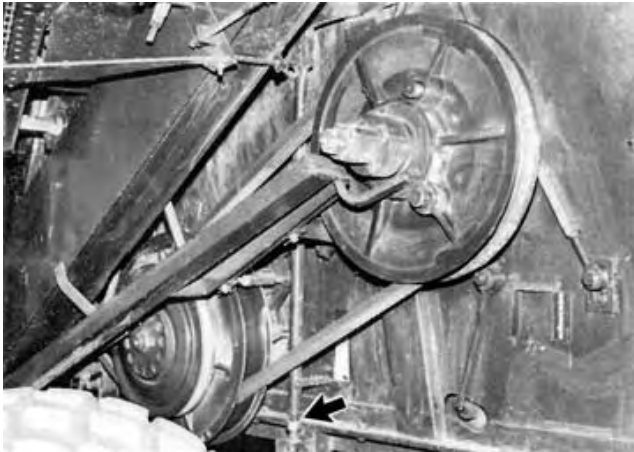
FIGURE 11. Concave Adjustment.

Changing concave clearances was slow and inconvenient, requiring a flat wrench and socket with ratchet. The adjusting bolt was difficult to reach and the thread pitch made large clearance changes tedious and time consuming. It is recommended that the manufacturer consider providing a more convenient concave adjusting mechanism.

Leading bar clearances varied from 10 to 30 mm (0.39 to 1.18 in) while trailing bar clearances varied from 4 to 8 mm (0.16 to 0.32 in). At minimum setting, the cylinder-to-concave clearance was zero in the centre segment of the concave, while rear clearance was still 4 mm (0.16 in), due to the arc of the concave.

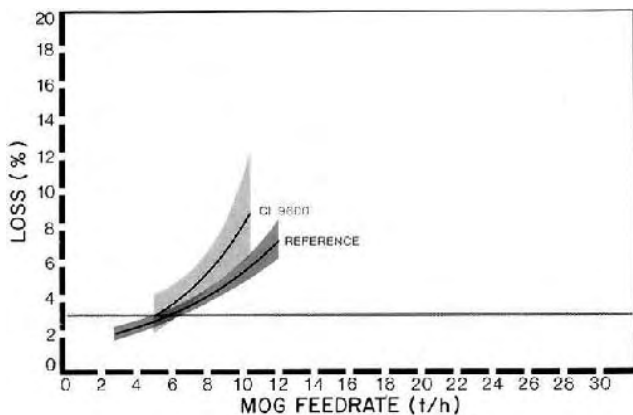
FIGURE 19. Total Grain Loss in Candle Canola.

FIGURES 19 to 21 compare the total grain losses of the CI 9600 and the PAMI reference combine in the crops described in TABLE 4. The shaded areas on the figures are the 95% confidence belts. If the shaded areas (confidence belts) overlap, loss characteristics of the two combines are not significantly different whereas if the shaded areas do not overlap, the losses are significantly different. The capacity of the CI 9600 was similar to the capacity of the reference combine and the CI 9600 had grain losses similar to those of the reference combine when operating at the same feedrate.

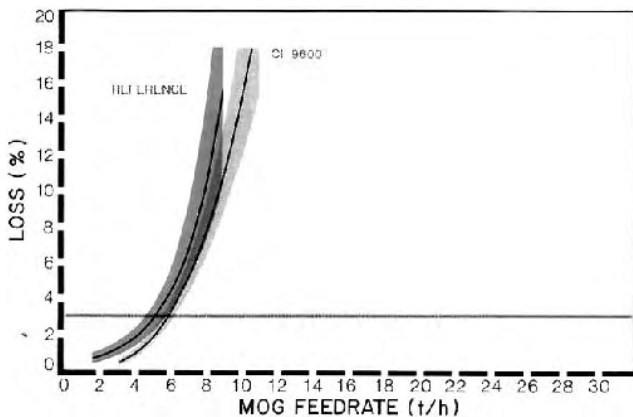
FIGURE 21. Total Grain Loss in Klages Barley.

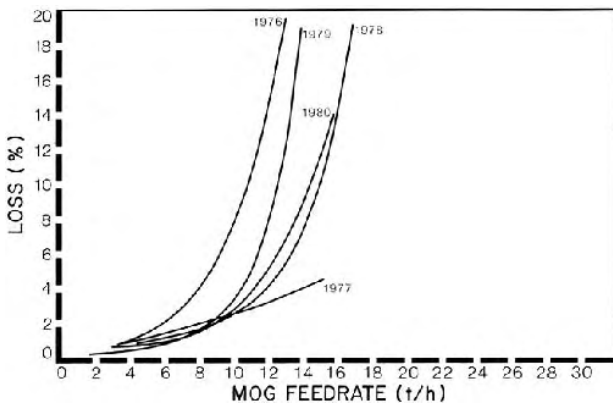
FIGURE 23. Total Grain Loss for the PAMI Reference Combine in Neepawa Wheat.

FIGURE 23 shows capacity differences in Neepawa wheat for the five years. Most 1980 Neepawa wheat crops shown in TABLE 7 were of average straw yield and better than average grain yield. Most of the crops were average to thresh while the grain moisture was slightly lower than the other years and the straw moisture content was average to lower than normal.
