# Evaluation Report

# 311

## Allis-Chalmers Gleaner L2 Self-Propelled Combine

# ALLIS-CHALMERS GLEANER L2 SELF-PROPELLED COMBINE

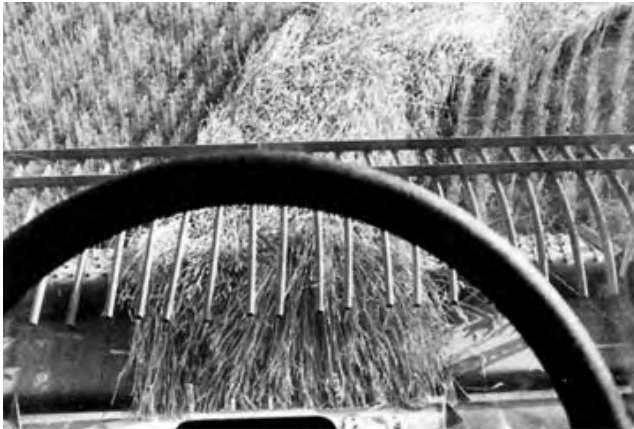
For most operators, visibility of the incoming windrow was very good (FIGURE 2). However, in dry dusty crops, dust coming from the feeder greatly reduced visibility (FIGURE 3). The grain level was visible through the rear window until the tank was nearly full.

FIGURE 2. Normal View of Incoming Windrow.

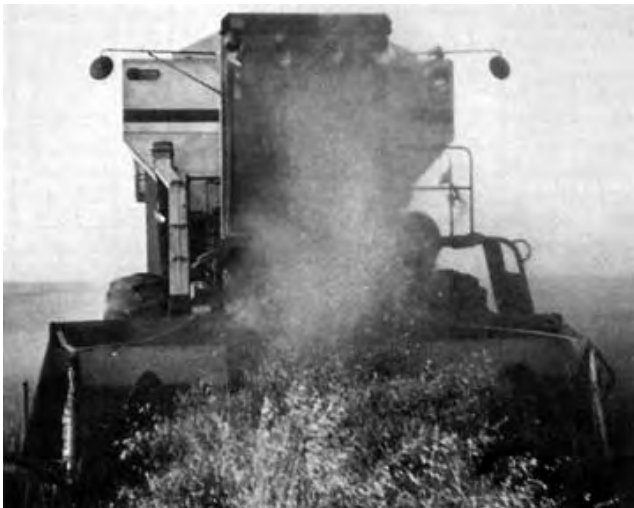
FIGURE 3. Obscured View in Dusty Crop.

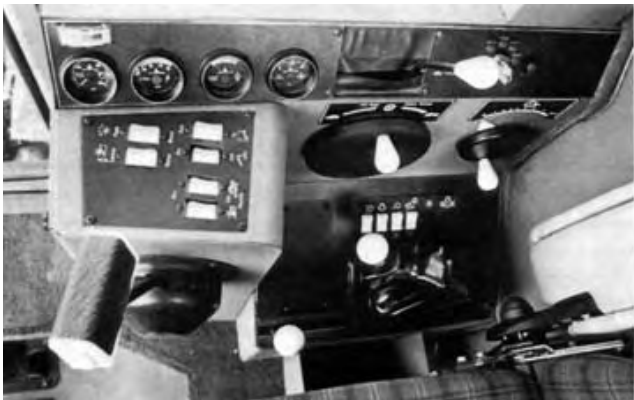
**Controls:** The controls for the Gleaner L2 are shown in FIGURE 4. Most controls were conveniently located, clearly identified and easy to operate. The hydrostatic ground speed control lever was smooth and responsive. However, the neutral position was very

difficult to find and maintain. The transmission had to be shifted into neutral to prevent the combine from creeping. It is recommended that the manufacturer consider modifications to prevent the combine from creeping when the hydrostatic ground speed lever is in the neutral position.

FIGURE 4. Instrument and Control Console to the Right of the Operator.

**Instruments:** The instruments were located on two consoles, one to the right of the operator, the other above the windshield (FIGURES 4 and 5). The lower console housed gauges for turbocharger boost pressure, battery voltage, coolant temperature, engine oil pressure, and grain loss monitor meter. The upper console had the grain loss monitor adjustments, engine and separator hour meters, and digital read out that selectively displayed fuel

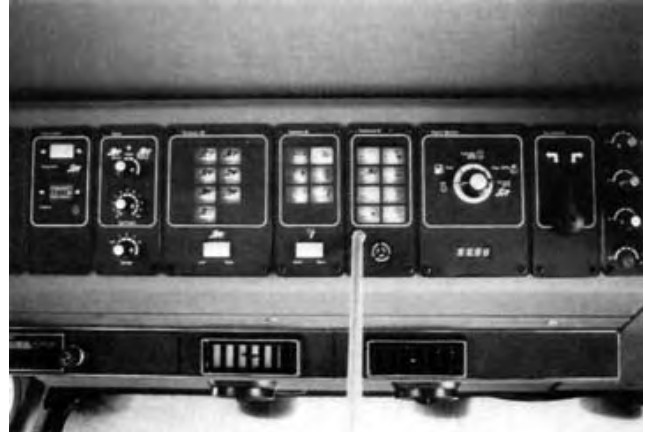
level, cylinder speed, engine speed, and combine ground speed. As standard equipment, indicators alerted the operator of an open stone trap door, engaged parking brake, excessive hydraulic oil temperature, straw walker overload, engine air filter restriction, low coolant level, fuel restriction, excessive transmission oil temperature, and reduced speeds of the major combine drives. Optional equipment on the test machine included warning devices for low engine oil pressure, low hydraulic oil level, low battery voltage, excessive coolant temperature, full grain tank and an extended unloading auger. All monitored functions had warning lights and most were accompanied with a four second audio alarm.

FIGURE 5. Instrument Panel Above the Windshield.

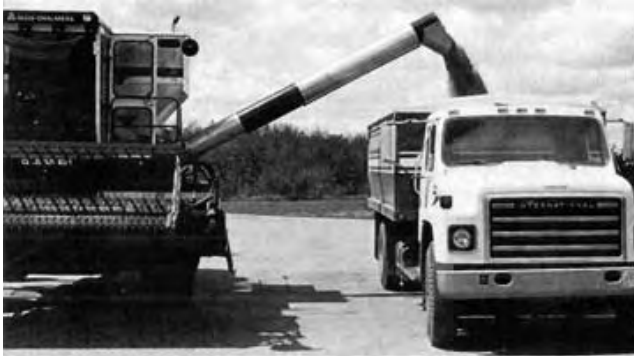
The unloading auger clearance was adequate for most trucks and grain trailers (FIGURE 6). The unloading auger delivered a compact stream of grain, and unloaded a full tank of dry wheat in about 120 seconds.

FIGURE 6. Unloading. FIGURE 7. (1) Concave Thresher Door, (2) Concave.

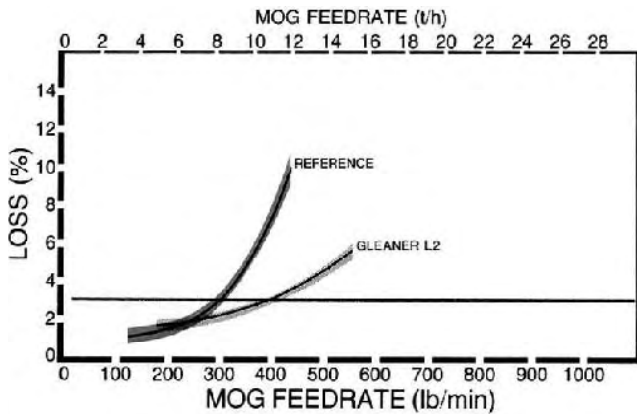
FIGURES 14 to 18 compare the total grain losses of the Gleaner L2 and the Machinery Institute reference combine in the five crops described in TABLE 4. The shaded areas on the curves are 95% confidence belts. If the shaded areas overlap, loss characteristics of the two machines are not significantly different whereas if the shaded areas do not overlap, losses are significantly different.

FIGURE 17. Total Grain Loss in Neepawa Wheat (E).
