Evaluation Report

437

Straw Storm Straw and Chaff Spreading Attachment

STRAW STORM STRAW AND CHAFF SPREADING ATTACHMENT

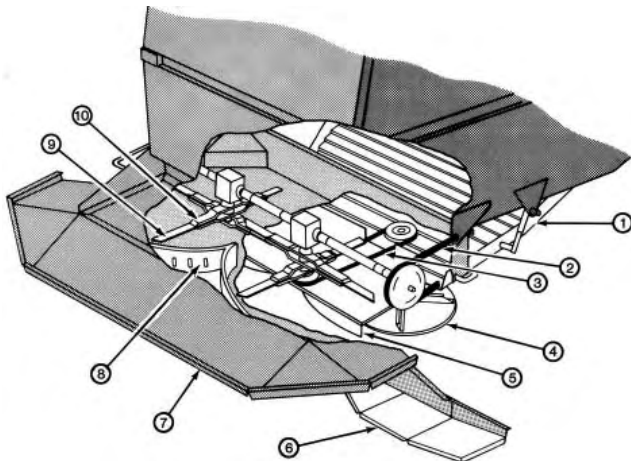
FIGURE 1. Straw Storm Straw and Chaff Spreading Attachment: (1) Chaff Pan, (2) Main Drive Belt, (3) Chaff Spreader Drive Belts, (4) Chaff Spreading Discs, (5) Chaff Deflector Shield, (6) Side Deflectors, (7) Rear Shield, (8) Shroud, (9) Flails, (10) Rotors.

Straw from the straw walkers or rotor falls onto two sets of horizontally rotating sharpened flails. The flails chop and accelerate the material, throwing it out of the sides or rear of the spreader body (see FIGURE 1). A pan attached to the rear of the cleaning shoe conveys chaff to two spreading discs. Fins on these discs

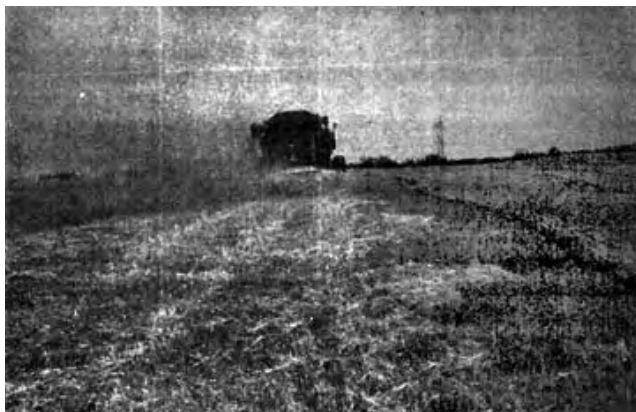
FIGURE 2. Typical Spread Pattern.

Spreading Width: In dry average conditions, and when properly adjusted, the Straw Storm spread straw 50 ft (15.2 m) (FIGURE 2). In heavy damp windrows, straw was spread up to 60 ft (18.3 m). In narrow windrow spacings, the spread could be reduced to 36 ft (11 m) to prevent straw from being thrown onto adjacent windrows. In dry average conditions, the chaff spread was usually 20 ft (6.1 m). With heavy damp chaff, the maximum chaff spread width was 28 ft (8.5 m). The widest chaff spread was obtained with the discs raised within the deflectors.

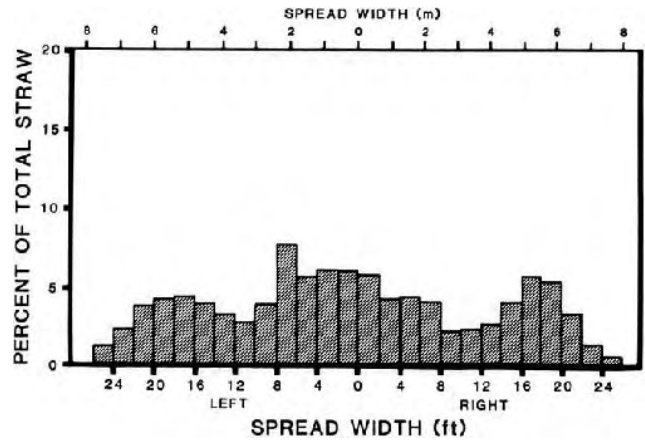
FIGURE 3. Typical Straw Spread Pattern Uniformity.

Typical straw and chaff spread patterns are shown in FIGURES 3 and 4. The coefficient of variation (CV)¹ was 39% for the straw and 19% for the chaff. These are well within the acceptable limit. The uniformity of the spread pattern will differ considerably with field conditions and machine adjustments.

¹The coefficient of variation (CV) is the standard deviation of the material in each successive 24 in (508 mm) section across the spread pattern expressed as a percent of the average amount of material in a section. The lower the CV, the more uniform is the spread pattern.

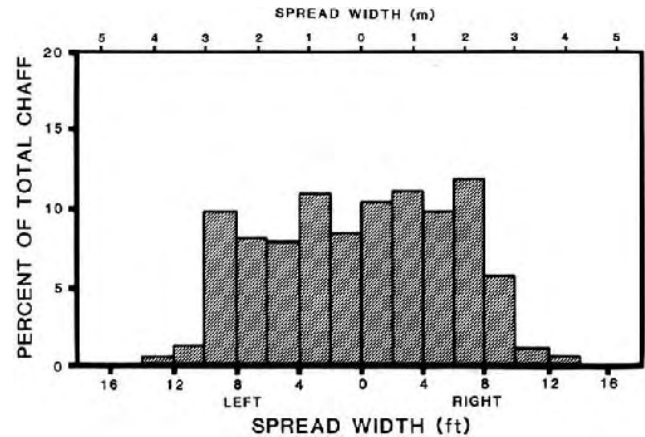
FIGURE 4. Typical Chaff Spread Pattern Uniformity.

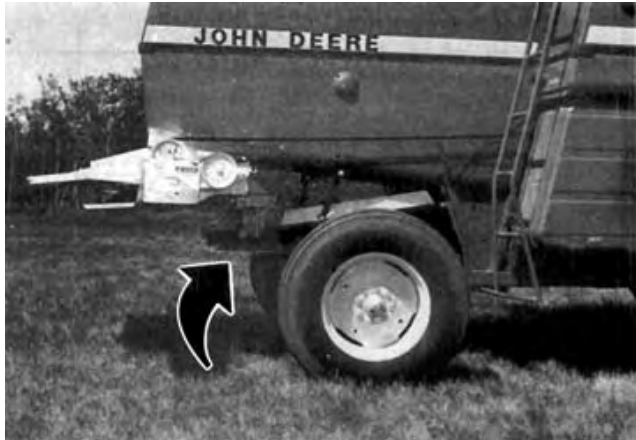
FIGURE 5. Limited Access to Shoe Adjustments.

Combine Adjustment: Ease of adjusting the combine's cleaning shoe was poor with the Straw Storm installed (FIGURE 5). The chaff pan and chaff spreading discs restricted access to the combine shoe, making it difficult to adjust the chaffer cleaning sieve. The operator had to remove the chaff spreading discs and climb onto the chaff pan to view the chaffer and sieve. It is recommended that the manufacturer modify the chaff pan to allow easy access to the combine shoe.
