Evaluation Report

Western Roto Thresh Self-Propelled Combine

WESTERN ROTO THRESH SELF-PROPELLED COMBINE

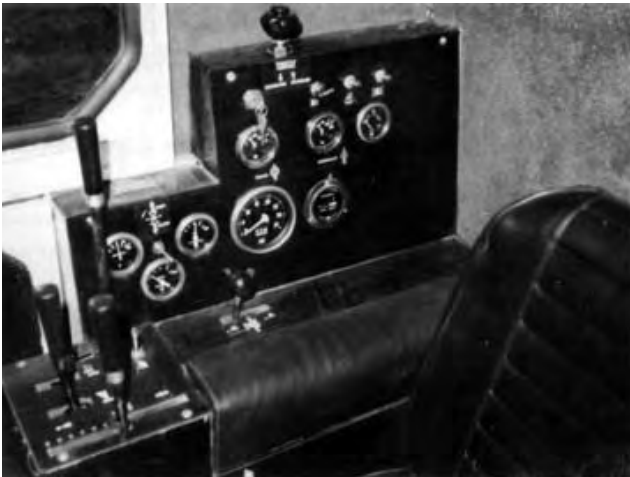
Instruments: The instrument console (FIGURE 3) included gauges for engine oil pressure, coolant temperature, battery charging, hydraulic oil temperature, hydrostatic oil temperature, engine speed, fuel level and engine hours.

FIGURE 3. Instrument Console.

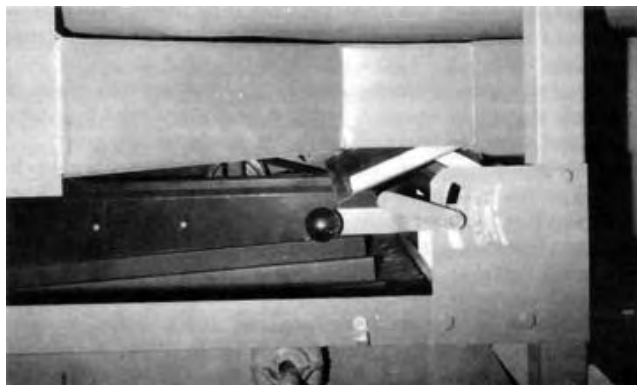
Aspirator Adjustment: The aspirator was easy to adjust. Suction was controlled by varying a door in the suction throat opening (FIGURE 8). Best results were obtained with the door fully closed in wheat, from fully closed to 25 mm (1 in) open in barley and from 60 to 100 mm (2.4 to 3.9 in) open in rapeseed.

FIGURE 8. Suction Throat Adjustment.

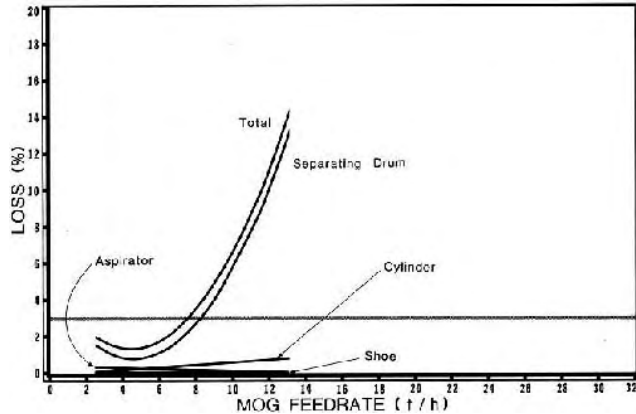
The grain loss characteristics for the Western Roto Thresh, in the three crops described in TABLE 4, are presented in FIGURES 10 to 12.

FIGURE 10. Grain Loss in Betzes Barley.

Separating Drum Loss: Separating drum loss was the most significant factor limiting capacity in all grain crops. The performance was similar to conventional combines, where straw walker loss is usually the most significant factor. A reduction in free grain loss over the separating drum would have enabled much higher combining rates especially in difficult to separate crops such as barley.

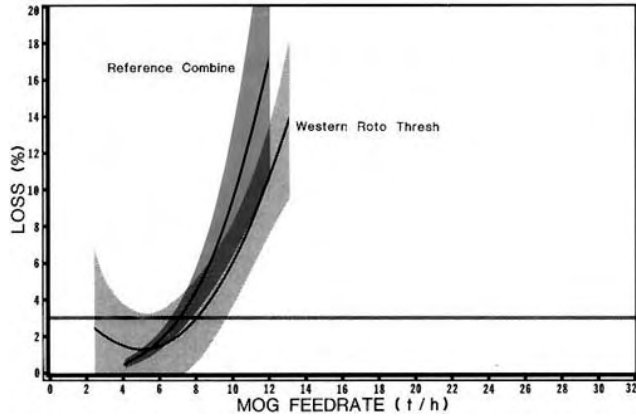
FIGURE 14. Total Grain Losses in Betzes Barley.

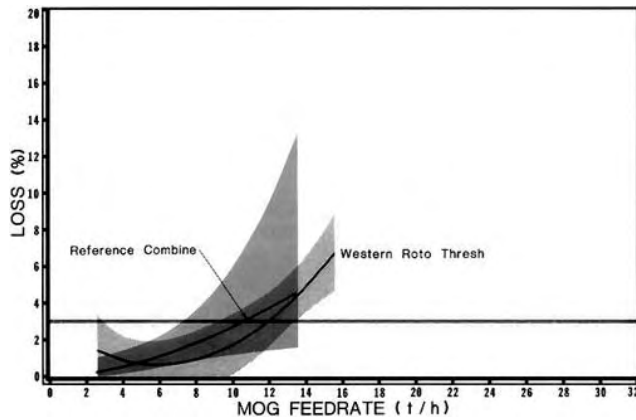
FIGURE 15. Total Grain Losses in Neepawa Wheat.
