Evaluation Report

John Deere 9500 Self-Propelled Combine

JOHN DEERE 9500 SELF-PROPELLED COMBINE

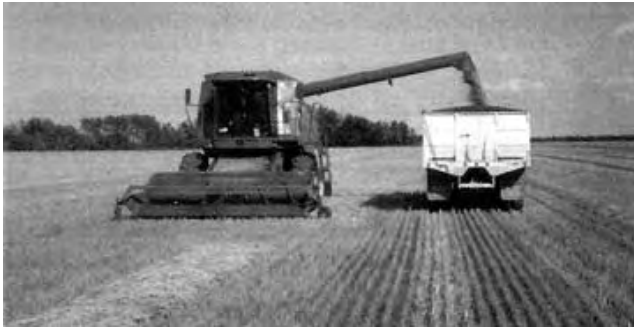
FIGURE 10. Unloading.

The unloading auger had ample reach and clearance for all trucks encountered (FIGURE 10). The unloading auger was hydraulically positioned for unloading to the left, and would unload in any position. The two position throttle switch only allowed the combine to unload either at full speed or idle. At the maximum unloading speed, the auger discharged the grain in a reasonably compact stream, unloading a full tank of dry wheat in about 95 seconds. This was generally too fast for topping loads. Switching the engine to an idle reduced unloading speed greatly, and was

too slow to be practical. It is recommended that the manufacturer consider adding an engine speed setting, which would provide a more suitable unloading rate for topping loads. Optional grain tank auger covers could be installed to reduce unloading rate if desired. Straw and Chaff Spreading: Straw spreading was good and chaff spreading was very good.

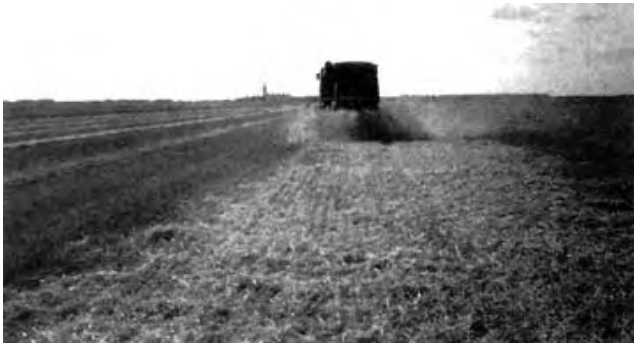
FIGURE 11. Typical Straw Spread.

Width of straw spread was set by adjusting the tail plate angle and the fin angle. Under ideal conditions, straw was evenly spread over widths up to 25 ft (7.6 m) (FIGURE 11).

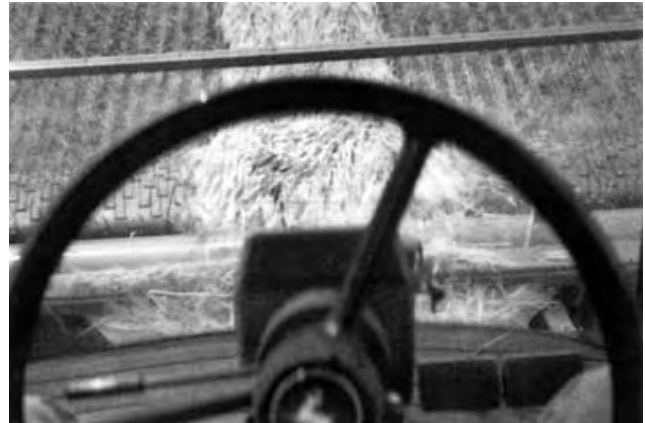
FIGURE 12. View of Incoming Windrow.

The operator had a clear view forward and to the sides. The large convex rear view mirrors provided adequate rear visibility. For most operator's, view of the incoming windrow was partially obstructed by the steering wheel, regardless of seat or steering wheel position (FIGURE 12). Dust from the feeder (FIGURE 13) often reduced visibility of the feeder area especially in low light conditions, such as at dusk. Grain entering the tank was clearly visible through the rear cab and grain tank windows. The unloading auger was easily viewed when swung fully forward but the operator had to lean forward to see the auger if it was swung back to less than 90 from the combine body.

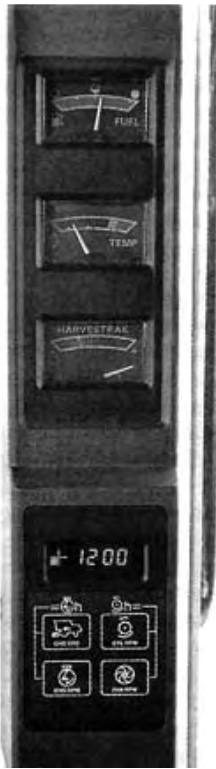
FIGURE 14. Instruments in Cab Pillar.

The instruments were located in the right front cab pillar (FIGURE 14) and in a panel above the windshield (FIGURE 15). The instruments in the pillar included gauges for fuel level and

engine coolant temperature, and a digital display to selectively show engine RPM, cylinder RPM, cleaning fan RPM, ground speed, and engine hours, or separator hours. The overhead panel contained an alarm and color coded indicator lamps for parking brake engagement, separator drive filter obstruction, separator drive oil temperature, hydraulic oil temperature, improper battery voltage, engine air filter obstruction, plugged straw walkers, full grain tank, low hydrostatic charge pressure, low separator drive pressure, excessive engine coolant temperature, and inadequate oil pressure, as well as reduced speed of the engine and key machine components. All warning lamps worked very well and were clearly labelled for easy identification. However, some operators found the location inconvenient to check alarms source at a glance.

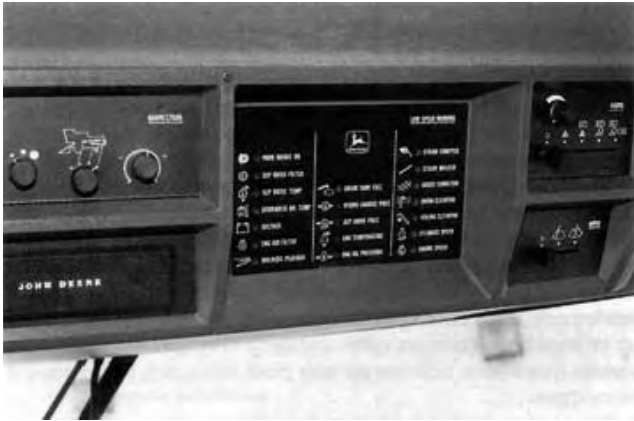
FIGURE 15. Instruments in Overhead Console.

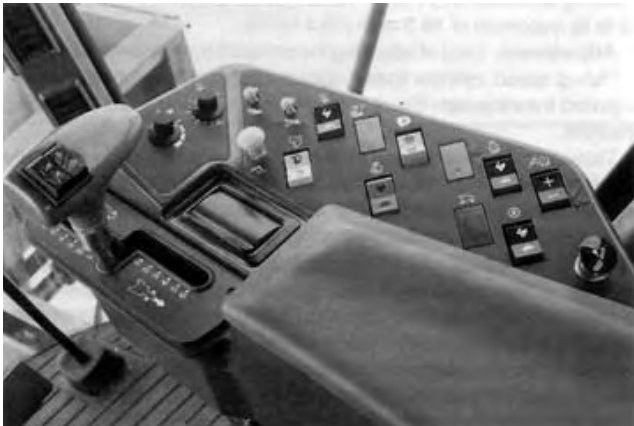
FIGURE 16. Integrated Control Console and Arm Rest.

The separator and header drives were engaged with toggle switches. These switches were protected from accidental engagement with detents, which required the switch to be lifted before it could be activated. The header reverser was controlled with a rocker pedal on the cab floor and was convenient to use. The header height control switch was located in the handle of the hydrostatic control lever, and was positioned horizontally in the top

of the handle (FIGURE 16) rather than vertically on the handle's side as they are on many other combines. This location permitted switch operation with either the thumb or a finger, however, the direction of activation was somewhat confusing at first for operators accustomed to other combines. After a period of time, most operators found the control logical, and convenient to use. The automatic header height control consisted of a rotary switch, which allowed the operator to select one of three preset pickup angles. This system worked well and effectively maintained pickup position, even over widely varying ground contours.
