# Evaluation Report

## Thomas Model 635 Potato Harvester

# THOMAS MODEL 635 POTATO HARVESTER

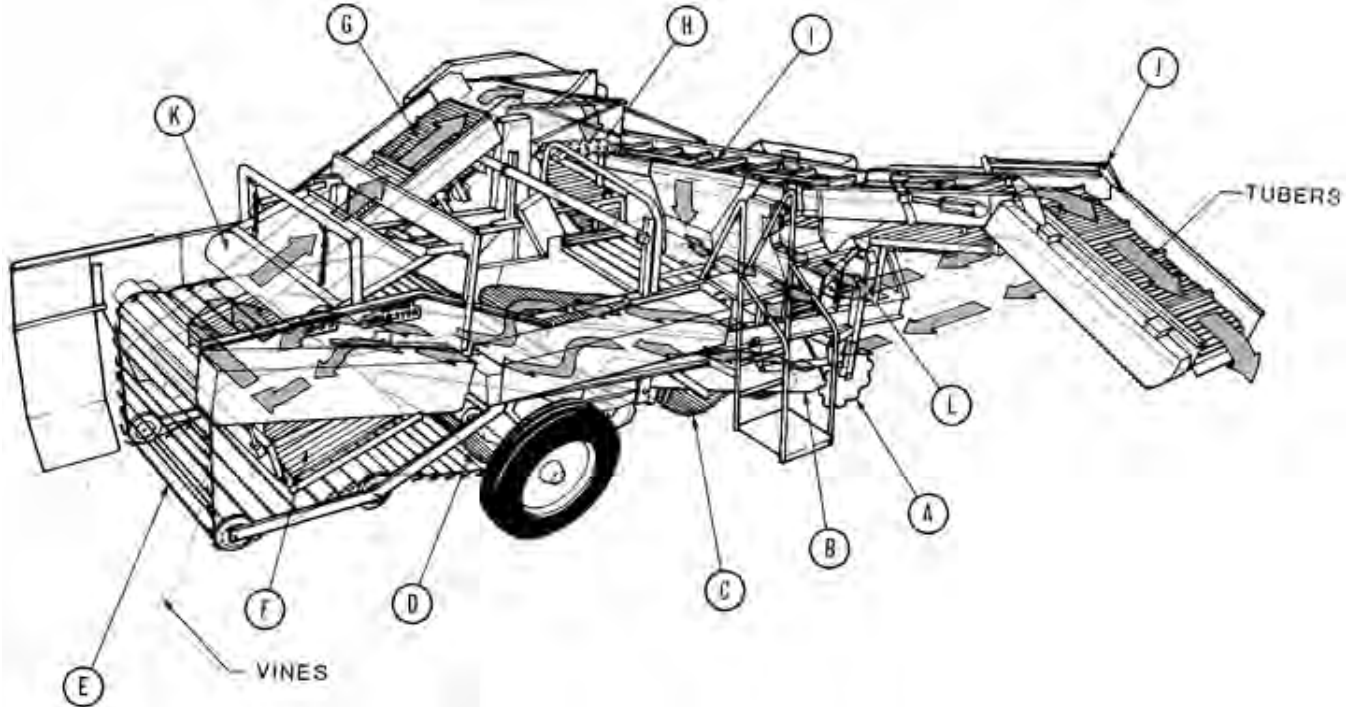
FIGURE 1. Thomas 635 Potato Harvester: (A) Coulters, (B) Spade, (C) Primary Digger Chain, (D) Secondary Digger Chain, (E) Deviner, (F) Cross Conveyor, (G) Elevating Conveyor, (H) Clod Roller Table, (I) Sorting Table, (J) Delivery Boom, (K) Stripper Roller, (L) Trash Conveyors.

The Thomas 635 (FIGURE 1) is a two row, power take-off driven, pull-type potato harvester, with a 1.6 m cutting width.

The spade moves through the soil beneath two rows of potatoes, lifting a mass of soil, tubers and vines onto the primary digger chains. A portion of the soil falls through the primary digger chains, while the remaining soil, tubers and vines are delivered to the secondary digger chains. A larger pitch deviner chain, which rotates outside the secondary chains, carries vines and trash out the back of the harvester. The secondary chains complete loose soil separation and deliver tubers and soil clods to the cross conveyor. Tubers and clods are conveyed up an elevating conveyor to a clod roller table where a series of rollers remove small tubers and clods. Final sorting and cleaning takes place on a hand sorting table, with provision for up to six labourers. Sorted tubers are finally delivered to the receiving vehicle on an adjustable conveyor boom.

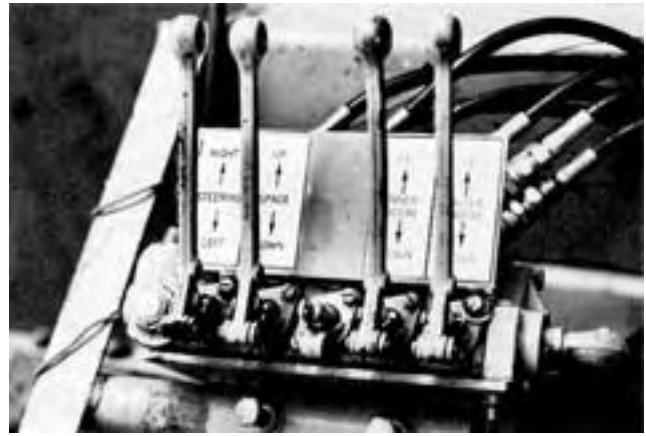
FIGURE 2. Hydraulic Control Valve Assembly.

The Thomas 635 was powered by a standard 540 rpm power take-off shaft from the tractor. It was equipped with its own hydraulic control valve assembly (FIGURE 2) which connected to one set of outlets on the tractor hydraulic system and which could be mounted

**Controls:** Access to hydraulic controls was convenient since the control assembly could be mounted at a suitable location on the tractor. Individual hydraulic controls were provided for spade depth, delivery boom height and optional power steering.

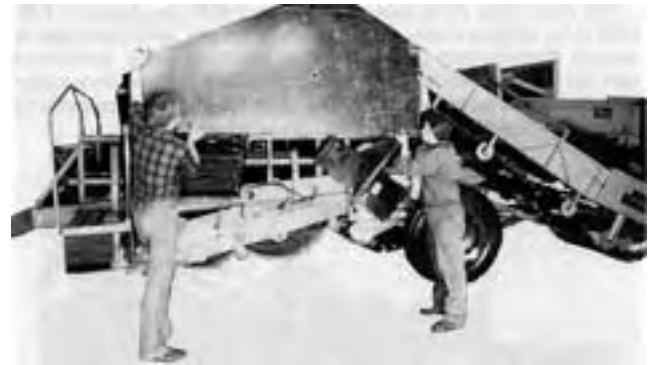
FIGURE 4. Clod Roller Drive Shield.

Many shields had to be removed to lubricate the roller chains. The large shield covering the clod table drive (FIGURE 4) was particularly cumbersome and heavy to remove. Lubrication access holes in the chain shields would have greatly facilitated chain servicing.

It is recommended that the manufacturer provide a lubrication schedule, consider providing access holes in chain shields to facilitate lubrication and consider modifying the clod roller drive shield to improve ease of access to the drive assembly.

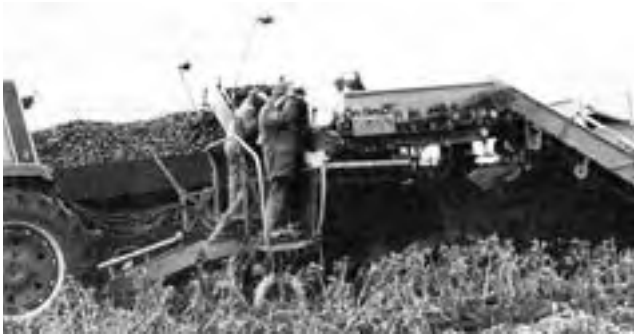
FIGURE 5. Hand Sorting Table.

**Manual Sorting:** As with most potato harvesters, the quality of the product delivered to the receiving truck depended primarily on the ability of the hand sorters, (FIGURE 5) to perform final sorting. The sorting table had room for six people. The effectiveness of the hand sorting and the number of labourers needed was governed by the harvesting rate and by soil conditions. In dry, lumpy soil, which

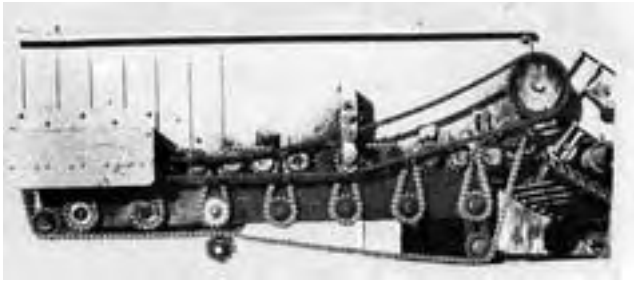
**Clod Table Drive:** The clod table was equipped with a complicated drive arrangement. A single roller chain drove the 16 rollers by passing over 16 drive sprockets and nine idler sprockets (FIGURE 7). Deformation of the idler mounts during operation resulted in chain misalignment. Slight chain wear resulted in rapid idler sprocket wear due to the large chain wraparound the idler sprockets. Repeated idler sprocket failures necessitated drive modification.

**FIGURE 7.** Original Clod Table Drive Assembly.

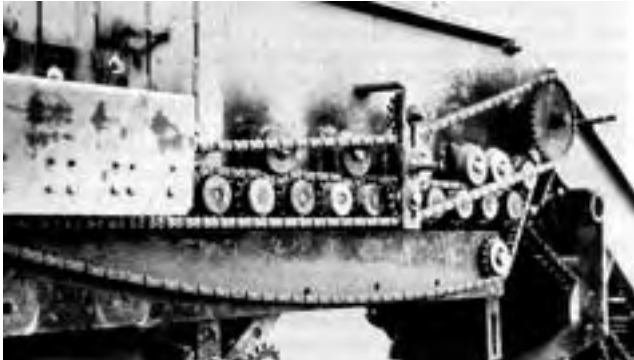
The clod table drive was modified by PAMI, as shown in FIGURE 8, to reduce chain wrap around the idler sprockets and to reduce deformation problems. The modified drive performed well for the last 115 hours of field operation. It is recommended that the manufacturer modify the clod table drive assembly to reduce durability problems.

**FIGURE 8.** Modified Clod Table Drive Assembly.

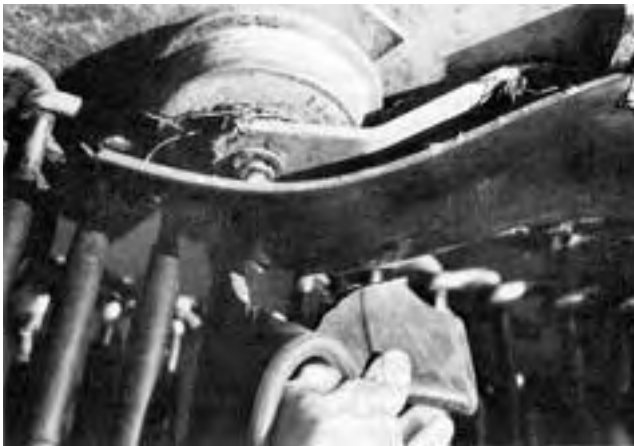
**Elevator Flights:** After 230 hours of use, many rubber flights on the elevating conveyor and delivery boom were badly torn at their

ends (FIGURE 9). The damaged flights caused some tuber roll back on elevating conveyor.

**FIGURE 9.** Torn Elevator Flighting.
