Evaluation Report

122

New Holland 28 Forage Blower

NEW HOLLAND MODEL 28 FORAGE BLOWER

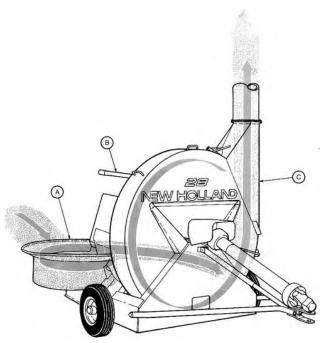
FIGURE 1. New Holland 28: (A) Feed Rotor Hopper, (B) Clutch Lever, (C) Blower Fan.

The New Holland 28 (FIGURE 1) is a 540 rpm, power take-off driven forage blower. It is equipped with a horizontal feed rotor in a circular hopper, and a six-blade blower, mounted on a two wheel transport trailer.

Clutch Lever: The feed rotor could be stopped with the clutch lever (FIGURE 1) if clogging was imminent. It took about 360 N force to operate the clutch. A lower force requirement would have improved safety and convenience.

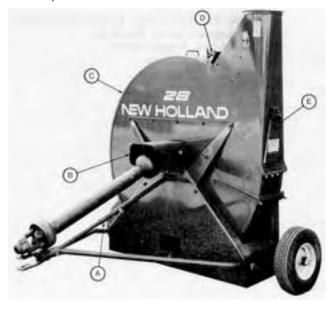
Positioning: The New Holland 28 was equipped with an adjustable hitch to aid in levelling the blower. No hitch jack was supplied, however, due to low hitch weight, one was not required. Hitch height adjustment range was 575 mm. Opening or closing the telescopic hitch support (FIGURE 2) to adjust the hitch height, took about one minute. No stabilizer stands were required due to the smooth operation of the machine.

FIGURE 2. Blower Front View: (A) Telescoping Hitch Support, (B) Drive Shield, (C) Housing Band, (D) Band Tightener, (E) Clean-out Door.

Removable Blower Housing Band: The blower housing band could be rotated, to facilitate pipe coupling, by loosening the band tightener. A clean-outdoor provided for easy cleaning when the blower clogged.

Servicing: The New Holland had eleven pressure grease fittings requiring daily lubrication and one fitting requiring weekly lubrication. The five hopper drive fittings were on an easily accessible bank. Lubricating the rear universal joint on the power take-off drive required the removal of the drive shield (FIGURE 2). Daily lubrication and maintenance took about 5 minutes.
