Evaluation Report

Bee Model 7410 Combine Loss Monitor

A Co-operative Program Between

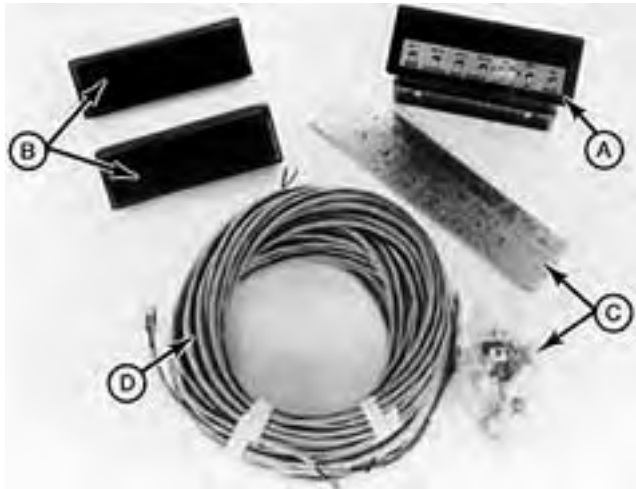
FIGURE 1. BEE Model 7410 Combine Loss Monitor: (A) Control Box (B) Sensors (C) Mounting Hardware (D) Wiring Harness.

The BEE Model 7410 combine loss monitor senses grain losses over the shoe and straw walkers of a combine and indicates changes in the rate of grain loss to the operator. It is designed to mount on most self-propelled or pull-type conventional combines.

Small pad-type sensors, which detect impacts from grain kernels, are attached beneath the rear of the straw walkers and shoe to intercept grain losses. Sensor signals are fed by cables to a control box mounted at the operator's station, where the rate of kernel impacts is measured and displayed.

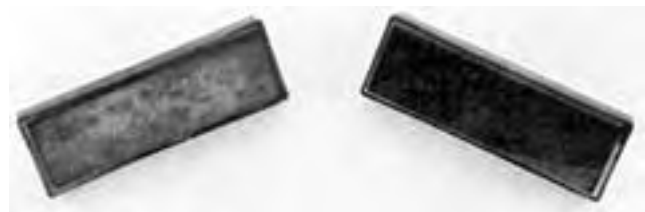
Sensor Installation: The BEE 7410 is supplied with two 156 x 56 mm (6.1 x 2.2 in) pad-type sensors (FIGURE 2) for mounting at the rear of the straw walkers and shoe.

FIGURE 2. Sensors.

The shoe sensor may be mounted behind the shoe or beneath the shoe behind the tailings auger. It was found that a sensor, mounted behind the shoe, gave more positive sampling of losses than did the one beneath the shoe.

The walker sensor may be mounted in the bottom of a closed straw walker or on the grain pan beneath an open straw walker. It was found that a sensor could also be mounted behind the straw walker however, flying objects from the straw chopper could damage this sensor.
