Evaluation Report

35

Riteway RS-400 Field Sprayer

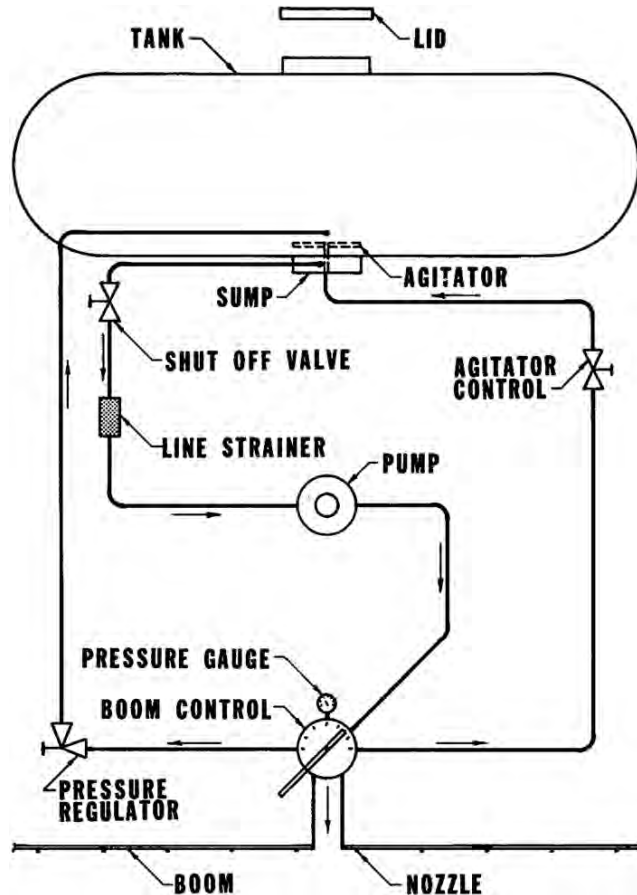
Figure 1. Flow Diagram for Riteway RS-400.

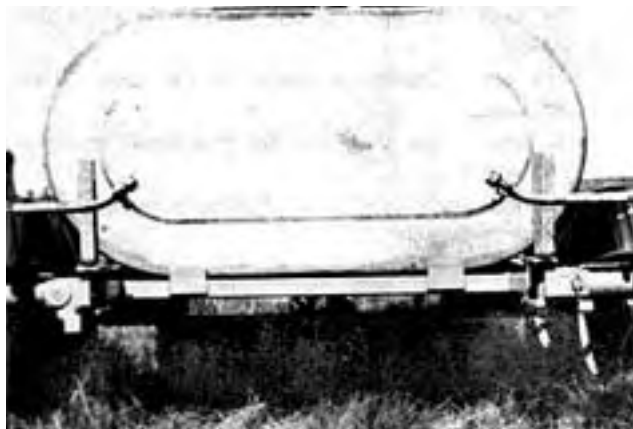
Distribution Patterns: Figure 2 illustrates the positioning of the nozzles at the centre of the RS-400. This design eliminates the need for a third boom behind the sprayer tank and simplifies boom height and angle adjustment. To obtain pattern overlap the two inside nozzles are angled inward, using the same 65° nozzles (TeeJet 6501) as used on the rest of the booms. As a result of this design, the spray pattern directly behind the tank was unacceptable. High spray application occurred at the centre of the sprayer, where the patterns from the two inside nozzles met, with reduced coverage on either side of this peak. A typical spray pattern for the centre boom section is shown in Figure 3. The application rate at 8 km/h (5 mph) varied from 25 to 98 L/ha (2.2 to 8.7 gal/ac) over the 1000 mm (40 in) length of boom covered by the two angled nozzles. This distribution pattern had a coefficient of variation (CV)¹ of over 27%.

Figure 2. Boom Design at the Centre of the RS-400.

1. Modifying the boom configuration at the centre of the sprayer to improve the spray pattern and to permit the use of a wider variety of nozzle tips.
2. Supplying 80° nozzle tips as standard equipment.

1. The boom configuration has been changed to achieve a standard nozzle spacing of 508 mm (20 in) at the centre of the sprayer. The centre nozzles are no longer angled inward.

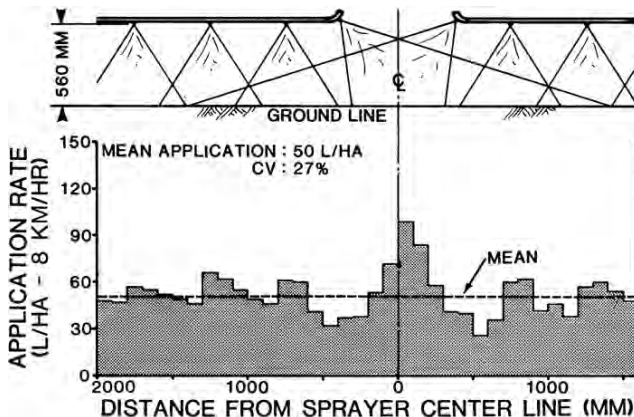
Unacceptable distribution patterns at the centre of the sprayer were evident at all operating pressures. The boom design requires modification to improve the spray pattern and prevent high chemical concentrations at the centre of the sprayer.

Figure 3. Distribution Pattern at the Centre of the Spray Boom at 275 kPa (40 psi) Pressure with TeeJet 6501 (65°) Nozzles, 560 mm (22 in) above the Ground.

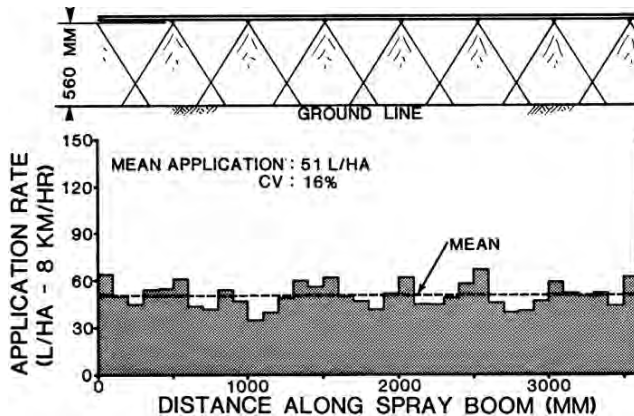
The distribution pattern for a straight section of boom, operating at the same pressure, is shown in Figure 4. This figure shows an improved distribution pattern with a CV of 16%. For this boom section, the application rates at 8 km/h (5 mph) varied from 35 to 67 L/ha (3.1 to 6.0 gal/ac).

Figure 4. Distribution Pattern for a Straight Section of Spray Boom at 275 kPa (40 psi) Pressure with TeeJet 6501 (65°) Nozzles, 560 mm (22 in) above the Ground.

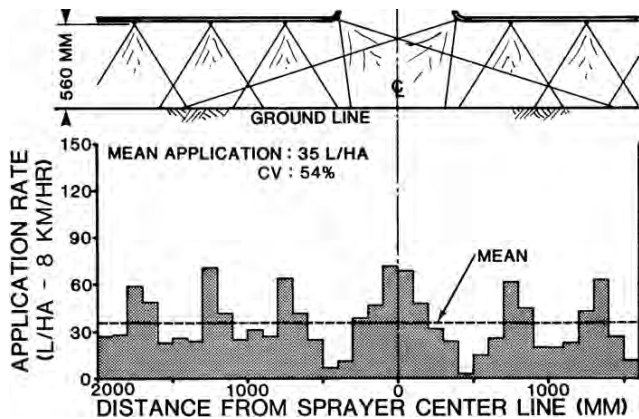
Figure 5 shows the distribution pattern at the centre of the sprayer when using 65° nozzles at a pressure of 140 kPa (20 psi). In this case, the CV was 54% with application rates along the boom varying from 3 to 73 L/ha (0.3 to 6.5 gal/ac) at a forward speed of 8 km/h (5 mph). At low pressures, high concentrations occur directly below each nozzle with inadequate coverage between the nozzles. Higher pressures improve the distribution pattern but result in more spray drift.

Figure 5. Distribution Pattern at the Centre of the Spray Boom at 140 kPa (20 psi) Pressure with TeeJet 6501 (65°) Nozzles, 560 mm (22 in) above the Ground.

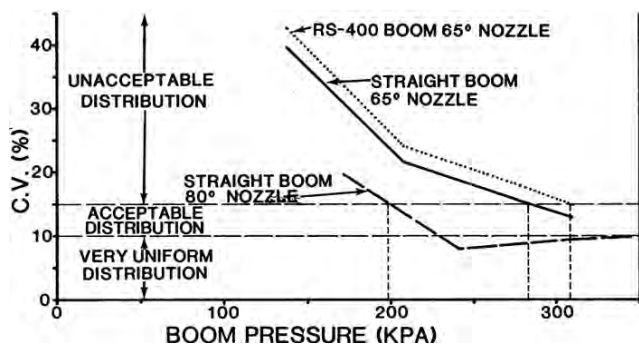
Figure 6 compares spray pattern uniformity at various boom pressures, for the RS-400 boom with angled centre nozzles (Figure 2), for a straight boom without angled centre nozzles, both using 65° nozzles (TeeJet 6501), and for a straight boom using nozzles of the same capacity but with a spray angle of 80° (TeeJet 8001).

Spray distribution was unacceptable on the centre boom section at pressures below 310 kPa (45 psi). Using the same 65° nozzles on a straight boom section, spray distribution was unacceptable at pressures below 283 kPa (41 psi). Neither of these boom configurations produced very uniform distribution (CV less than 10%) in the accepted operating range below 310 kPa (45 psi). However,

the straight boom section with 80° nozzles produced acceptable spray distribution at pressures above 200 kPa (29 psi) and in the range from 225 to 340 kPa (33 to 50 psi) the distribution was very uniform. It is evident that 80° nozzles would greatly improve spray distribution and allow spraying at lower pressures to reduce drift.

Figure 6. Spray Pattern Uniformity at Various Boom Pressures with 65° and 80° Nozzles.

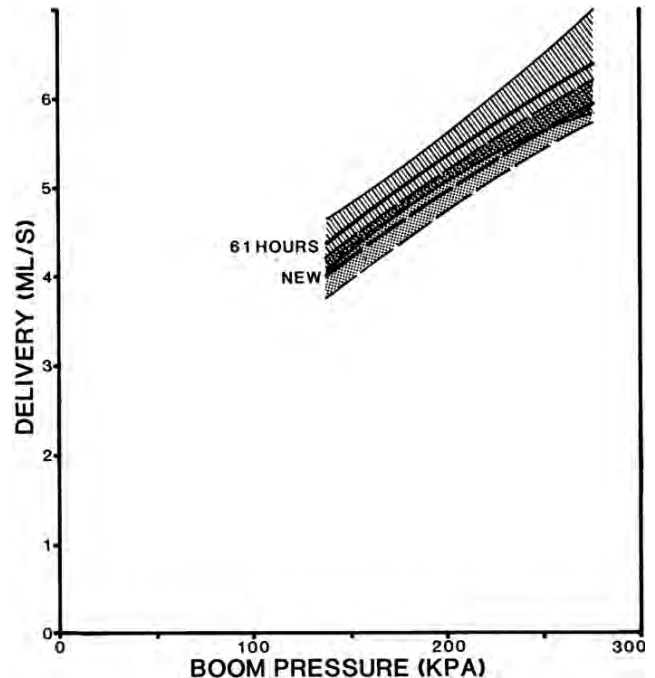
Nozzle Calibration and Wear: Figure 7 compares the delivery rates of the TeeJet 6501 brass nozzles when new and after 61 hours of operation. Nozzle wear during field operation caused the output of the nozzles to increase by 8%. Some researchers indicate that a nozzle needs replacement once delivery has increased by more than 10%. Nozzle wear depends on the type of chemicals sprayed and water cleanliness.

Figure 7 also shows the variability among individual nozzles. The shaded areas represent the range over which the deliveries from 10 nozzles varied when new and after field tests. A narrow range indicates that nozzle discharges are very similar while a wider range indicates more variability among individual nozzle deliveries. Variability among individual nozzle deliveries on the RS-400 was low. The coefficient of variation of the nozzle deliveries was 2.3% when new and increased to 3.6% after the field tests.

The delivery of the new nozzles was 8% lower than the manufacturer's rated capacity. This was due to the nozzle check valves, which caused a 35 kPa (5 psi) pressure drop from the boom to the nozzles.

Figure 7. Delivery Rates of TeeJet 6501 Nozzles - New and Used 61 Hours.

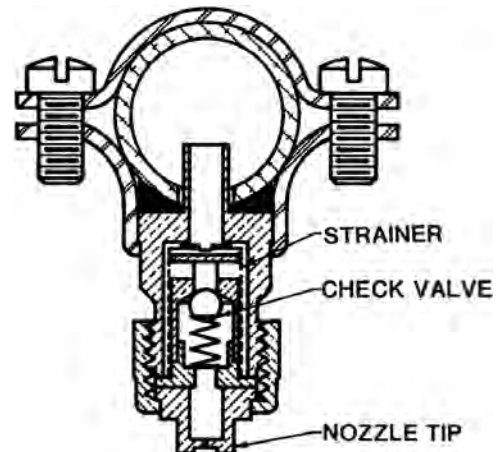
standard TeeJet nozzle body assemblies (Figure 8), so a wide range of nozzle sizes could be used. Flooding or cone type nozzles, which require a nozzle angle other than vertical, would not function normally due to the boom configuration at the centre of the sprayer.

Figure 8. Cross Section of Nozzle.

The non-drip nozzle check valves (Figure 8) caused a pressure drop of 35 kPa (5 psi) at the entrance to each nozzle. This pressure drop could affect calibration and nozzle spray patterns. Control valve pressure must be set 35 kPa (5 psi) higher than the desired application pressure to compensate for this pressure drop.

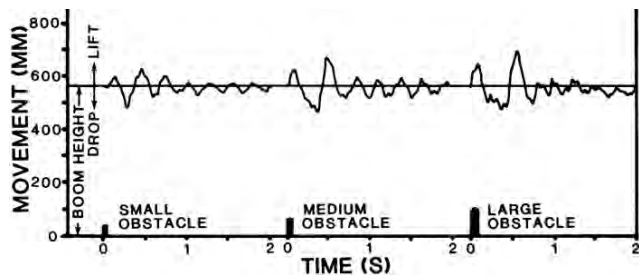
Figure 9 shows vertical boom movement (bounce) when the castor wheel was driven over the obstacles at 9 km/h (5.6 mph). The maximum movement at the end of the boom was a lift of 130 mm (5.1 in) and a drop of 80 mm (3.1 in). This resulted in a variation in boom height above the ground from 480 mm (18.9 in) to 690 mm (27.2 in), compared to the correct boom height of 560 mm (22 in). Figure 10 compares the nozzle overlap at these three boom heights.

Figure 9. Vertical Boom Movement at Boom End (lift and drop) when the Boom Castor Wheel is Driven over Different Obstacles at a Forward Speed of 9 km/h (5.6 mph).

Operations at 6 km/h (3.7 mph) caused vertical boom bounce about half as great as that at 9 km/h (5.6 mph). Driving over the obstacles at 12 km/h (7.5 mph) caused vertical boom bounce about 1.5 times greater than that at 9 km/h (5.6 mph).

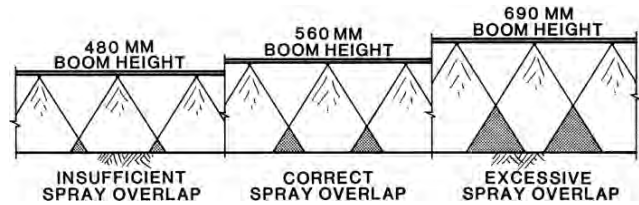
Figure 10. The Effect of Boom Lift and Drop on Spray Overlap.

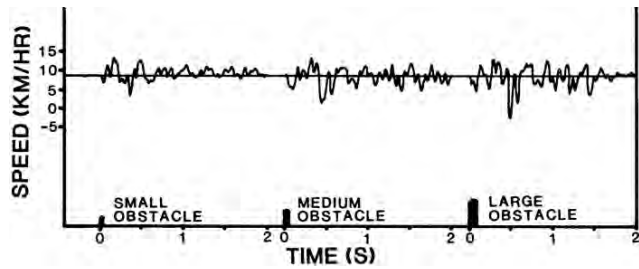
Figure 11 shows the forward speed of the boom end relative to the ground when the boom wheel was driven over the standard obstacles. Boom forward speed is important since application rate is inversely proportional to speed (doubling the forward speed cuts the application rate in half). Assuming that the nozzle spray follows boom movement, Figure 11 illustrates the resultant variation in application rates. High application rates occur at low speeds

while low application rates occur at high speeds. Extremely high variations in application rates can result for short periods of time due to horizontal boom movement. For example, at a forward speed of 9 km/h (5.6 mph) driving over the 65 mm (2.6 in) obstacle caused boom speed to vary from 3 to 14 km/h (1.9 to 8.7 mph).

Figure 11. Variation in Boom End Speed when the Boom Castor Wheel is Driven over Different Obstacles at an Average Forward Speed of 9 km/h (5.6 mph).

Respective application rates would vary from 133 to 29 L/ha (11.8 to 2.6 gal/ac). This variation occurred in only 0.14 second during which time the sprayer travelled 350mm (14 in). Speed changes due to horizontal boom movement were very similar on the RS-400 at operating speeds of 6 and 9 km/h (3.7 and 5.6 mph). At 12 km/h (7.5 mph), speed changes were much larger. In addition, when passing over the largest obstacle at 12 km/h (7.5 mph) the castor wheel made a complete rotation about the castor pivot as it was going over the obstacle. This caused extreme bouncing of the boom and the boom took about twice as long to stabilize after passing over the obstacle.

The data presented in Figure 11 are based on the assumption that the nozzle spray output follows boom movement over very short periods of time (0.1 second). The extreme variations in application rate that are suggested due to boom movement indicate that more research is required on boom stability and its effect on nozzle discharge and spray distribution.

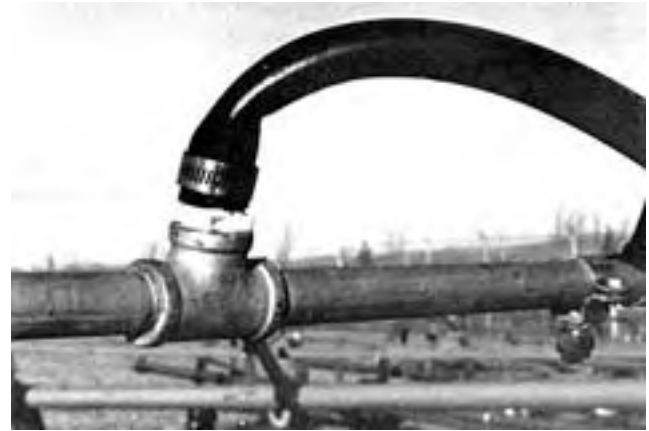
Buckling of the boom supply hoses (Figure 12) could possibly cause appreciable pressure drops as the hoses became fatigued. Modifications are required to eliminate this possibility.

Figure 12. Buckling of Supply Hose at Boom Inlet.

6. Modifying the boom hose inlets to prevent buckling of the boom hose.
7. Providing boom hose tie downs and re-routing the hoses to eliminate hose damage.

6. & 7. The boom is now being fed from the end and the hoses have been rerouted.
8. We have not developed a high capacity strainer at the tank filler opening but plan to do so in the future.

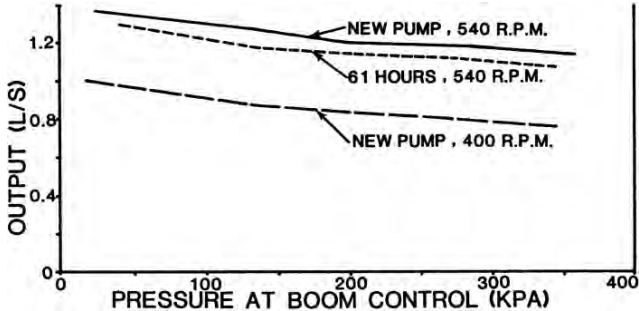
Agitation Capability: The new pump delivered 1.18 L/s (15.6 gal/min) at 276 kPa (40 psi) and 540 rpm (Figure 13). This was adequate to apply 177 L/ha (15.8 gal/ac) of emulsifiable concentrates or 67 L/ha (5.9 gal/ac) of wettable powders at 8 km/h (5 mph) and provide sufficient agitation to keep solution in the tank properly mixed. Normally recommended agitation rates for emulsifiable concentrates such as 2,4-D are 0.03 L/s per 100 L of tank capacity (1.5 gal/min per 100 gal of tank capacity). For wettable powders such as Atrazine and Sevin recommended agitation rates are 0.05L/s per 100 L of tank capacity (3.0 gal/min per 100 gal of tank capacity).

Figure 13. Pump Curves.

Operation at Reduced Speed: Figure 13 also shows that reducing pump speed from 540 rpm to 400 rpm resulted in a 30% decrease in pump output. Reduction in pump speed could occur when reducing tractor speed to turn a corner or when operating at reduced engine speed to obtain a correct ground speed to suit nozzle calibration.

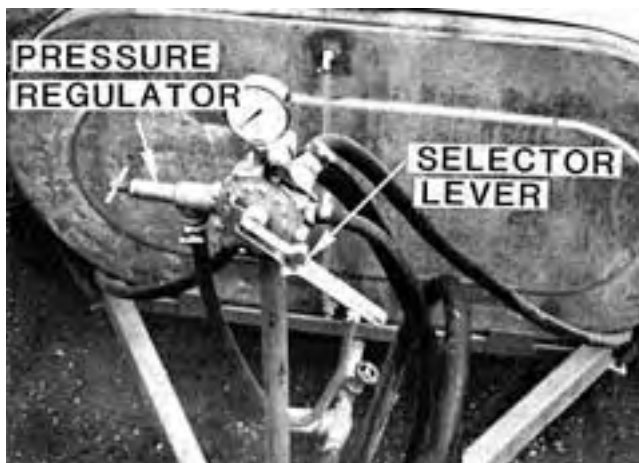
Controls: Application rate was controlled by adjusting tractor speed and spraying pressure. Pressure was easily regulated by adjusting the pressure regulator (Figure 14). Chemical flow to the booms was conveniently controlled with the selector lever. Most controls were accessible and the pressure gauge was easily read from the seat of most tractors. The agitator control valve (Figure 15), which was located near the bottom of the tank, could not be reached from the tractor seat. It would be desirable to have this valve near the boom control valve so that agitation could be adjusted from the tractor seat.

Figure 14. Controls.

9. We are considering changing the tank filler opening.
10. A tank drain plug will be provided for 1978 production.
11. The agitator control valve has been moved up to the selector valve.

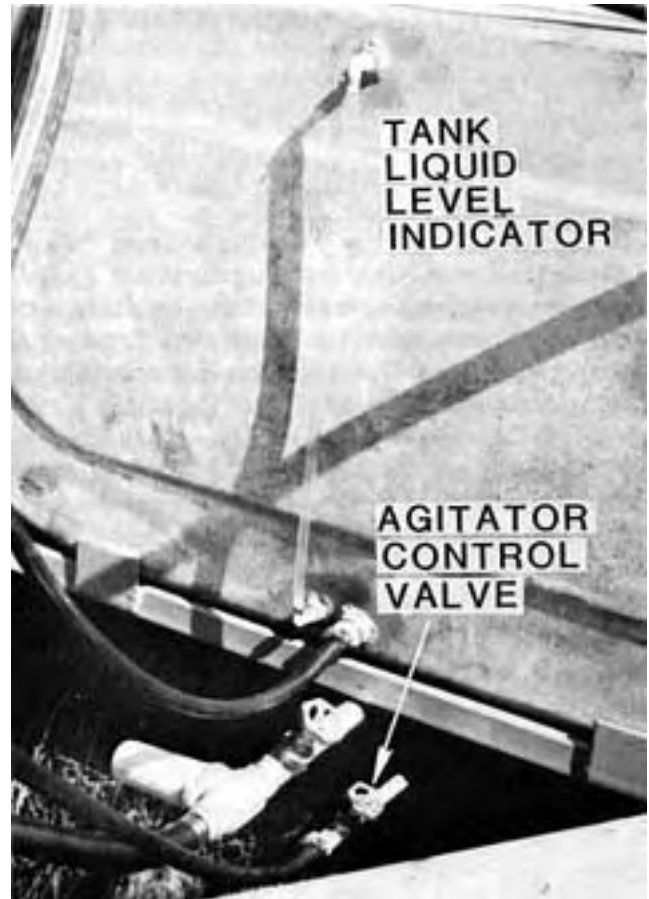
The tank liquid level indicator (Figure 15) was easy to read

if the solution in the tank was opaque. With clear solutions such as Banvel, the level in the tube was difficult to read. The gauge was only a rough indicator of liquid remaining in the tank because operation on hills and movement of liquid in the tank caused the level in the tube to fluctuate.

Figure 15. Awkward Location of Agitator Control Valve.

10. Providing a tank drain plug.
11. Relocating the agitator control valve so that it can be adjusted from the tractor seat.
12. Modifying the front radius arm brackets so they are more accessible.

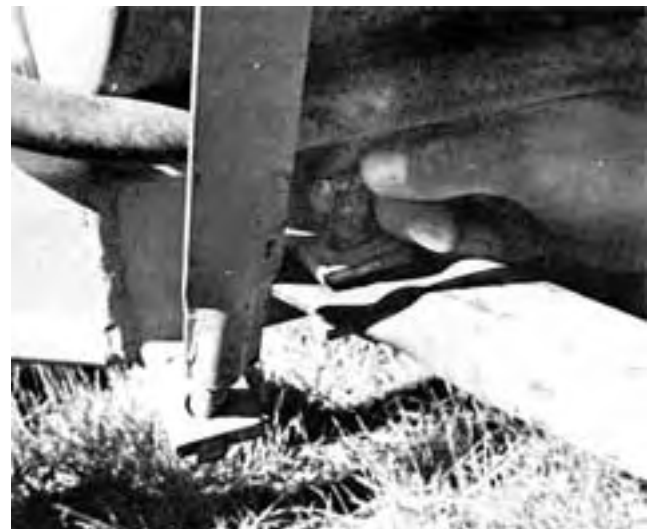
Transport: The RS-400 could be folded into transport by one man in 10 minutes without using tools. The pin located at the front of the radius brace (Figure 16) was difficult to install. Aligning the pinholes was difficult since the bracket was located underneath the tank. Lengthening the bracket to locate the pin further from the

Figure 16. Awkward Location of Radius Brace Pin.

12. We are considering this recommendation for the future.

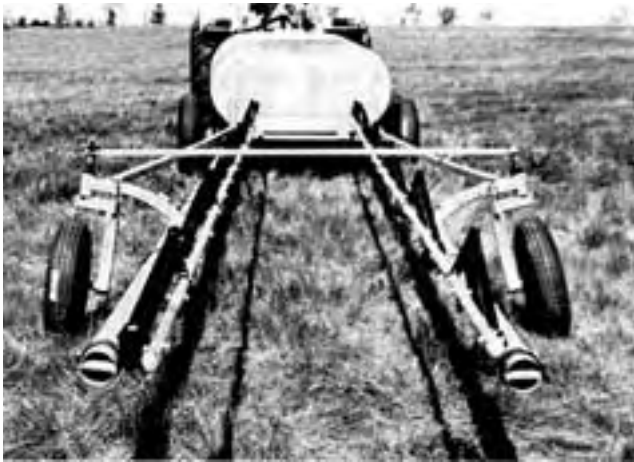
The castor wheels had to be cambered excessively in transport to keep the boom rail level in field position (Figure 17).

Figure 17. Excessive Camber of Castor Wheels.

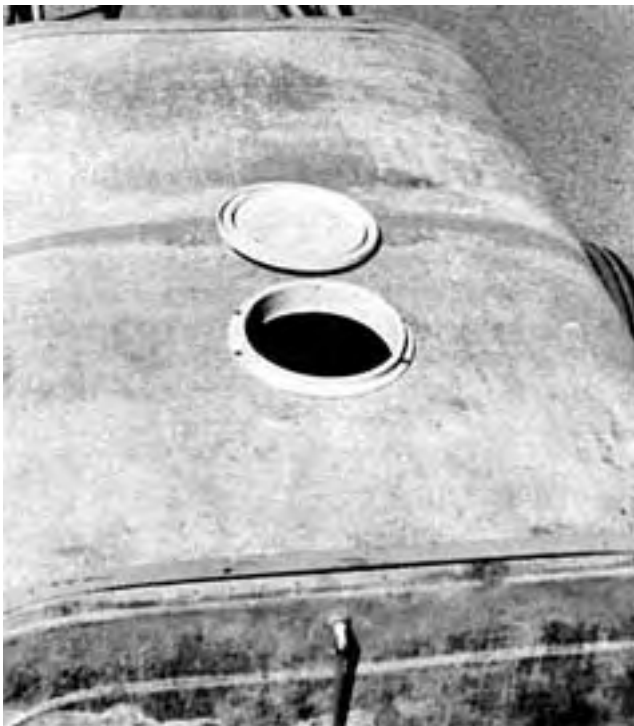
Tank Filling: The low profile tank was easily filled by gravity from a nurse tank on a farm truck. The 255 mm (10 in) filler opening was adequate for adding chemicals and water. Tank filling would have been more convenient if the opening was located closer to one edge of the sprayer tank instead of near the centre (Figure 18). There was also no convenient place to stand while lifting and pouring chemicals into the tank. An operator stand or platform should be provided to prevent the possibility of spillage or slipping while handling toxic chemicals.

Figure 18. Location of Tank Filler Opening.

8. Supplying a high capacity 100 mesh strainer at the tank filler opening.
9. Relocating the tank filler opening and providing a platform to facilitate safe and convenient addition of chemicals to the tank.

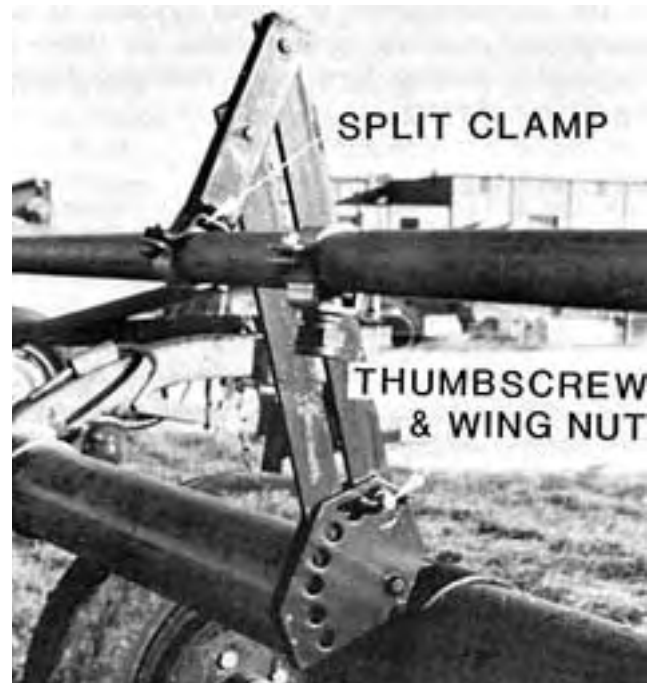
Nozzle Adjustment: Nozzle height adjustment required removing and replacing 10 thumb screw and wing nut assemblies (Figure 19). This took about 10 minutes if no problems were encountered. The thumbscrews and wing nuts were easily lost in the field and it was difficult to tighten the wing nuts sufficiently without tools so that they would not loosen during operation.

Nozzle angle adjustment was time consuming and awkward. A screwdriver was required to loosen 10 split clamp assemblies (Figure 19) before the booms could be rotated. The machine screws were awkward to loosen since they turned in from the bottom of the split clamp assembly. These screws also loosened in the field due to vibration.

Figure 19. Boom Adjustment.

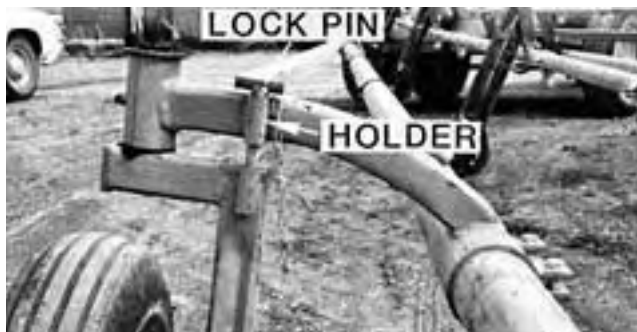
Castor Lock Pins: The chains on the castor lock pins broke where they were welded to the pin. The chain did not have sufficient strength to restrain movement of the lock pin. When the chain broke, the pin fell through the holder (Figure 20). A length of rod was welded across the top of the lock pin to eliminate this problem.

Figure 20. Castor Assembly.

3. Modifications to eliminate loosening of the boom carrier bolts during operation.
4. Modifications to eliminate castor wheel shimmy.
5. Modifying the castor lock pin to prevent chain failure.

4. A totally new castor system has been developed and implemented for 1977.
5. The castor lockpin has been modified by welding a "T" to the top of the pin.

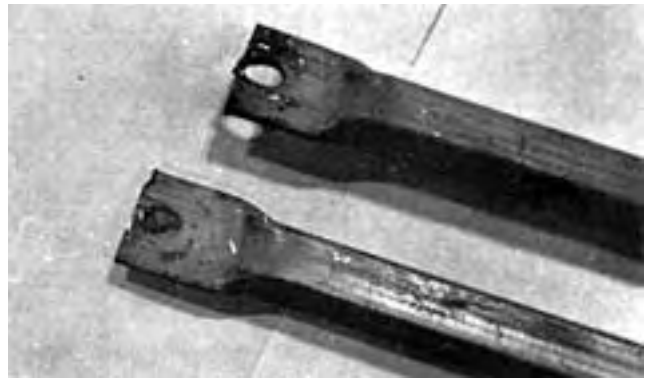
Radius Brace: The radius brace holes wore due to insufficient bearing surface against the pins (Figure 22). The radius braces vibrated excessively in the field contributing to the wear on the radius brace holes. The ends of the radius braces were reinforced with a steel plate. No significant wear was apparent after this modification.

Figure 22. Worn Radius Brace Holes.

13. Modifying the radius braces to prevent premature failure at the pin holes.
14. Supplying a slow moving vehicle sign.
15. Supplying an operator's manual.

13. The radius braces have been modified and strengthened for 1977 production.
14. The sign has been left for the operator to provide in 1977. It will be featured as standard equipment on the 1978 production.
15. An operator's manual is being composed.
16. We are sure that pressure gauges will be metric or dual calibrated for 1978 production before conversion to the SI system and will be featured as standard equipment.

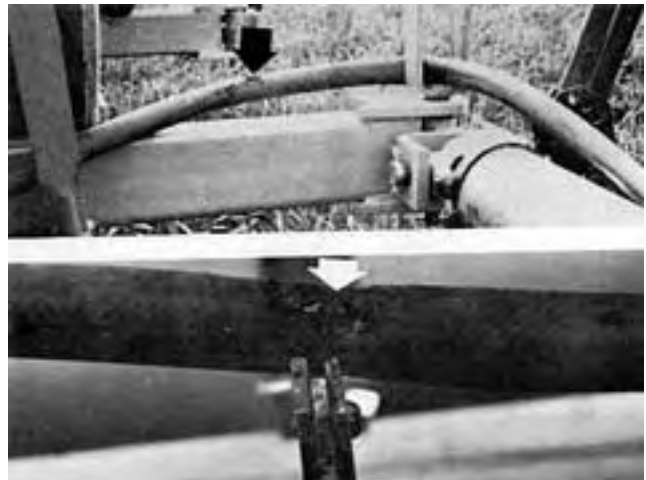
Boom Hoses: Damage to the boom hoses occurred at the boom universal joint (Figure 23). The hoses were also not adequately restrained to prevent damage due to rubbing against sharp surfaces. For example, rubbing against the boom carriers caused hose damage.

Figure 23. Damaged Hose.

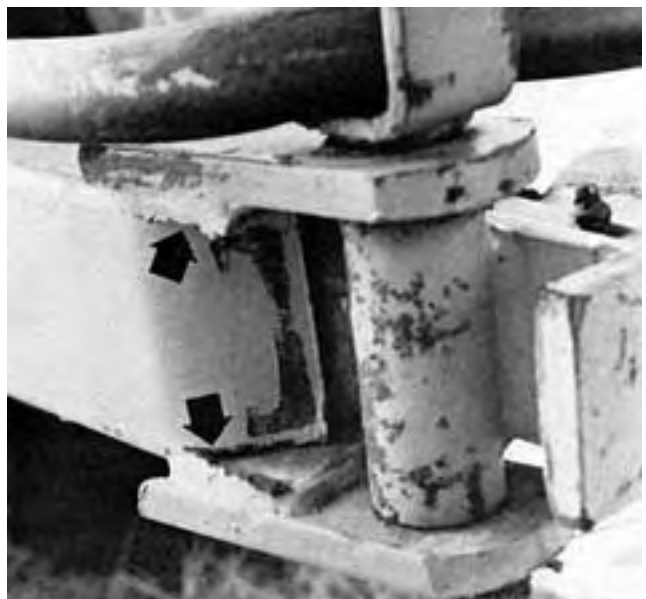
The inside of the trailer frame cracked (Figure 24) as a result of turning too short in transport position. The boom universal joint interfered with the frame, causing the tubing to crack and bend. A more desirable design would eliminate interference between the boom universal joints and the boom main frame during short turns in transport.

Figure 24. Failure of Trailer Frame.
