# **Evaluation Report**

174

# Morris 80-14 Seed Rite Hoe Drill

#### **MORRIS 80-14 SEED RITE HOE DRILL**

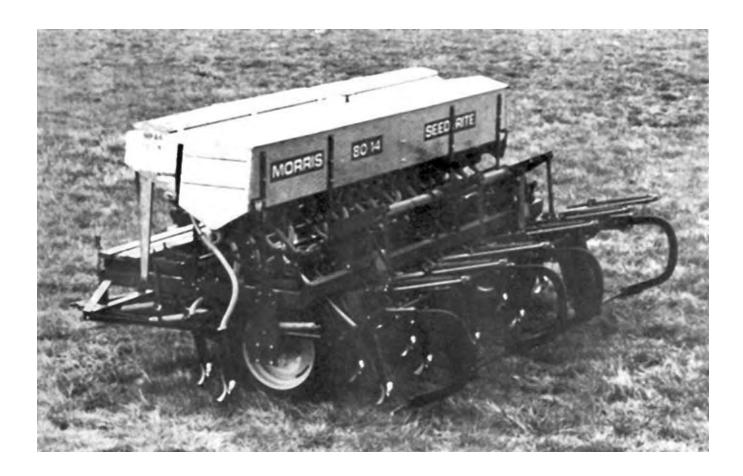
FIGURE 1. Morris 80-14 Seed Rite: (A) Hoe Opener, (B) Ground Rod, (C) Fluted Grain Feed Roll, (D) Grain Box, (E) Optional Spierco M80 Fertilizer Attachment, (F) Walkway, (G) Castor Wheel, (H) Hitch, (I) Outer Wheel, (J) Grain Tube.

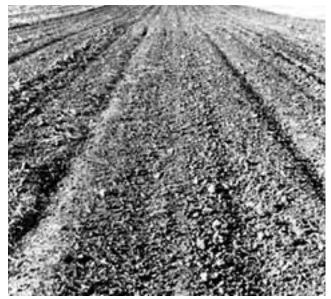
FIGURE 5. Soil Surface after Seeding.

adjustment was important to ensure that seeds were not uncovered by the ground rod. The ground rod compacted soil around the seeds leaving the surface loose (FIGURE 5). Seed depth and coverage were not significantly affected by ground speed but higher speeds resulted in more soil pulveration.

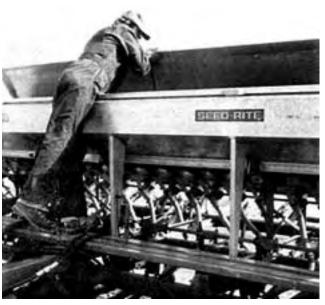
FIGURE 11. Awkward Opening of Grain Box Lid.

**Filling:** The grain box had to be filled from the end of the drill, since the 300 mm (12 in) wide wooden walkway was located at the front. This would be inconvenient with a multiple drill hook-up. Reaching over the fertilizer attachment (FIGURE 11) and the 450 N (100 lb) opening force required, made the grain box lid awkward to open.
