# Evaluation Report

421

## Amazone NT 375 No-Till Grain Drill

# AMAZONE NT 375 NO-TILL GRAIN DRILL

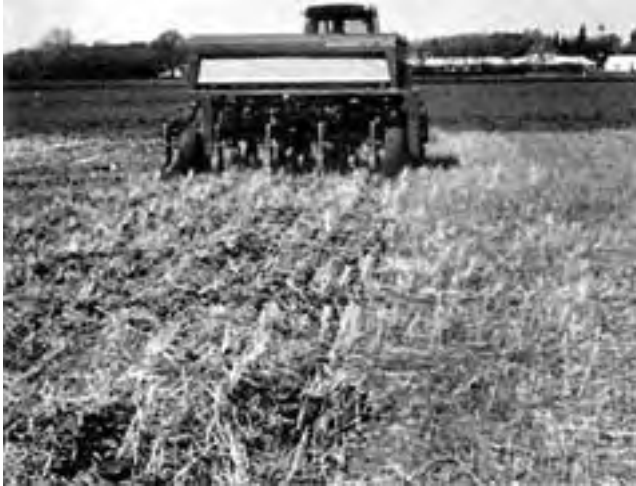
FIGURE 3. Penetration of Hoe Openers in Typical Field Conditions.

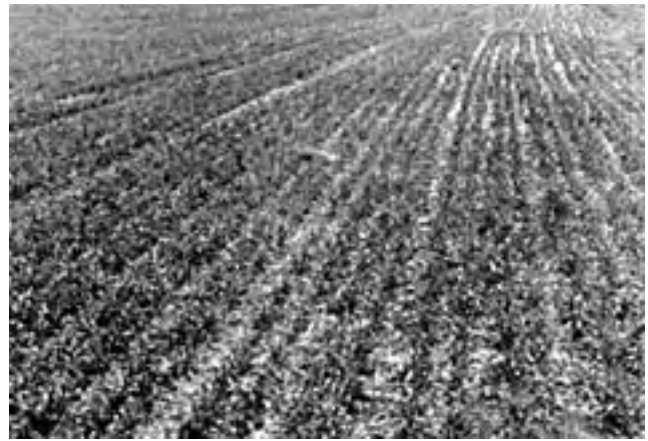
FIGURE 4. Emergence of Wheat Drilled Directly into Flax Stubble with Average Moisture Conditions.

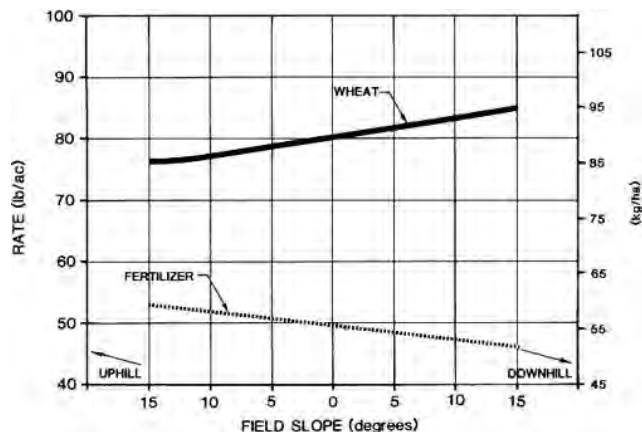
FIGURE 8. PAMI Calibrations Compared to Manufacturer's Calibrations While Applying 11-51-00 Fertilizer.

The fertilizer application rate was not significantly affected by the level of fertilizer in the box, ground speed or field vibrations. As shown in FIGURE 8, variation in field slope had a small effect on the application rate. When travelling up a 15° hill the fertilizer application

rate increased by about 8.1%.

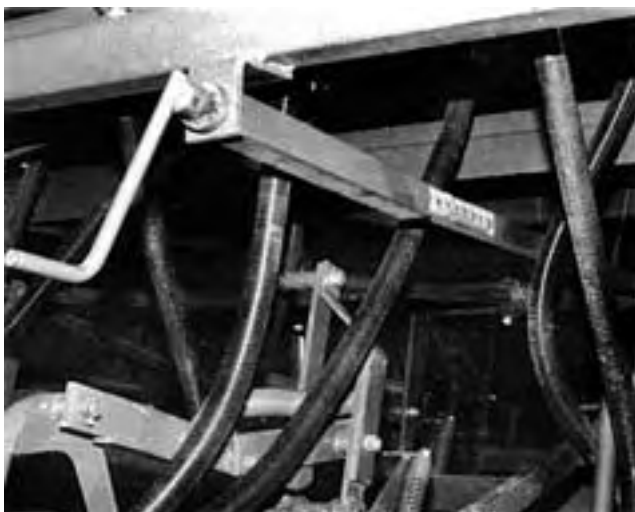
**Depth:** The 20 hoe openers were raised and lowered almost simultaneously even though each opener had its own hydraulic cylinder. One crank at the rear of the machine adjusted the depth of the opener. A scale along the edge of the crank made depth setting convenient (FIGURE 10).

**FIGURE 10.** Depth Adjustment.

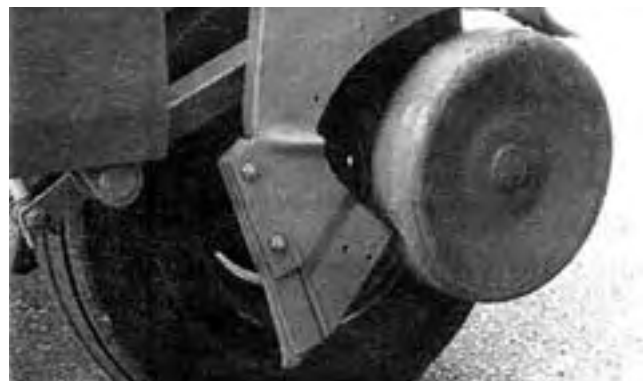
**Hoe Openers:** Four hoe openers were bent due to stony conditions (FIGURE 11). They were initially repaired and then replaced with new openers. It is recommended that the manufacturer consider modifying the opener to eliminate bending in stony land.

**FIGURE 11.** Bent Hoe Opener.

6. On future production runs we are considering fastening the hitch to the castor wheels to prevent them from oscillating as you mentioned.
7. The hoe openers of your test machine were not made correctly. The coulters could bend because the welds were not placed as prescribed in our blueprints. This deficiency was dealt with on the NT375 in the spring of 1985. Additionally a reinforcement has been inserted so that the coulters are now stable.

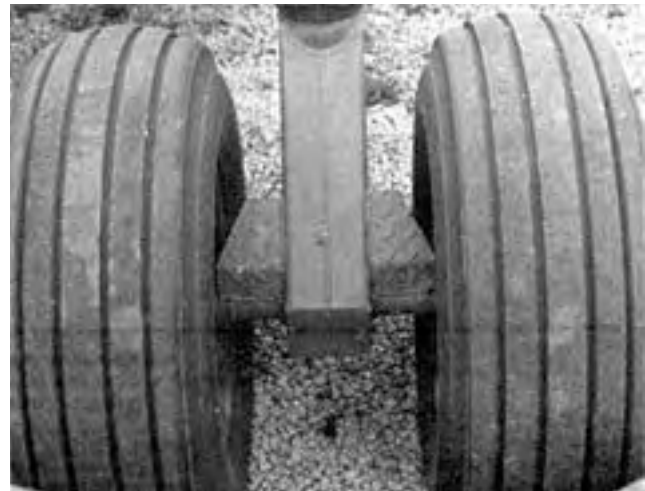
**Castor Wheels:** The weld between the castor wheel upright and spindle reinforcements broke and was repaired after 350 m (560 km) of highway travel with occasional castor wheel shimmy. It was repaired by welding larger reinforcements into place (FIGURE 1). Castor wheel shimmy did not reoccur after this modification.

FIGURE 1. Castor Wheels With Reinforcements.
