Evaluation Report

Co-op Implements 1001 Disker

CO-OP IMPLEMENTS 1001 DISKER

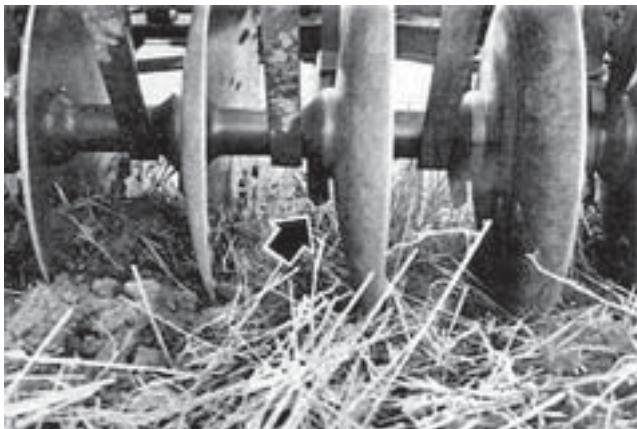
Seed Placement: Seed placement was good in most field conditions. The seed tubes were positioned behind the disk (FIGURE 3) to place the seed at the bottom of the furrow. At 8 km/h (5 mph), most seeds were placed within 13 mm (0.5 in) of the average seed depth. Some seed scattering occurred at higher speeds and depths greater than 76 mm (3 in). In the bottom of ravines or gullies, seed was placed on the soil surface as the disks were unable to follow variations in ground contour.

FIGURE 3. Seed Tube Position.

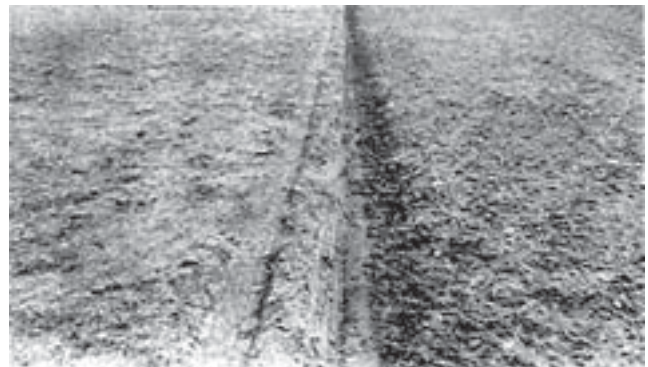
Ridging: The CI 1001 usually produced an even seedbed with a uniform soil surface (FIGURE 4) provided it was properly adjusted. The centre furrow wheel lock stabilized the centre furrow wheel and reduced untilled strips or overlapping between the front and rear units on steep hillsides. Slight furrow bottom ridging occurred on hillsides and gradual left turns as the width of cut increased. Furrow bottom ridging decreased with narrower widths of cut. A width of cut 10% less than the nominal width of cut is recommended for seeding to obtain a good weed kill and to provide a uniform furrow bottom for seed placement. At speeds above 11 km/h (7 mph), bouncing of the disk harrow produced an uneven seedbed.

FIGURE 4. Soil Surface after Seeding into Stubble: (A) Heavy Trash Cover, (B) Light Trash Cover.

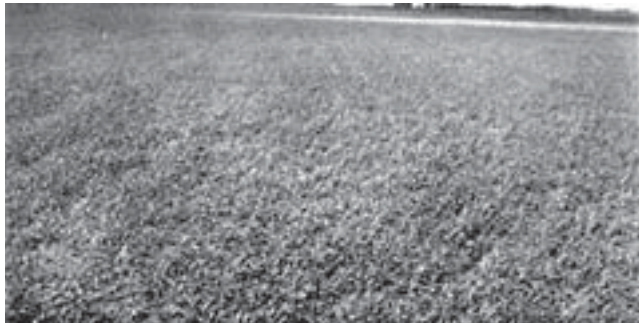
Plant Emergence: Plant emergence was uniform (FIGURES 5 and 6) in all fields with sufficient moisture and nutrient reserves. Emergence was delayed in hard or dry soils.

FIGURE 5. Neepawa Wheat 23 Days after Seeding into Stubble. Moisture Conditions Good.

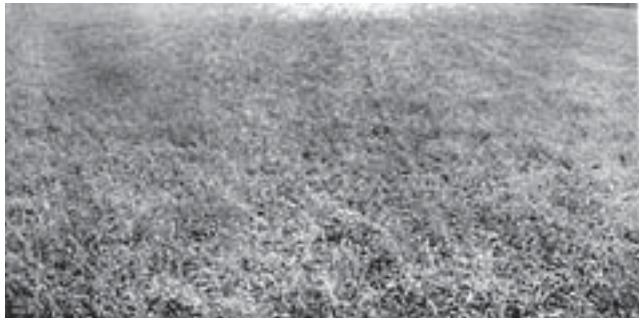
FIGURE 6. Klages Barley 24 Days after Seeding into Stubble. Moisture Conditions Good.

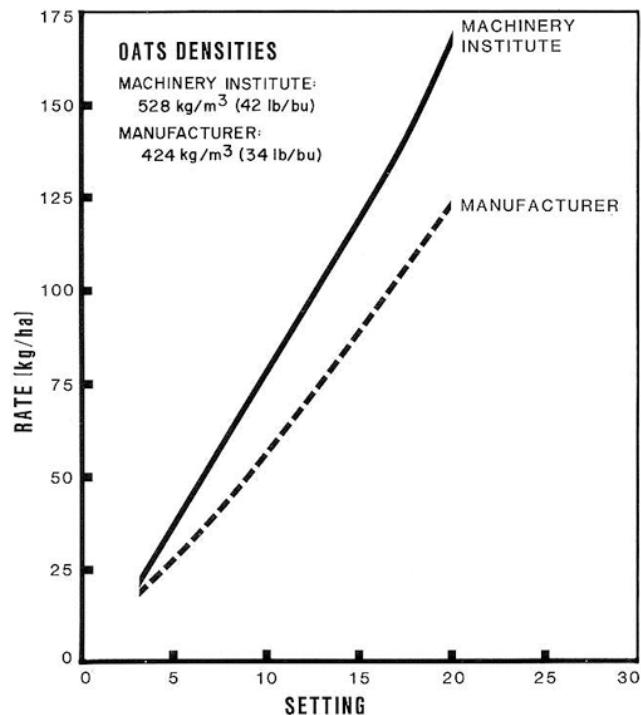
Seed metering system accuracy was very good in wheat, barley, oats and good in rapeseed. The manufacturer's calibration charts for wheat and barley were the same as the Machinery Institute's calibrations. Some differences were obtained between the manufacturer's calibrations and the Machinery Institute's calibrations for oats and rapeseed (FIGURES 8 and 9). Differences in seeding rates will occur when using seed of different size, density and moisture content or when operating at different widths of cut. To obtain exact seeding rates, it is important to adjust for different seed properties and widths of cut.

FIGURE 8. Oats Calibration.

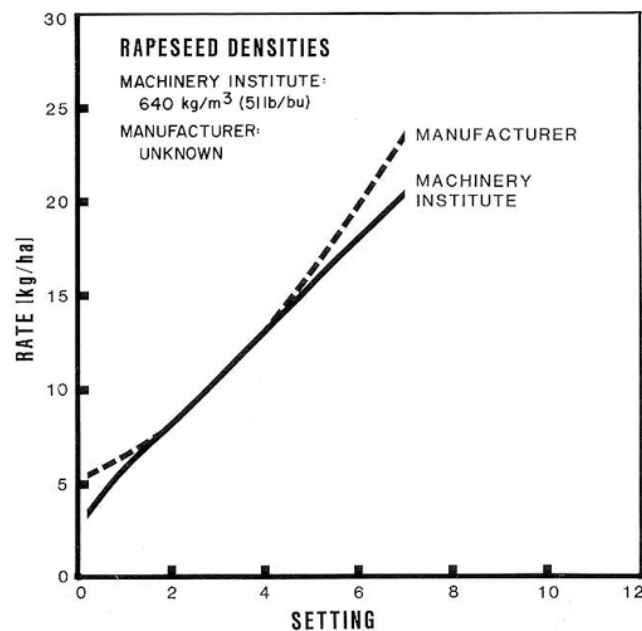
FIGURE 9. Rapeseed Calibration.

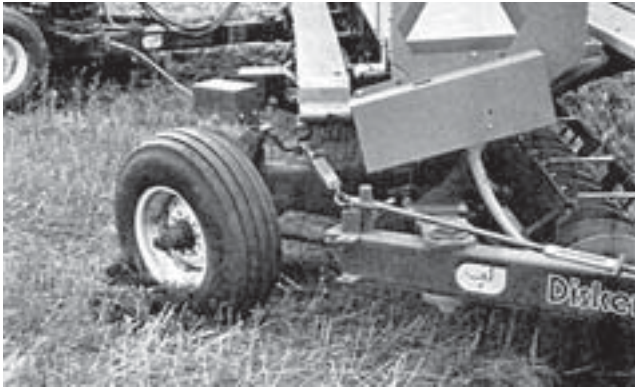
Turning: Left 90° turns were easily made. Sharp left turns greater than 90° caused skidding of the rear land wheel (FIGURE 11). Tilled corners were smooth and could easily be covered by two passes when finishing the field. Sharp right turns had to be made with caution due to interference between the tractor tire and the front unit. When making right turns, the gangs should be raised to reduce draft and prevent possible disk damage in stony fields.

FIGURE 11. Skidding of the Rear Land Wheel when Making Sharp Left Turns.

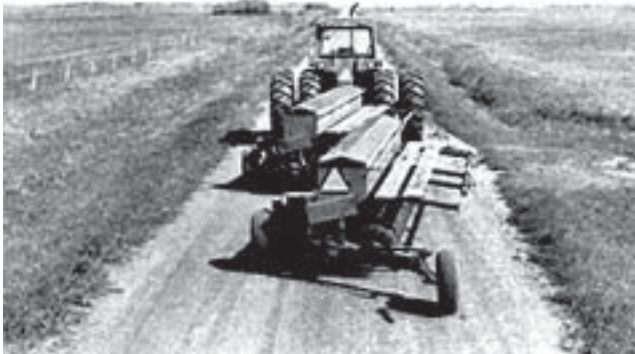
jack and adjustable front hitch made hitching to the tractor easy. A lock on the hydraulic cylinder prevented the disk gangs from being lowered while transporting. Damage could not occur when the hydraulics were activated with the lock engaged. Transport width was narrow enough to allow most vehicles to pass on secondary roads (FIGURE 12).

FIGURE 12. Full Transport Position.

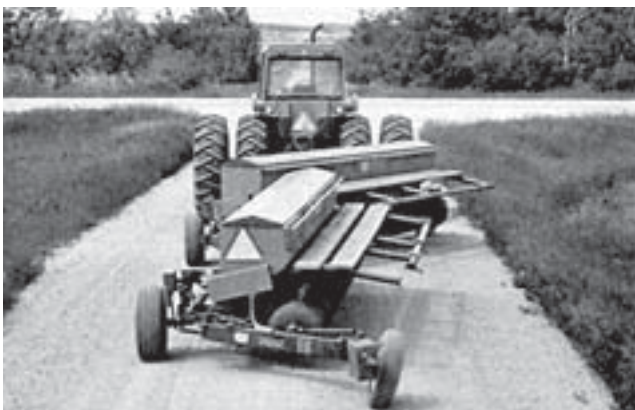
The CI 1001 could be safely transported at speeds up to 30 km/h (19 mph) in semi-transport. Semi-transport width with the hitch brace collapsed was narrow, making transport on secondary roads safe and easy (FIGURE 13). The CI 1001 could be placed in or taken out of semi-transport by one person in about 5 minutes. Wheel lead adjustments for semi-transport did not affect field settings. Right or left turns were easily made in semi-transport.

FIGURE 13. Semi-Transport Position with Hitch Brace Collapsed.
