# Evaluation Report

# 711

## Pickett Bean Planter

# PICKETT BEAN PLANTER

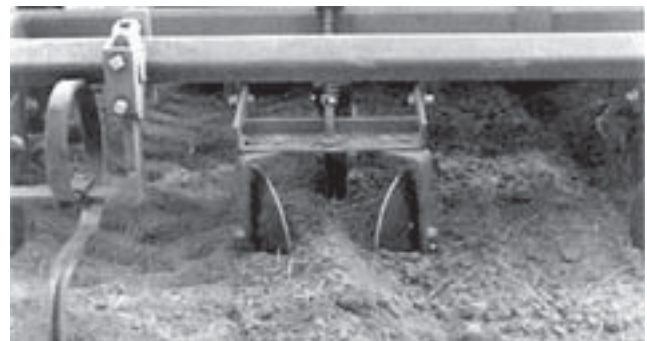
**Soil Finishing:** Soil finishing of the planter was good. A set of double-covering discs closed the seed furrow and formed a hill of loose soil over the seed as shown in FIGURE 4. The discs could be adjusted to vary the size of the row hill. On the test unit the double-covering discs were set at 6.5 in (165 mm) apart. Average row hill height was 4 in (102 mm). Vertical force of the closing discs was varied by adjusting the spring tension. The seedbed was not packed. No information was provided about proper adjustment of the double-covering discs for optimum seed coverage.

FIGURE 4. Double-Covering Discs.

The hill of loose soil placed over the seed resulted in deeper seed placement. Due to a wet growing season there was poor seed emergence as shown in FIGURE 5. Soil moisture at the time of seeding was good so packers would have been adequate to firm the seedbed for better seed emergence. The double-covering discs may have performed better in drier growing conditions. The manufacturer should clarify the soil conditions the double-covering discs should be

used in to receive good seed emergence. The AFMRC recommends the manufacturer offer row packers as optional equipment.

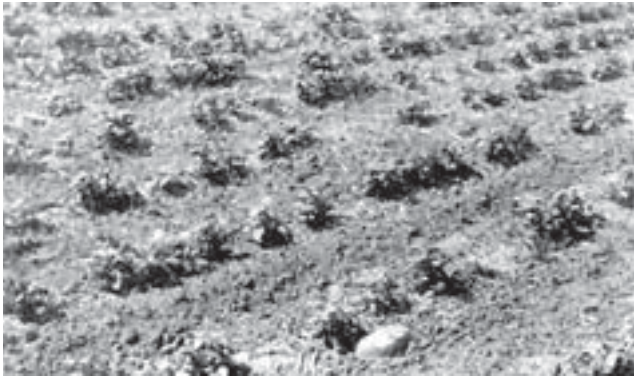
FIGURE 5. Seed Emergence of a Field of Pinto Beans.

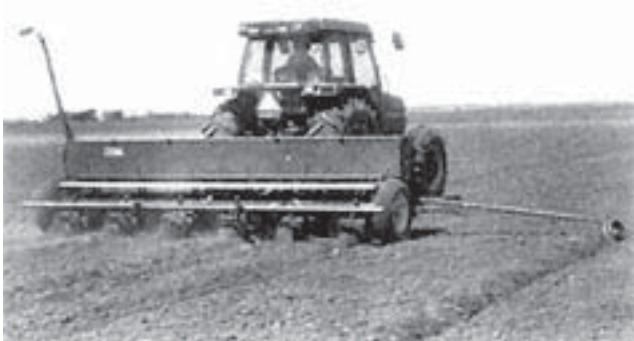
**Marking System:** The quality of the marking system was very good. FIGURE 6 shows the mark left by the marking system in tilled field conditions. The mark was visible from the tractor cab due to the difference in colour of moist and dry soil. Disc depth was controlled with a depth band. Disc angle was adjustable.

FIGURE 6. Row Marker.

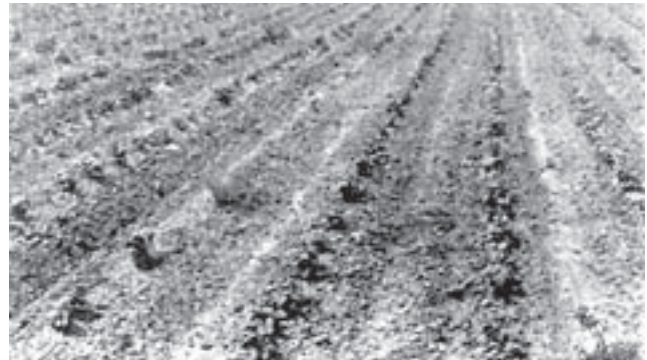
From field observations, there were a number of misses over several feet long along the plant row as shown in FIGURE 8. The misses were attributed to the seed temporarily bridging over a meter (FIGURE 9). The AFMRC recommends the manufacturer modify the agitation bar to prevent seed bridging over the meter.

FIGURE 8. Seed Emergence Misses.

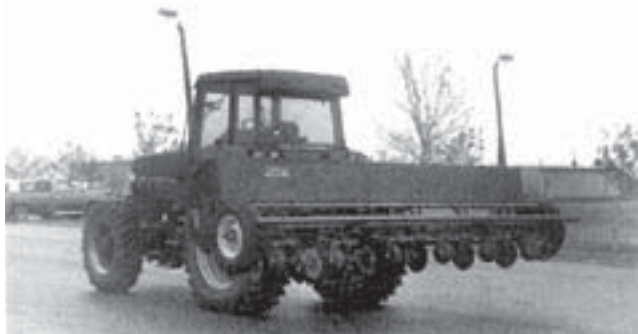
**Transporting:** Ease of transporting the Pickett planter was very good. The unit was placed into transport position by the tractor's hydraulics (FIGURE 10). The transport lock on the tractor's three-point hitch hydraulic system locked the unit in transport position. The markers were secured to the planter when in the transport position.

FIGURE 10. Transport position.
