Susceptibility of Chickpea Varieties to Impact Damage

PRAIRIE AGRICULTURAL MACHINERY INSTITUTE

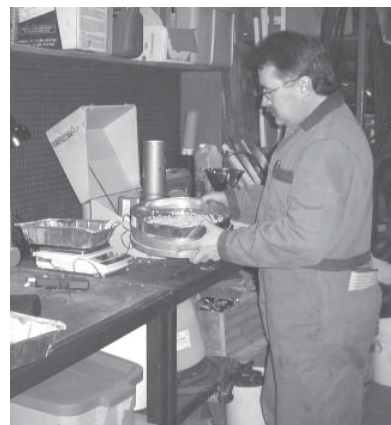
Sorting seeds after impact test.

Chickpea damage was evaluated using two different methods. The first method was by visual inspection of physical seed damage including splits, cracks, or any seed coat penetration. Physical seed damage was quantified by removing damaged seeds from the sample and expressing this weight as a percent of the original sample weight. The second assessment method was to quantify hidden damage to the seed. Hidden damage was determined by sending the undamaged seeds to an accredited seed lab for germination tests. Total damage was calculated as the sum of percent physical damage plus the percent reduction in germination.
