Case IH Air Seeder--Chickpea Seeding

Introduction

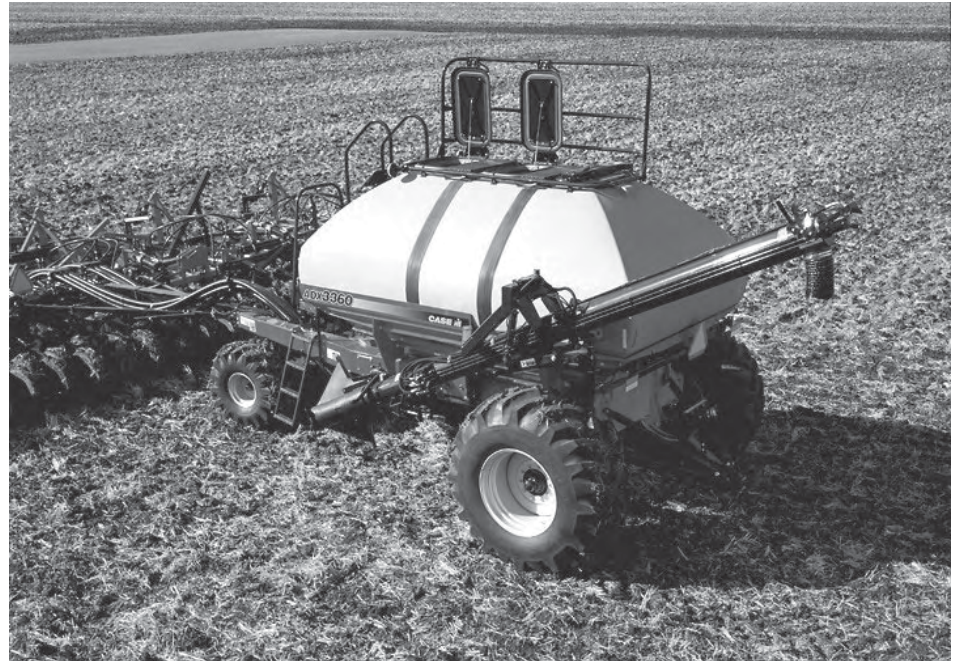
A Case IH ADX 3360 air cart with an air package mounted on a Concord ATX Air-Till Drill was used for the test. Seed was metered with an externally fluted, extra coarse, metering roll into five delivery hoses. Each hose ran into an Easy Flow Header manifold with nine 1 in (2.5 cm) inside diameter (ID) delivery hoses.

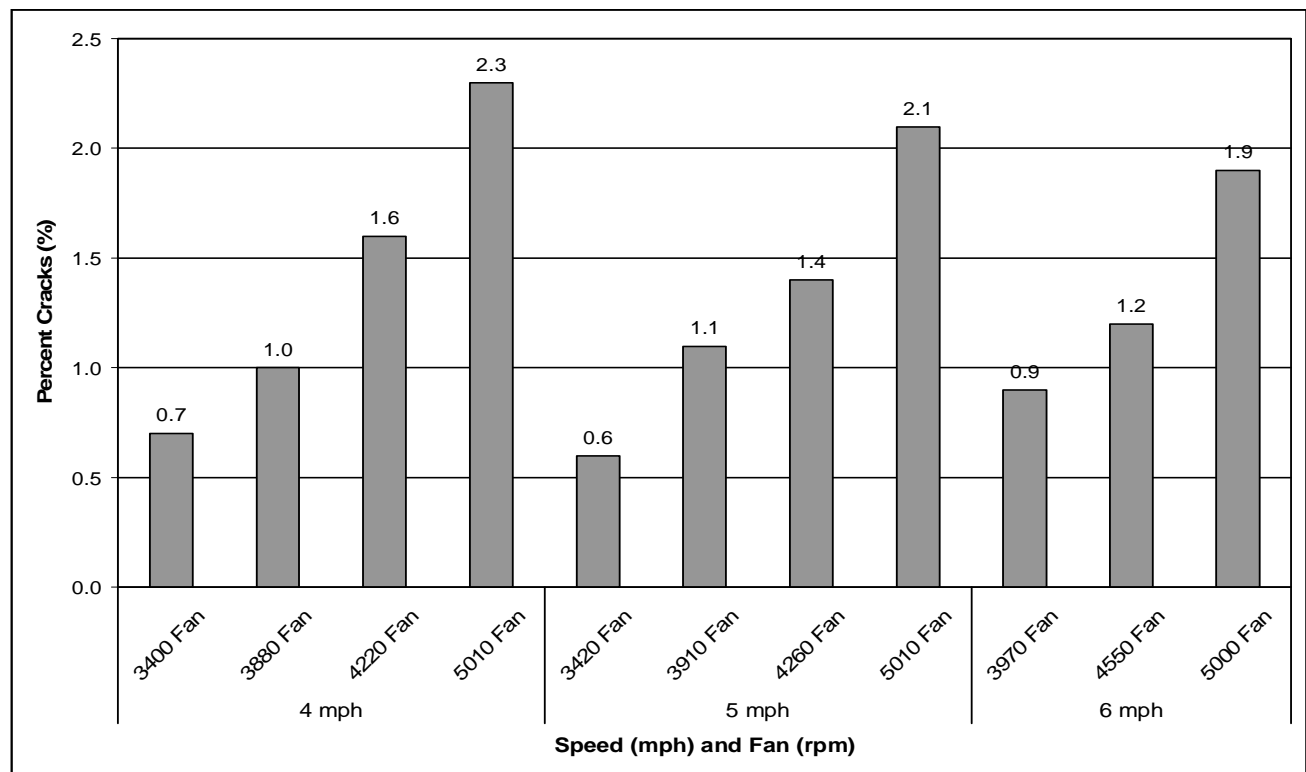
Figure 1. Effect of the Case IH Ground and Fan Speeds on Chickpea Damage.

Chickpea damage with the Case IH system was very low at all tested fan speeds (**Figure 1**).

more typical operating fan speed for field conditions. Although seed damage increased at higher fan speeds, even at maximum fan speed total seed damage was less than 3%.

The single air tank/air delivery system test conducted with the two other seed varieties resulted in damage of 0.7% with CDC Xena and 1.2% with CDC Desiray.

These results suggest that seed damage with the Case IH system is very low with all tested varieties and should not be a concern to producers.

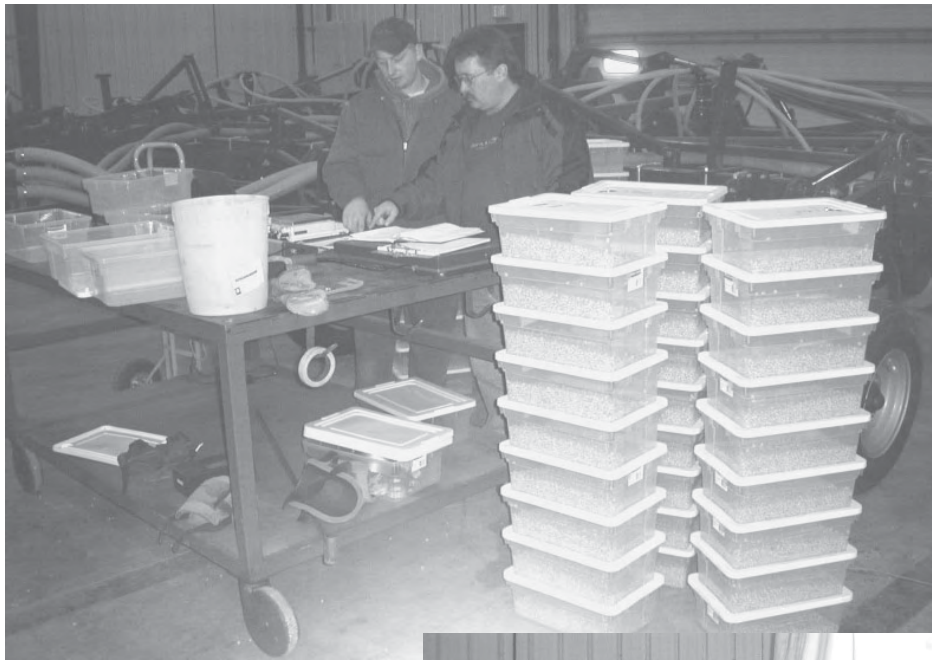
Recording data from collection tubs.

at a simulated ground speed of 4 mph (6.4 km/h). Air tank/air distribution samples were collected in plastic tubs at the end of each delivery hose. Samples were combined from each outlet and divided down for damage assessment.

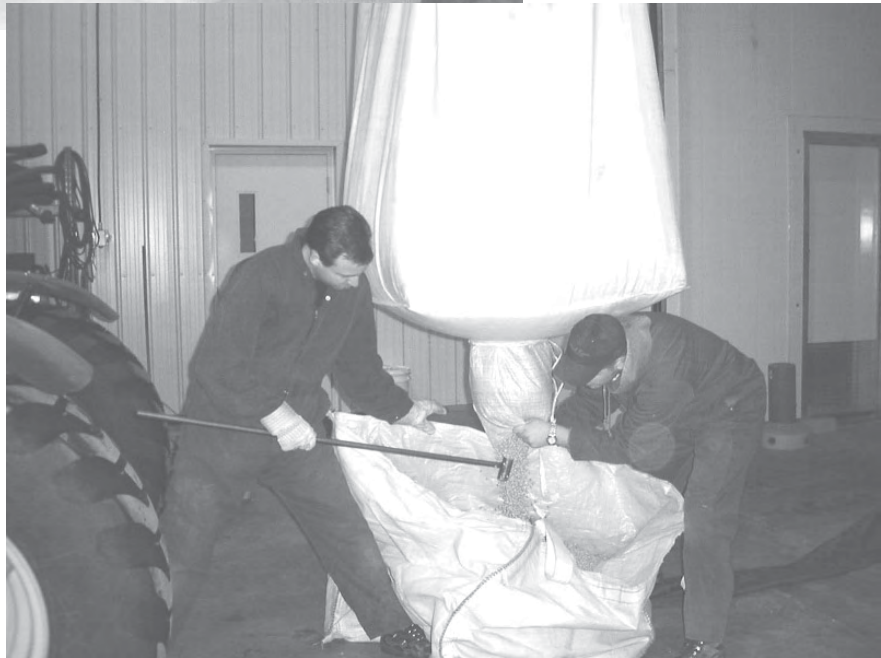
Collecting a check sample for comparison with chickpea samples that have been through the air seeder.

Check seed samples were collected prior to transferring the seed into the air cart. Metering samples were collected using the standard Case IH calibration method
