Evaluation Report No. E3178B
Printed: January, 1979
Tested at: Humboldt
ISSN 0383-3445

Evaluation Report 145

Massey-Ferguson MF 560 Baler

A Co-operative Program Between
ALBERTA FARM MACHINERY RESEARCH CENTRE
PAMI
PRAIRIE AGRICULTURAL MACHINERY INSTITUTE

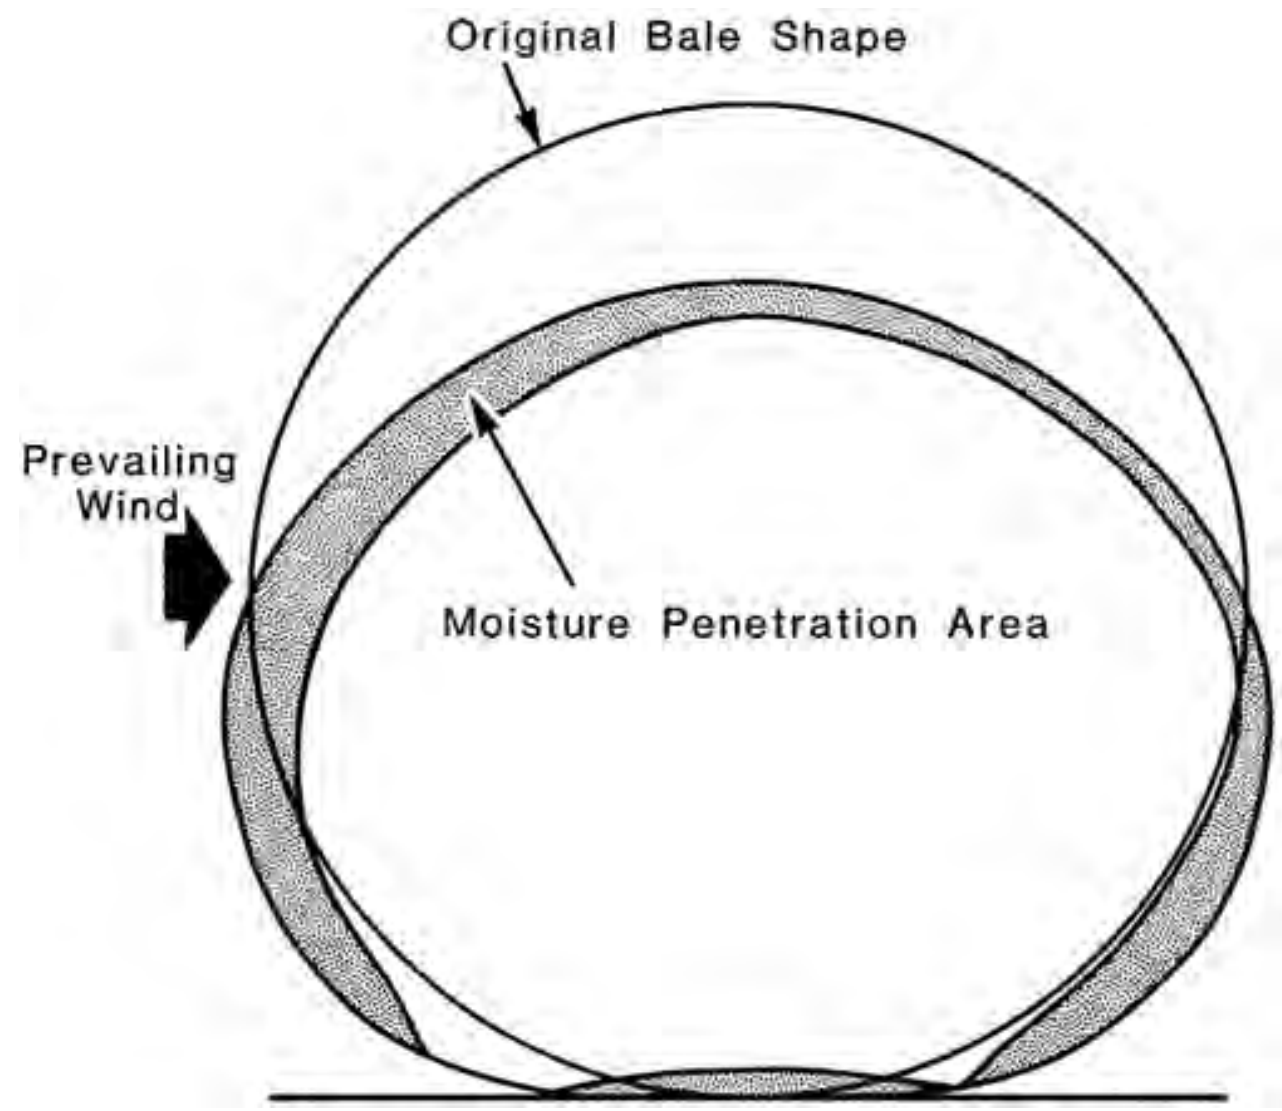
Bale Weathering: A common practice in the prairie provinces is to store round bales outside. FIGURE 3 shows the condition of a typical MF 560 hay bale (bromegrass and alfalfa mixture) after 100 days of weathering. The weathering period was the time between baling and freeze-up. Bales were situated in a well drained area with prevailing winds striking one side. Bales were exposed to about 75 mm of rain and average prairie wind conditions.

The condition of the weathered bales was good. Moisture had penetrated to a maximum of 150 mm on the windward bale side. Since bales had retained 82% of their original height, they were easy to pick with round bale handlers.

FIGURE 3. A Typical Bale After 100 Days of Weathering.

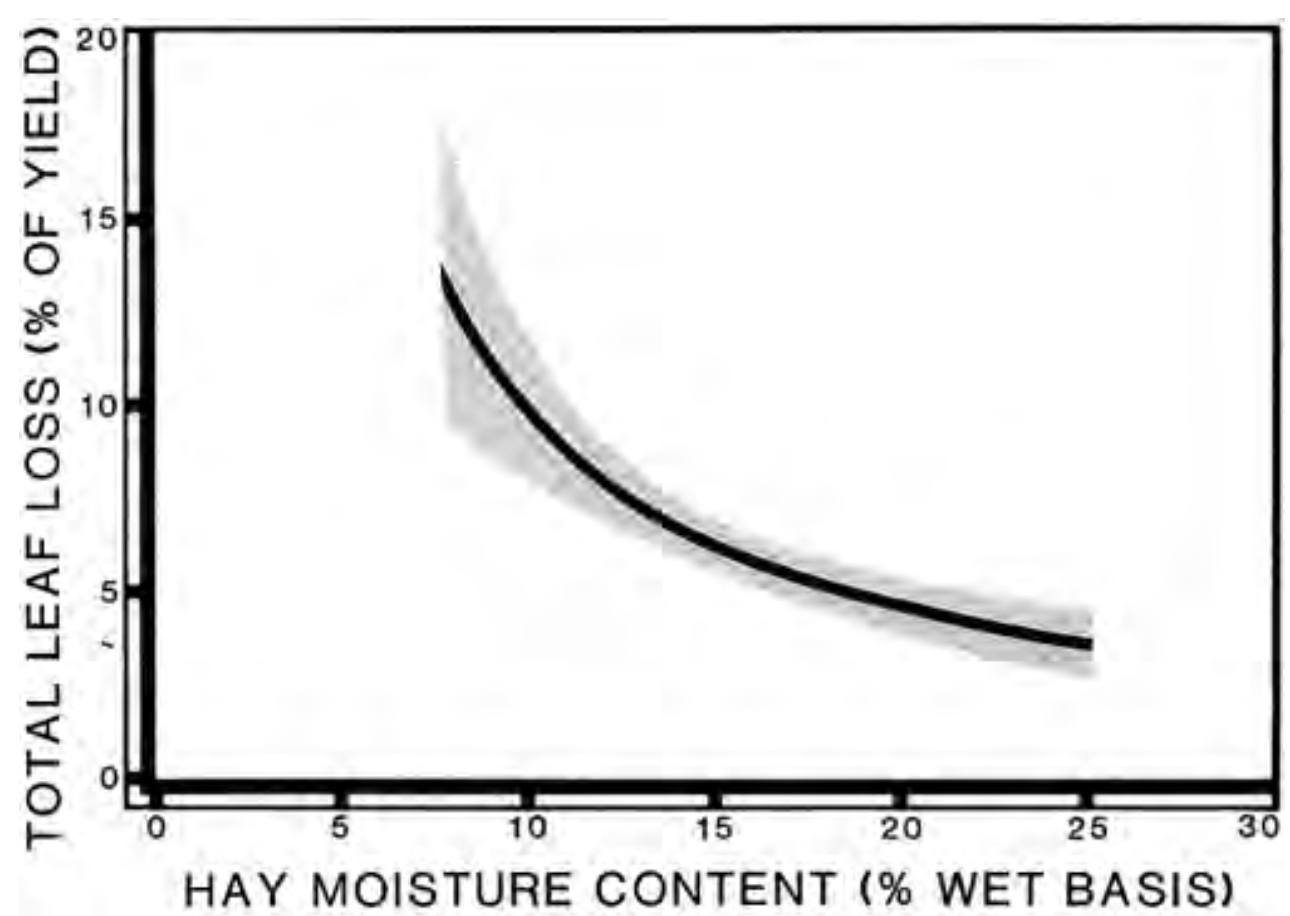
FIGURE 4. Leaf Loss in Mixed Alfalfa, Crested Wheatgrass and Bromegrass.

FIGURE 4 shows the importance of baling at high moisture contents. This figure shows the total measured leaf loss, over a range of hay moisture contents, in fields of mixed alfalfa, crested wheatgrass and bromegrass. The crop had been cut with a 3.7 m mower-conditioner. Yields ranged from 2.7 to 4.6 t/ha with an average of 3.5 t/ha. As can be seen, total leaf loss ranged from about 15% when baled at 8% hay moisture content to 3% when baled at 22% hay moisture content. At 8% moisture content, pickup loss was about 9% and bale chamber loss about 6% whereas at 22% moisture content pickup loss was about 1% and bale chamber loss about 2%.

Although FIGURE 4 represents an accumulation of data for several round balers, performance of the MF 560 was within the range presented in this figure. FIGURE 4 represents nearly ideal baling conditions with relatively heavy windrows, which had been conditioned to enhance drying of the hay stems. Much higher leaf loss can be expected in light unconditioned windrows. While feedrate did not appreciably affect losses in the ideal conditions shown in FIGURE 4, loss tests in light unconditioned windrows have shown that round baler losses can be reduced by keeping the feedrate as high as possible to minimize time in the baling chamber. Bale chamber losses in light crops can also be reduced by running the tractor at a lower power take-off speed to reduce the number of turns needed to form a bale.

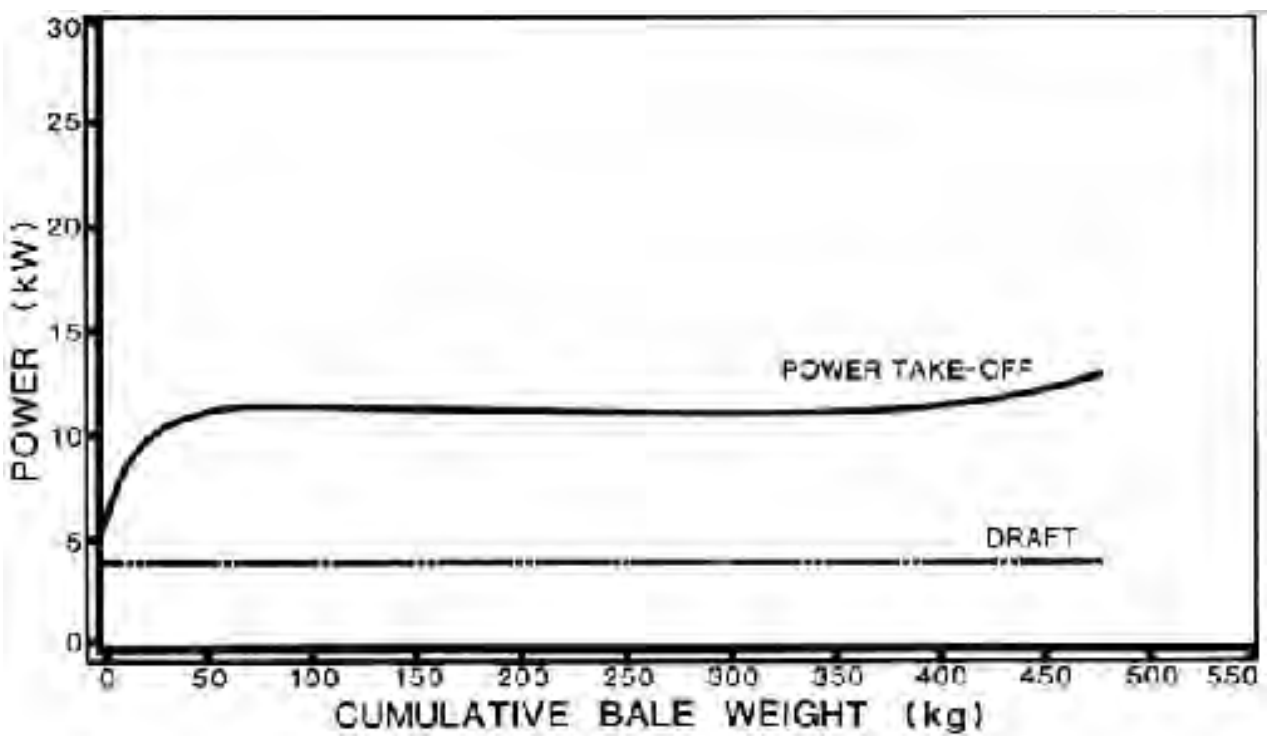
FIGURE 5. Power Consumption During Bale Formation in Alfalfa.

Power Requirements: FIGURE 5 shows the power take-off and drawbar input for the MF 560 in alfalfa. The power input is plotted against bale weight to show the power requirements while a bale is formed. Power take-off input varied from 6 kW at no load to a maximum of 13 kW in alfalfa and 18 kW in wheat straw. Drawbar requirements at 11 km/h were 4 kW.

Although maximum power requirements did not exceed 22 kW, additional power was needed to suit field conditions. In soft, hilly fields a 75 kW tractor would be needed to fully utilize baler capacity.

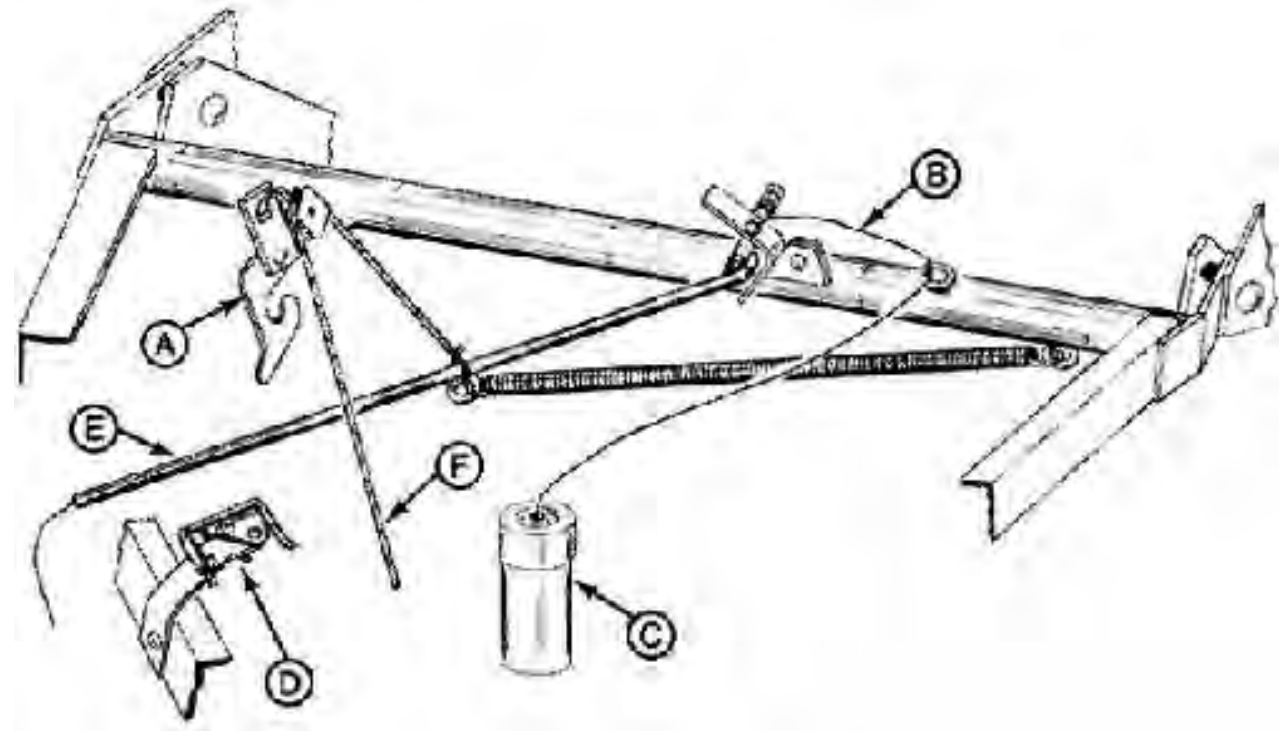
Many problems occurred with the twine wrapping mechanism. An excessive pull was needed to latch the twine tube. Frequently the twine broke at the end of the twine tube, rather than at the twine cutter. When switching between synthetic and sisal twines, adjustment to the twine system was necessary. As a result of wrapping problems, overall capacity of the baler was lowered significantly. Modifications to the twine wrapping mechanism to improve its operation are recommended.

FIGURE 7. Twine Wrapping Mechanism: (A) twine tube lock, (B) twine, (C) twine box, (D)

twine cutter assembly, (E) twine tube, (F) rope.

The twine cutter performed poorly. Modifications to improve its operation are recommended.

Twine Tie Mechanism: The twine tie tube was replaced in an attempt to reduce twine breakage at the twin tube during bale wrapping. The new twine tube also caused twine breakage problems.

1. Modifying the twine wrapping mechanism to improve twine cutter operation.

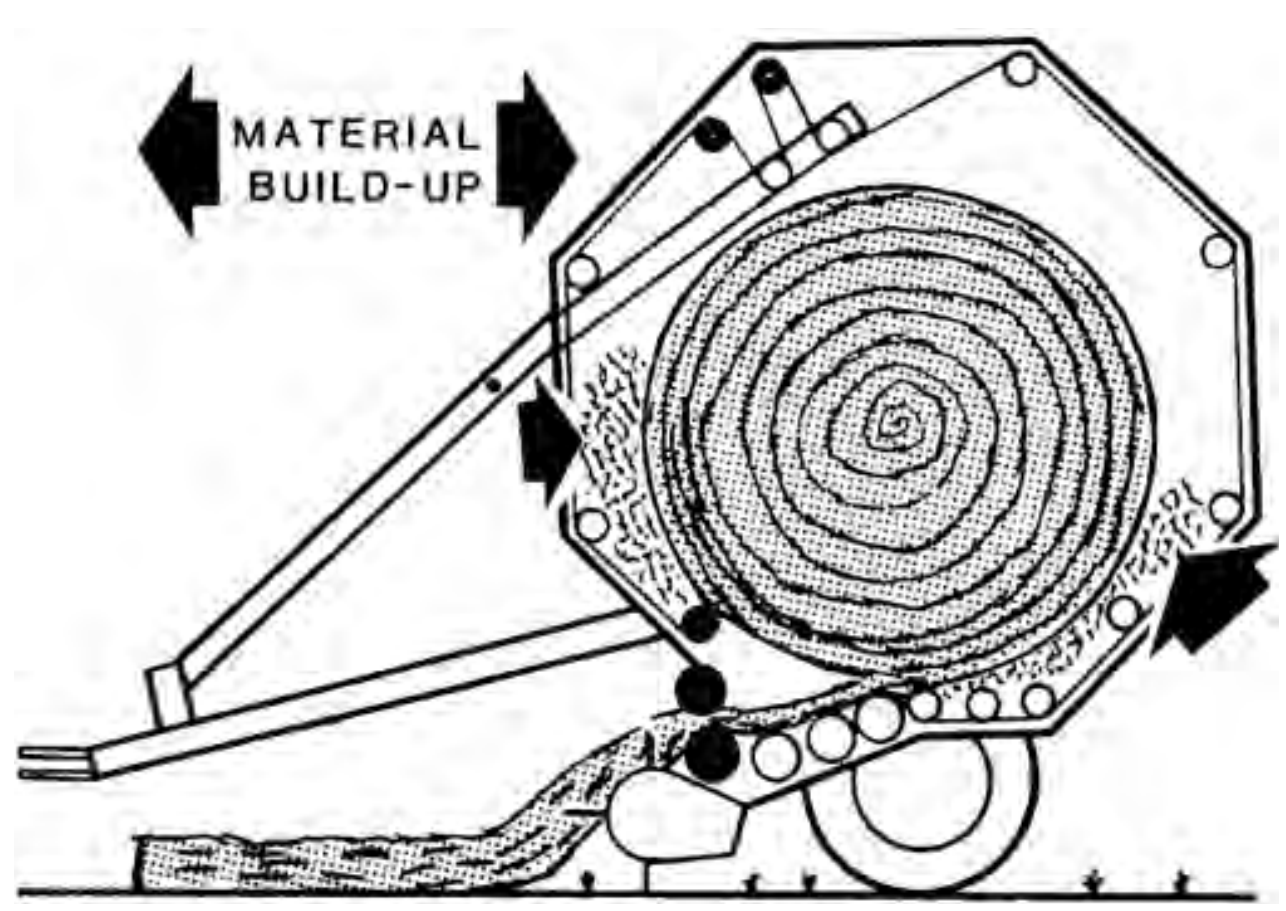
During baling, fine hay accumulated between the bale forming belts (FIGURE 8). When discharging a bale, this hay usually fell on the gate lock mechanism sometimes preventing proper locking. If baling was resumed with the gate unlocked, it opened during baling preventing bale formation.

FIGURE 8. Hay Buildup Between Belts.
