Evaluation Report 549

Flexi-coil 1100 Air Seeder

A Co-operative Program Between
ALBERTA FARM MACHINERY RESEARCH CENTRE
PAMI
PRAIRIE AGRICULTURAL MACHINERY INSTITUTE

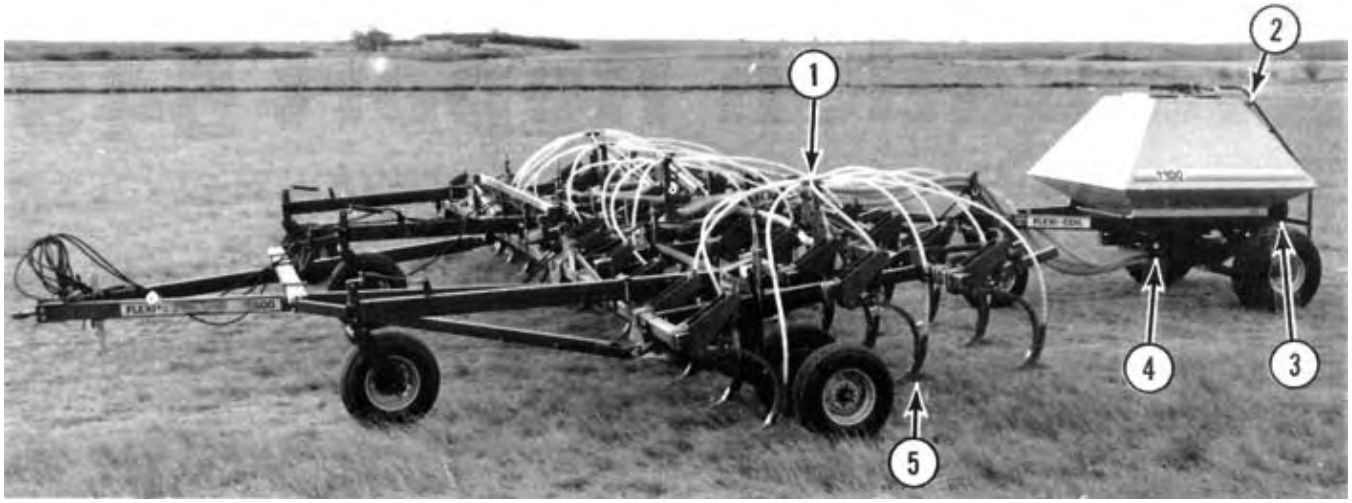
FIGURE 1. Flexi-coil 1100 Air Seeder: (1) Secondary Header, (2) Ladder, (3) Fan, (4) Metering System, (5) Seed Boot.

Mechanical Problems: The mechanical problems included the rubbing of the primary hoses on the front applicator tire and the rubbing of the electrical harness and hydraulic lines on the front pivot point.

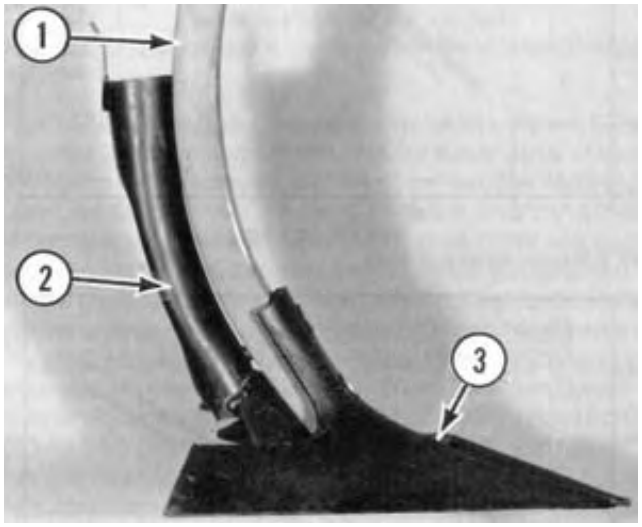
FIGURE 2. Flexi-coil 1100 Seed Boot: (1) Shank, (2), Seed Boot, (3) Sweep.

Seed Placement: The seed placement of the Flexi-coil 1100 air seeder was good. The Model 1100 was equipped with a welded v-shaped seed boot (FIGURE 2) to spread material behind the cultivator sweep. Plants emerged in two distinct rows in band widths ranging from 3.6 to 6.8 in (91 to 173 mm). With an 11.8 in (300 mm) cultivator shank spacing, distances between rows varied from 5.0 to 8.2 in (127 to 208 mm). The row spacing provided adequate windrow support providing light crops were laid across the rows rather than parallel to them.

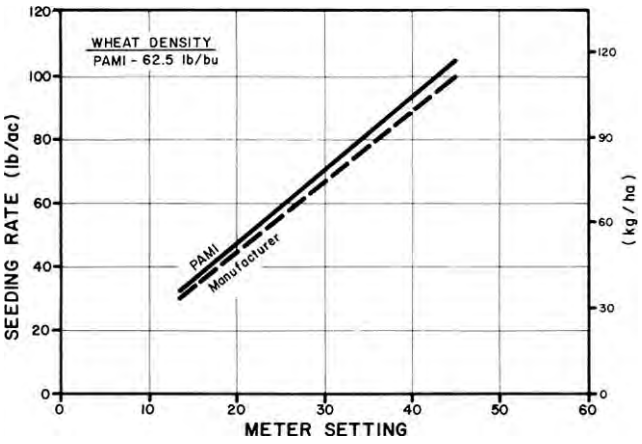
FIGURE 3. Metering Accuracy in Wheat.

system was very good. The metering rate was varied by loosening the lock bolt on the meter crank arm and then moving the crank arm to lengthen or shorten its turning radius. Calibration curves for wheat, barley, canola, and fertilizer are given in FIGURES 3 to 6. There was very little difference between the manufacturer's and PAMI's calibration curves for wheat, barley, canola and fertilizer. Operating on slopes (up to 10 degrees), variations in ground speed, fan speed and eld bounce had little effect on metering rates.

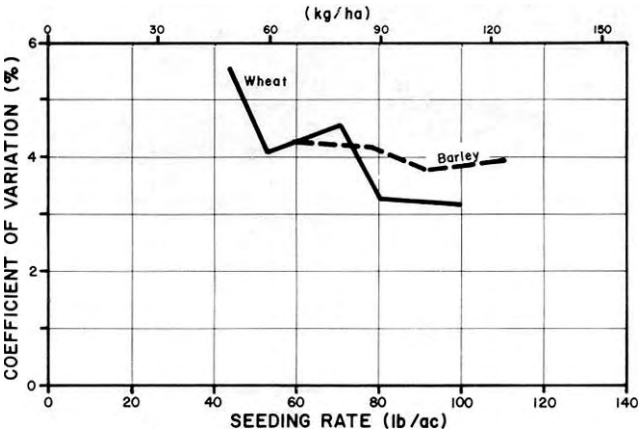
FIGURE 7. Distribution Uniformity in Cereal Grains over a Range of Seeding Rates at 5.0 mph (8 km/h) at Varying Fan Speeds.

Distribution Uniformity: The distribution uniformity of the Model 1100 was very good. Given in FIGURE 7 is the seeding distribution uniformity for the Model 1100 in wheat and barley. Distribution was uniform over the full range of seeding rates at a fan speed of 3300 rpm. For example, at a seeding rate of 70.3 lb/ac (79.9 kg/ha), the coef cient of variation[1] (CV) was 4.5% for wheat and at a seeding rate of 78.2 lb/ac (88.8 kg/ha) the coef cient of variation was 3.8% for barley. FIGURE 8 shows a typical seeding distribution pattern obtained in wheat at a seeding rate of 70.3 lb/ac (79.9 kg/ha). The seeding rate from each shank across the width of the air seeder varied from 58.9 to 75.8 lb/ac (66.9 to 86.1 kg/ha). Given in FIGURE 9 is a typical distribution pattern obtained in canola at a seeding rate of 6.1 lb/ac (6.9 kg/ha). The distribution uniformity was acceptable with a CV of 9.4%. The coef cient of variation ranged from 7.7 to 11.9% (FIGURE 10) over the full range of canola seeding rates. Distribution uniformity in 11-51-00 fertilizer was acceptable over the full application range with a CV ranging from 5.8 to 14.1% (FIGURE 11).

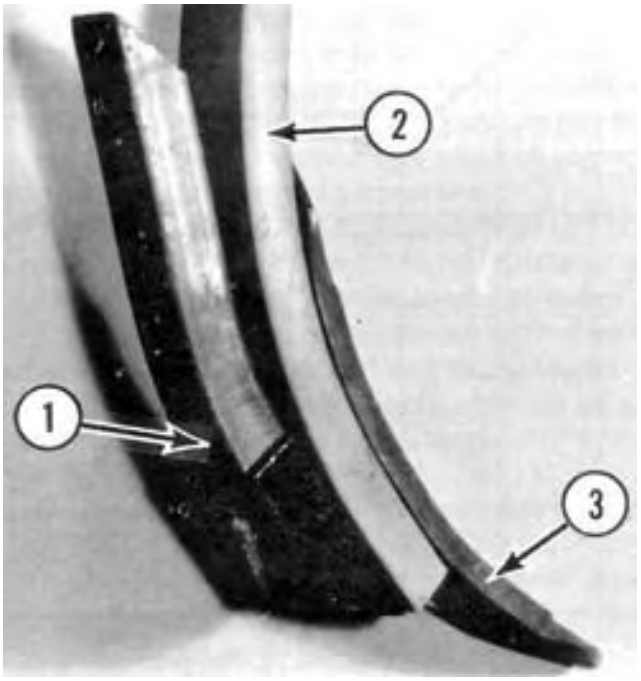
FIGURE 12. Flexi-coil Banding Boot: (1) Banding Boot, (2) Cultivator Shank, (3) Chisel Point.

secondary and primary eld conditions, fertilizer granules were placed in a band about 1 in (25 mm) wide, with fertilizer depth ranging from tip depth to 0.5 in (13 mm) above the tip depth (FIGURE 12). Wider fertilizer bands were obtained in lumpy soil conditions. Maximum application rates of 11-51-00 fertilizer, when using the front or rear meter only, were 200 lb/ac (227 kg/ha). When using both tanks a maximum application rate of 258 lb/ac (293 kg/ha) was possible at a ground speed of 5 mph (8 km/h). In both cases higher rates were possible but at unacceptable distribution uniformities.

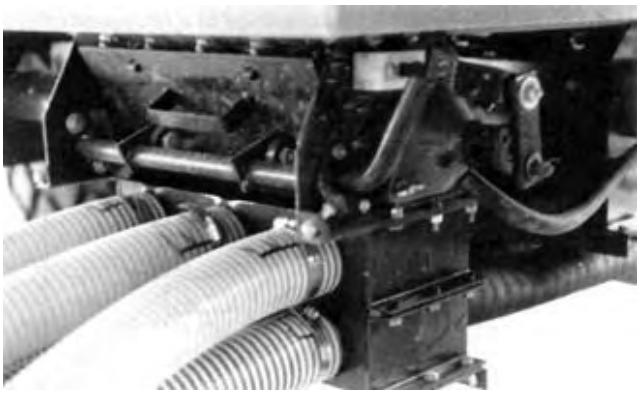
FIGURE 13. Meter Cleanout Door.

Access and cleaning of the meter box was not possible with the tanks full. Each tank was equipped with a cleanout door which was located in front of the meter box. Emptying the tanks was accomplished by rotating the cleanout door lock-bar lever (FIGURE 13) allowing the product in the tank to ow out through the cleanout ports. It was dif cult to turn the lock-bar lever because of the closeness of the lever handle to the metering assembly. It is recommended that the manufacturer consider modifying the cleanout door lock-bar lever to allow for more convenient access during the cleanout operation.

1. Modifying the cleanout door lock-bar lever to allow for more convenient access during the clean out operation.
2. Modifying the support structure for the primary hoses, electrical harness and hydraulic lines at the front pivot point to reduce wear of these components.
3. Supplying meter calibration charts in SI (metric) units as well as Imperial units.

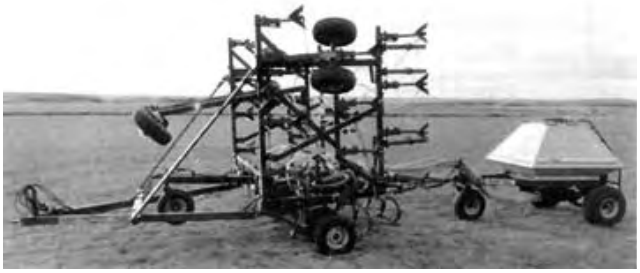
FIGURE 14. Transport Position.

Since the applicator towed behind, visibility of the cultivator was very good. This was considered a desirable feature of the Model 1100. However, the applicator and cultivator were dif cult to manoeuvre while backing up. The Model 1100 was easily placed into transport position in less than ve minutes (FIGURE 14). Four hydraulic cylinders raised the cultivator wings to the upright position. The meter drive clutch was conveniently engaged and disengaged

electronically from the tractor. Overall transport height and width were 14.8 ft (4.5 m) and 22.7 ft (6.9 m) respectively, requiring care when travelling on public roads.

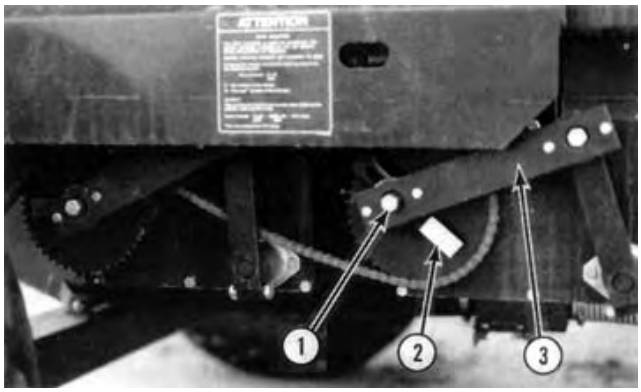
FIGURE 16. Seeding and Fertilizer Rate Adjustment: (1) Lock Bolt, (2) Scale, (3) Crank Arm.

Seeding and Fertilizer Rates: Ease of setting the seed and fertilizer rates was very good. The seeding and fertilizer rates were changed by loosening the lock bolt (FIGURE 16) on the meter crank arm and then moving the crank arm to lengthen or shorten its turning radius. The meter setting numbers were determined from the calibration charts. Changing from the course meter roller to the ne meter roller took one man approximately half an hour. The crank arm scale was calibrated increments of 1.0 ranging from 0 to 69 (FIGURE 16). Calibration charts, given in pounds per acre, were shown in the operator's manual. The metering scale allowed relatively precise seeding and fertilizer rate adjustment. For example, changing the meter setting by 1.0 in Tower Canola, changed the seeding rate by only 0.54 lb/ac (0.61 kg/ha).
