EVALUATION REPORT

353

CO-OP IMPLEMENTS 742 SELF-PROPELLED WINDROWER

A Co-operative Program Between

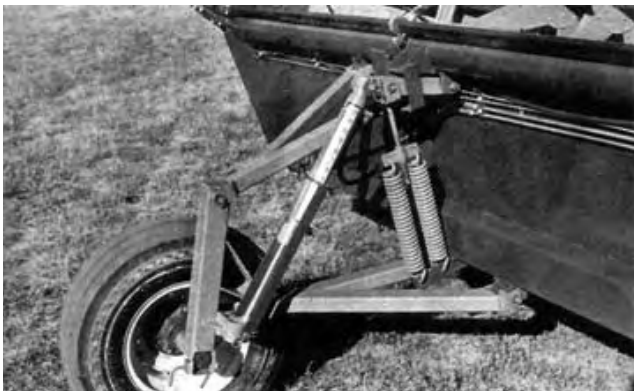
FIGURE 5. Wing Flotation System.

Header Flotation: Header flotation was very good. Flotation was provided by four tension springs on the traction unit (FIGURE 4) and two tension springs on each wing wheel (FIGURE 5). Header flotation minimized cutterbar damage in stony fields. The hinged wings enabled the header to follow most ground contours. Undulating stubble occurred only in very rough fields.

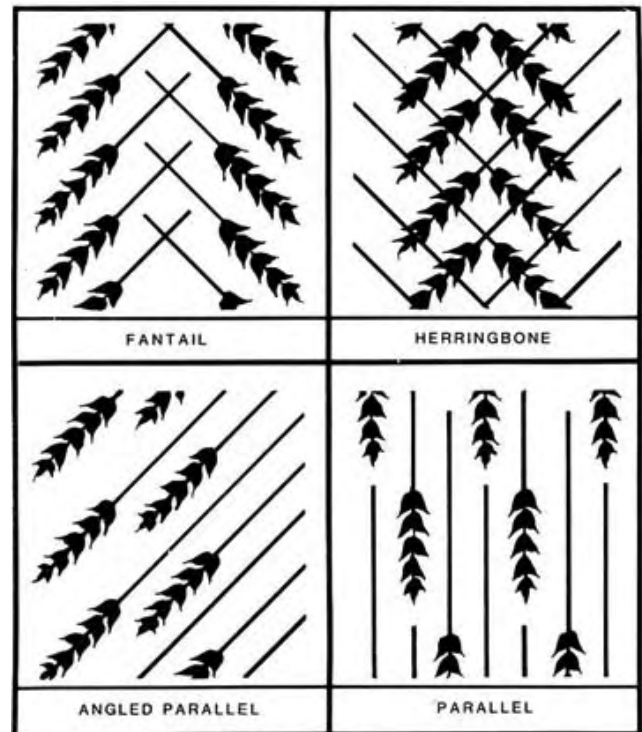
FIGURE 6. Windrow Types.

Windrow Formation: Windrows may be classified into four general patterns (FIGURE 6), although many combinations and variations exist. FIGURES 7 to 11 show typical windrows formed by the CI 742. The CI 742 produced parallel and fantail windrows in most grain crops. Wheat and barley windrows were usually formed in two parts. Herringbone windrows occurred in light crops, while fantail windrows were predominant in heavy, tall stands or ripe crops. In thin stands, reducing draper speed resulted in a wider, more parallel windrow.

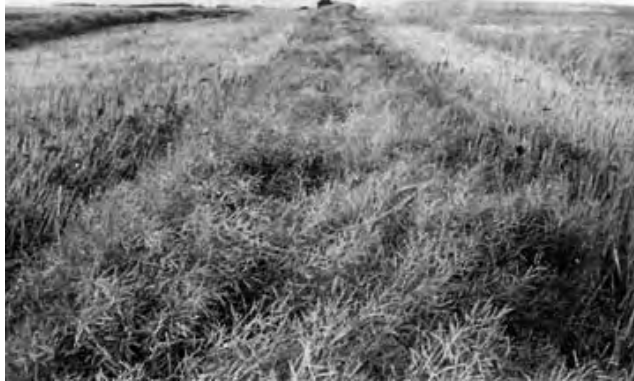
FIGURE 10. Rapeseed: 30 bu/ac (1.7 t/ha).

Windrow Uniformity: Windrows were uniform in most crops at speeds up to 6 mph (10 km/h). In rapeseed, bunched windrows resulted when the cutterbar plugged at the centre divider. In tall crops, some bunching occurred when material was dragged along

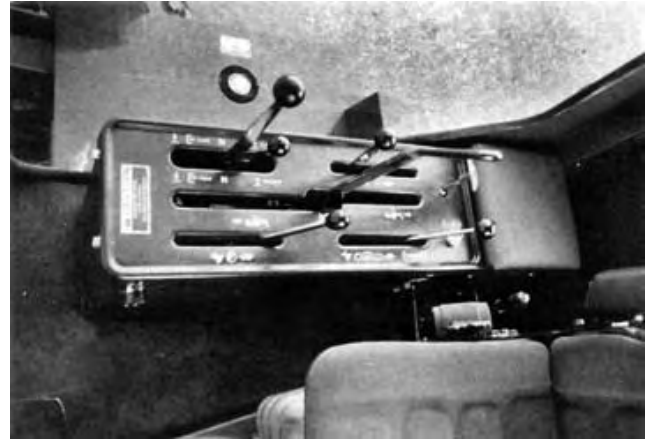
FIGURE 13. Hand Controls.

Controls: Most of the controls for the CI 742 (FIGURES 12 and 13) were conveniently located, properly identified and easy to operate. The range shifter was difficult to engage, as it had to be forced into place. The travel speed control lever was convenient to operate in both field and transport positions.

The height of the two sides of the reel could be controlled separately by foot pedals, but lifting rate was too slow for varying crop conditions. Also, after the heights have been varied several times, operation had to be stopped to relevel the two sides by fully raising and lowering the lift cylinders. It is recommended that the manufacturer consider modifications to the reel lift system to make it more convenient to operate. The header and wing height indicators aided the operator in controlling stubble height. Reel and draper speeds were easily controlled on-the-go by hand levers.

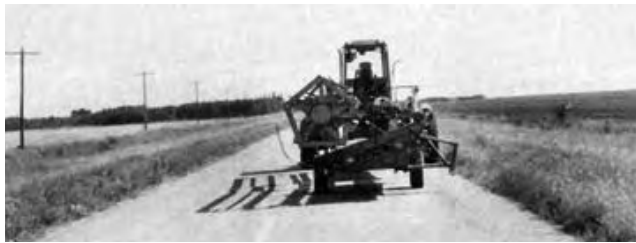
FIGURE 15. Full Transport Position.

Transporting: The CI 742 travelled very well on open roads in semi-transport at speeds up to 7 mph (11 km/h), and in full transport (FIGURE 15) at speeds up to 10.5 mph (17 km/h). In semi-transport, the wings were high enough to clear most obstructions, but the unit was too wide for meeting traffic. In full transport, the header trailed well and the unit negotiated corners easily and safely.
