Evaluation Report

402

Sperry New Holland 1100 Self-Propelled Windrower

SPERRY NEW HOLLAND 1100 SELF-PROPELLED WINDROWER

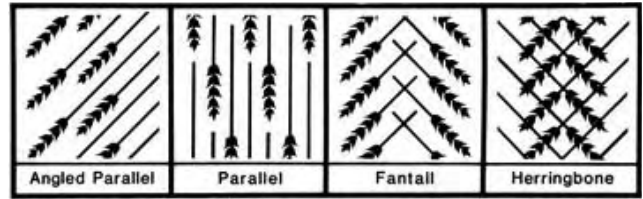
FIGURE 6. Windrow Types.

Windrow Formation: Windrows may be classified into four general patterns (FIGURE 6), although many combinations and variations exist. Windrow formation was very good. FIGURES 7 to 11 show typical windrows formed by the NH 1100. Centre delivery windrows were usually formed parallel or fantailed. Alternating end delivery resulted in parallel or angled parallel windrows depending on direction of crop lean. Herringbone windrows occurred in light crops, while fantailed windrows occurred in heavy tall stands or ripe crops. Hay windrows were wide and parallel, which could make them difficult to pick up. The 1116-D draper header was not recommended for use in hay.

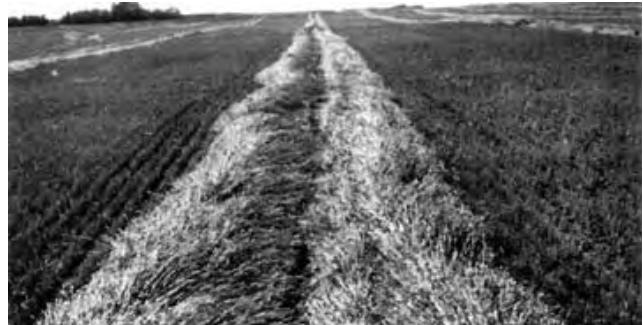
FIGURE 7. Wheat, Double Windrow: 38 bu/ac (2.6 t/ha).

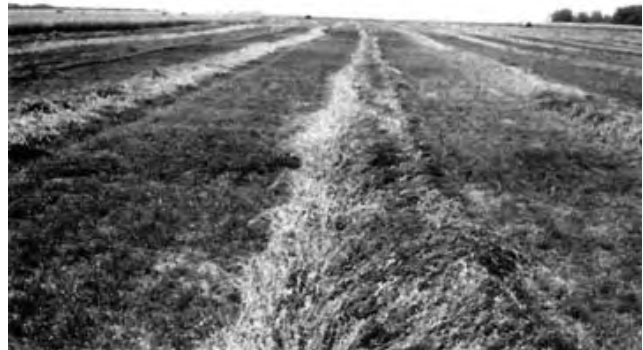
FIGURE 8. Brome Hay, Single Windrow: 0.9 ton/ac (2.0 t/ha).

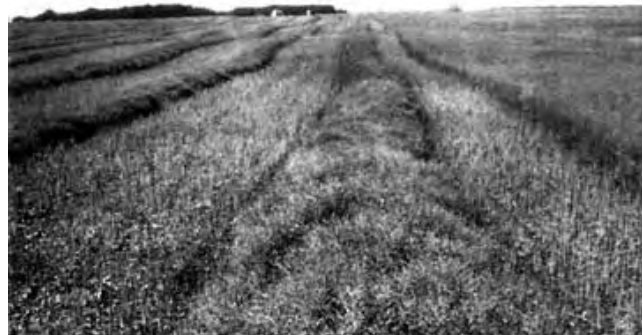
FIGURE 9. Rapeseed, Single Windrow: 24 bu/ac (13 t/ha).

Single, centre-delivery windrows were normally 3 to 4 ft (0.9 to 2.4 m) wide. Single rapeseed windrows were about 6 ft (1.8 m) wide. Side-by-side double windrows formed with alternating end delivery varied from 7.5 to 10 ft (2.3 to 3.1 m) wide. The gap between the windrows could be reduced from 20 in (508 mm) to about 6 in

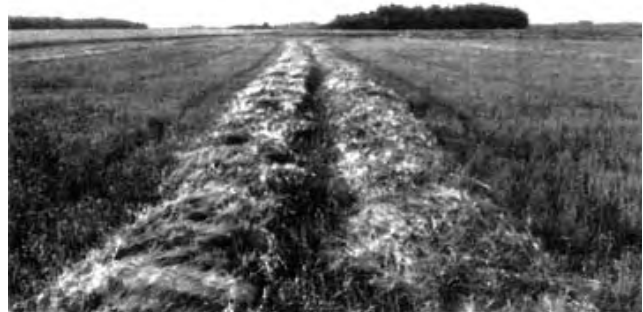
FIGURE 10. Barley, Double Windrow: 30 bu/ac (1.6 t/ha).

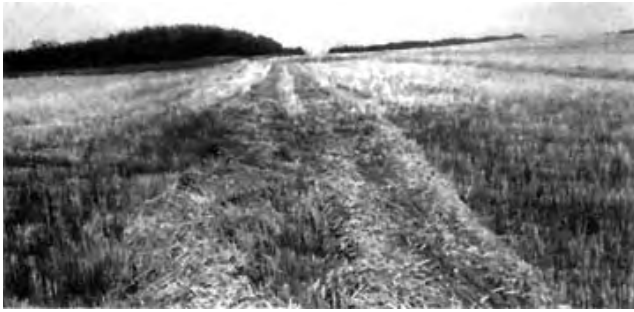
FIGURE 11. Fall Rye, Double Windrow 25 bu/ac (1 6 t/ha).

Windrow Uniformity: Windrow uniformity was good. Windrows were uniform in average and short crops at speeds up to 6 mph (10 km/h). In tall and heavy crops such as fall rye and wheat, bunched windrows resulted when the drapers plugged, or when material caught on the rear draper shielding at the windrow opening. Modifications to reduce draper plugging have been recommended.
