Evaluation Report

292

Leon 8200 (12.3 m) Rod Weeder

LEON 8200 ROD WEEDER

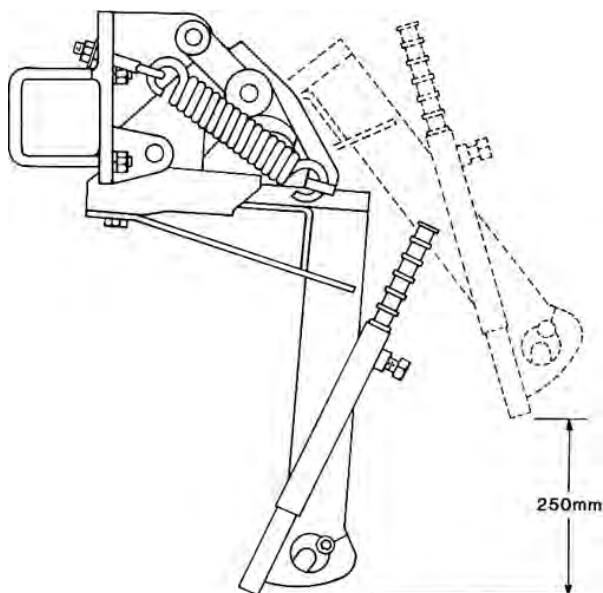
FIGURE 2. Rod Shank Lifting Pattern.

Shank Characteristics: The Leon 8200 was equipped with adjustable spring trip rod shanks that tripped independently to clear small obstructions. For large obstructions, all the shanks on the frame section tripped together. FIGURE 2 shows the lifting pattern of the shanks when stones or field obstructions were encountered. The maximum lift height of 250 mm (10 in) and the trip settings were adequate for the stony conditions encountered. No shank or rod failures occurred during the test.

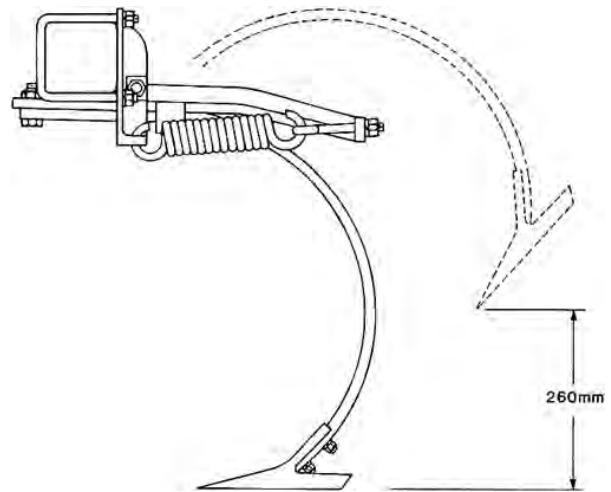
FIGURE 3. Cultivator Shank Lifting Pattern.

The cultivator shanks were equipped with adjustable cushion springs. FIGURE 3 shows the lifting pattern when the cultivator shanks encountered stones or field obstructions. The cultivator shank assemblies performed well. The maximum lift height of 260 mm (10.2 in) and the recommended spring settings were adequate for the stony conditions encountered.

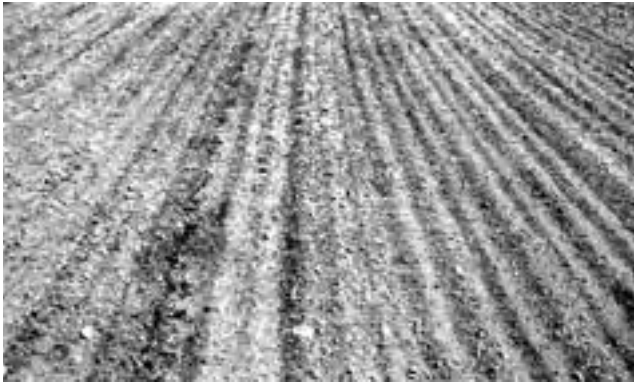
FIGURE 5. Typical Seedbed Preparation With Mounted Harrows and With Cultivator Shanks Removed.

Trash Burial and Surface Conditions: The rod drive shanks of the Leon 8200 left deeper furrows than the rod support shanks.

These furrows were usually filled in by the finishing harrows resulting in a uniform seedbed (FIGURE 5). The Leon 8200 buried less trash than most cultivators (FIGURE 6).

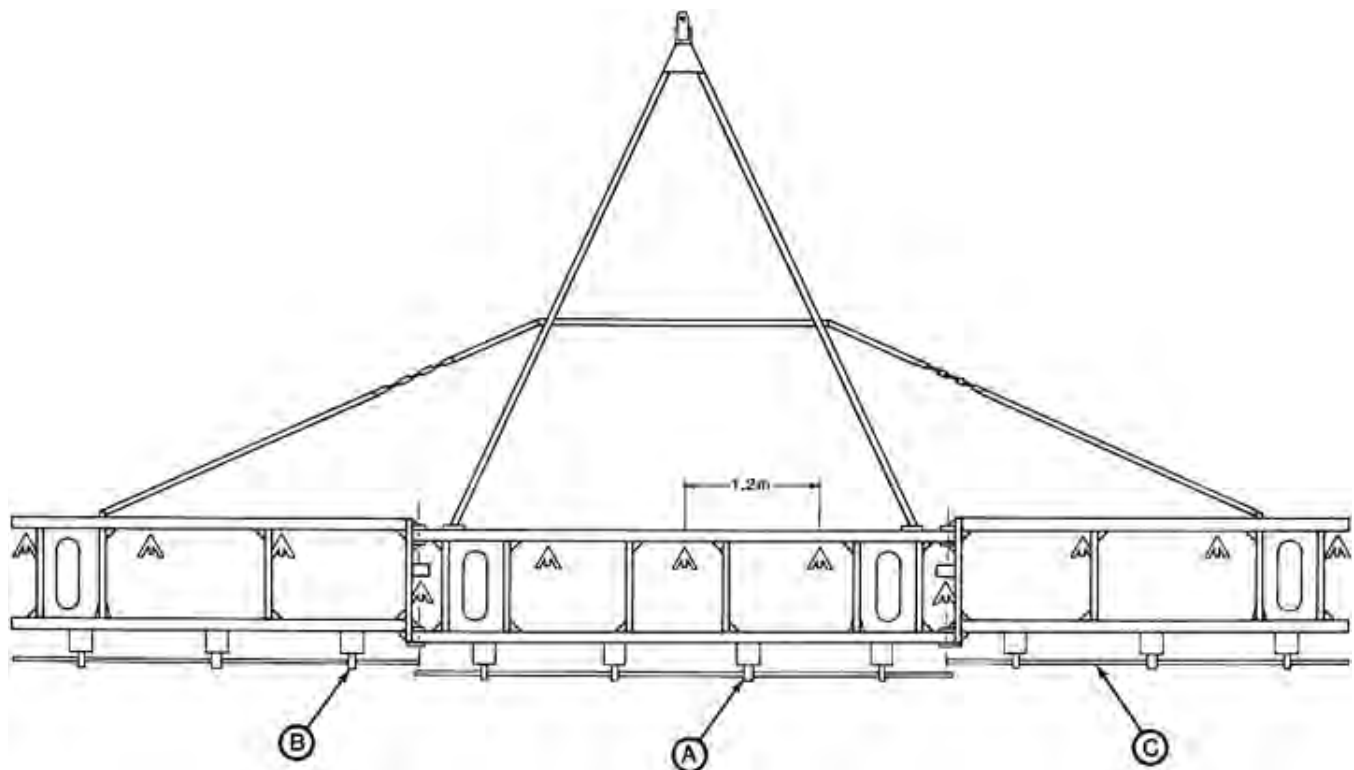
FIGURE 7. Shank Pattern (A) Rod Drive Shanks, (B) Rod Support Shanks, (C) Rod.

The rod drive shanks penetrated about 75 mm (3 in) deeper than the rod, when the wear rods were properly adjusted. This produced deep furrows behind the rod drive shanks and caused some seedling damage when operating the rod weeder in seeded fields. It is recommended that the manufacturer consider modifications to reduce excessive penetration of the rod drive shanks.

Skewing and Stability: The Leon 8200 was stable and sideways skewing only occurred on hillsides. The location of the rod shanks and cultivator shanks (FIGURE 7) did not impose any side forces on the rod weeder during normal tillage.

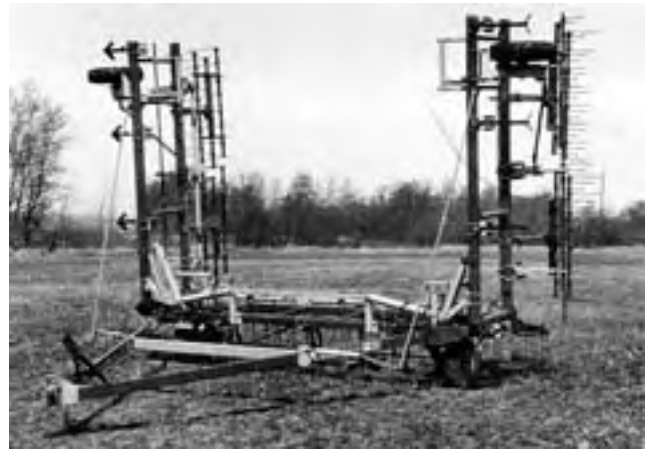
FIGURE 8. Transport Position.

Transporting: The Leon 8200 was easily placed into transport position in less than five minutes using the hydraulic wing lift system (FIGURE 8). The retaining straps between the hydraulic cylinders had to be replaced with shorter straps to provide easy installation of the transport lock pins. The transport locks for the depth control wheels on the centre section (FIGURE 9) were large and difficult to install or store when not in use. It is recommended that the manufacturer modify these transport locks to provide easier installation and storage.

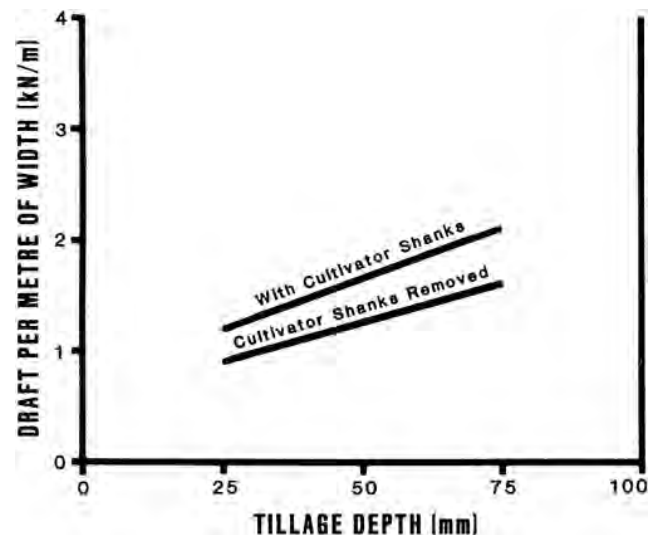
FIGURE 11. Average Draft Requirements for Rod Weeders in Secondary Tillage at 8 km/h.

Draft Characteristics: FIGURE 11 shows draft requirements for rod weeders in typical secondary tillage at a speed of 8 km/h (5 mph). This figure gives average requirements based on tests of six rod weeders in several different field conditions. Attempting to compare draft requirements of different makes of rod weeders is unrealistic. Variation in soil conditions affect draft much more than variation in machine make, usually making it impossible to measure any significant draft difference between different makes of rod weeders.

In secondary tillage with the cultivator shanks removed, the average draft per metre of width at 8 km/h (5 mph), varied from 0.9 kN/m (62 lb/ft) at 25 mm (1 in) depth to 1.6 kN/m (110 lb/ft) at 75 mm (3 in) depth. For the 12.3 m (40.4 ft) wide test machine this corresponds to a total draft ranging from about 11.1 to 19.7 kN (2500 to 4430 lb).
