Evaluation Report

305

Sperry New Holland Model 8500 Round Bale Wagon

SPERRY NEW HOLLAND MODEL 8500 ROUND BALE WAGON

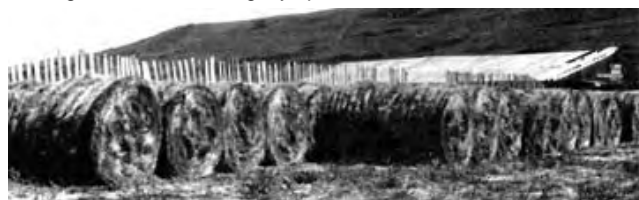
Placement Quality: Placement quality was good with solid, well formed bales (FIGURE 4). The New Holland 8500 placed bales in two rows with the circumferences of each bale touching in each row. Bale spacing was not possible within each load. Adjacent loads, however, could be easily spaced according to operator preference. An experienced operator could place adjacent loads together forming uniform rows of tightly spaced bales.

FIGURE 4. Bale Placement with New Holland 8500.

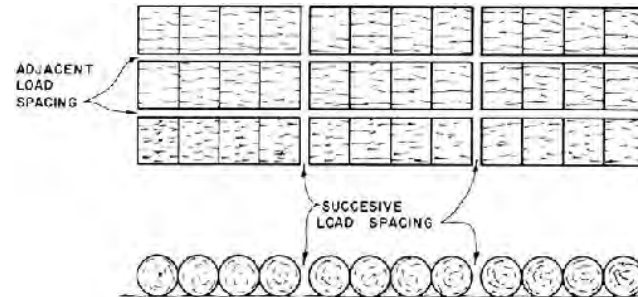
In areas of high precipitation, excessive spoilage may occur where the circumferences of each bale touch. In such areas, spaces should be left between successive loads (FIGURE 5) while adjacent loads should be placed as closely together as possible. Close spacing of adjacent loads decreases the exposed surface area and reduces weathering.

FIGURE 5. Load Spacing to Reduce Spoilage.
