# Evaluation Report

# 235

**Massey Ferguson Model 124 Baler**

# MASSEY FERGUSON MODEL 124 BALER

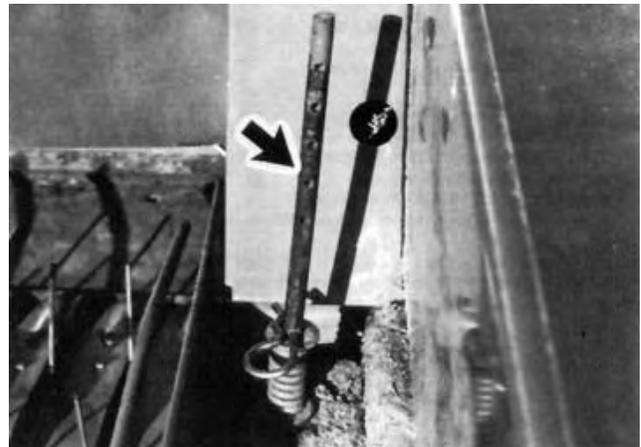
FIGURE 7. Pickup Height Adjustment.

**Pickup:** Pickup height was easily adjusted without tools (FIGURE 7). A wrench was needed to position the optional pickup gauge wheel. Wrenches were also required to adjust the pickup windguard for various windrow sizes. The windguard was easily removed without tools for convenient access to the feeding area.
