Evaluation Report

300

Krone KR180 Baler

KRONE KR180 BALER

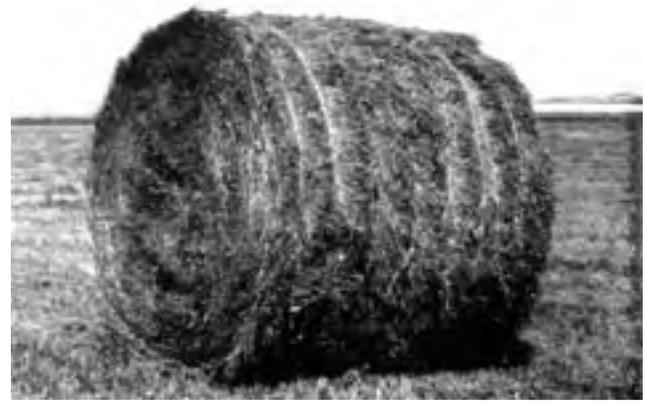
Bale Quality: The Krone KR180 produced firm, durable bales with flat ends and uniform diameter in most crops (FIGURE 2). Bales were of very good quality when baled in well formed windrows at the optimum moisture content. However, in light, dry conditions, irrespective of crop and in unconditioned greenfeed, bale quality was reduced to fair as it was difficult to consistently produce bales of uniform diameter and adequate durability (FIGURE 3). Similar to most round balers, it was also difficult to consistently produce uniform, durable bales in dry, short, chopped up straw, similar to that combined with rotary combines. In short straw conditions, bale quality was greatly improved if the straw was baled when slightly tough.

FIGURE 2. Typical Hay Bale.

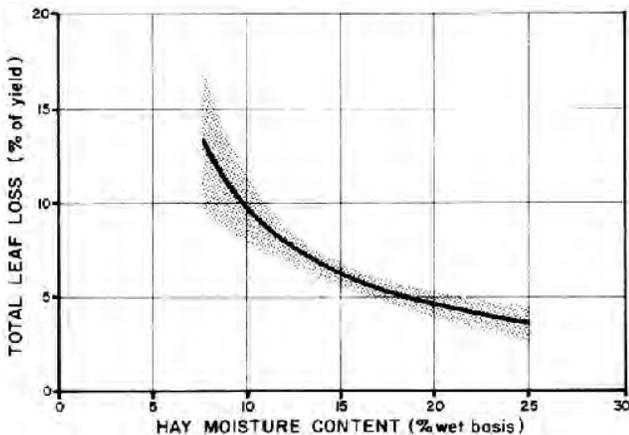
FIGURE 5 shows the importance of baling at higher moisture contents. This figure represents an accumulation of data for several round balers showing the total measured leaf loss over a range of hay moisture contents, in fields of mixed alfalfa, crested wheatgrass and bromegrass. Although the Krone KR180 was tested in a

different crop, its performance was within the range presented in the figure with the exception of slightly lower losses at higher moisture contents.

FIGURE 5 represents nearly ideal baling conditions with relatively heavy windrows, which had been conditioned to enhance drying of the hay stems. Much higher leaf loss can be expected in light, unconditioned windrows. While feedrate did not appreciably affect losses in the ideal conditions shown in FIGURE 5, loss tests in light unconditioned windrows have shown that round baler losses can be reduced by keeping the feedrate as high as possible to minimize time in the baling chamber. Bale chamber losses in light crops can also be reduced by running the tractor at a lower power take-off speed to reduce the number of turns needed to form a bale.

FIGURE 5. Leaf Loss in Mixed Alfalfa, Crested Wheatgrass and Bromegrass.

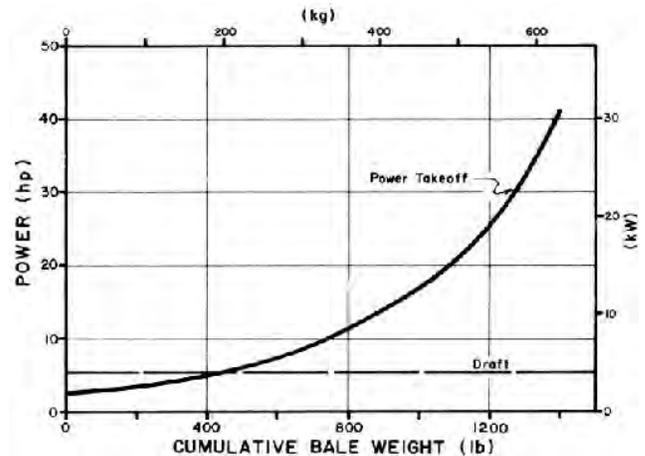
Power Requirements: FIGURE 6 shows the power take-off and drawbar input for the Krone KR180. The power input is plotted against bale weight to show the power requirements while a bale is formed. Power take-off input varied from 2.7 hp (2 kW) at no load to a maximum of 42 hp (31 kW). Drawbar requirements at 6.8 mph (11 km/h) on flat firm fields were about 5.5 hp (4 kW). Although maximum power requirements did not exceed 48 hp (36 kW), additional power was needed to suit field conditions. In soft, hilly fields a 65 hp (49 kW) tractor would be needed to fully utilize baler capacity.

FIGURE 6. Power Consumption During Bale Formation in Alfalfa Bromegrass.
