Evaluation Report

National 30A1 Diaphragm Hand Pump

NATIONAL 30A1 DIAPHRAGM HAND PUMP

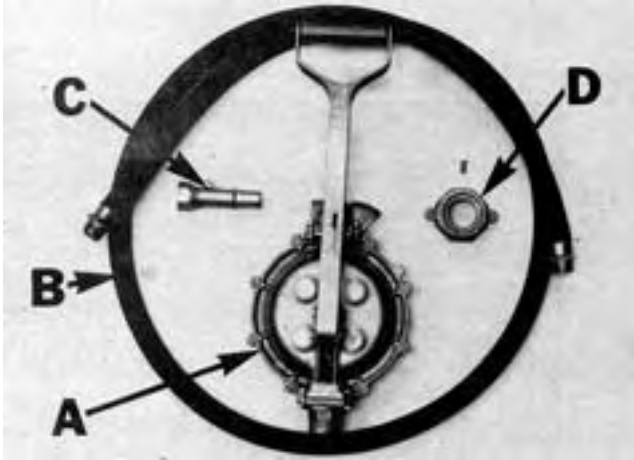
FIGURE 1. National 30A1 Hand Pump: (A) Pump Body, (B) Outlet Hose, (C) Outlet Nozzle, (D) Bung Adaptor.

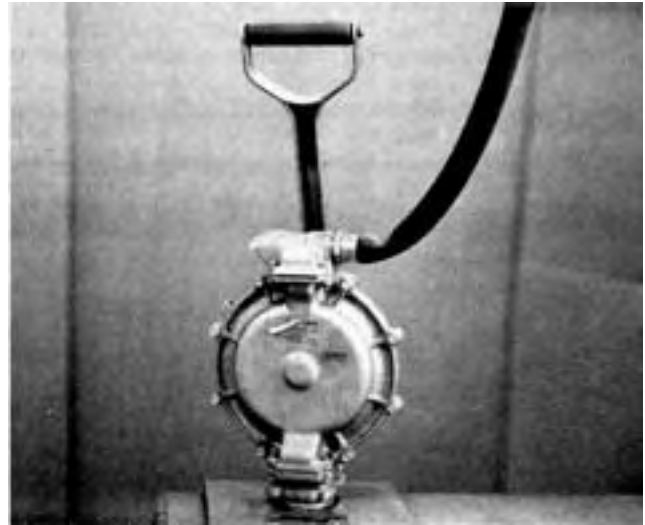
Filling A Fuel Tank: The outlet hose was equipped with a standard fuel nozzle. An automatic shut-off nozzle is available as optional equipment. Pumping at 35 strokes per minute, it took from 6 to 7 minutes to fill a 225 L (50 gal) tractor fuel tank with filler opening typically located 1 m (3.3 ft) higher than the top of a typical farm truck fuel supply tank. The outlet hose was very soft and kinked frequently (FIGURE 4), restricting fuel flow, when filling tanks that were higher than the fuel supply tank. It is recommended that the manufacturer modify the hose to prevent kinking.

FIGURE 4. Kinked Outlet Hose.

1. Modifications to prevent fuel leaking through the vent in the base of the pump.
2. Modifications to avoid hose kinking.
3. Modifying the bung adaptor to avoid pump body movement within the adaptor.
4. Investigating the possibility of eliminating the need for a spring on top of the outlet valve.
