Evaluation Report

146

Hesston 5500 Rounder

HESSTON 5500 ROUNDER

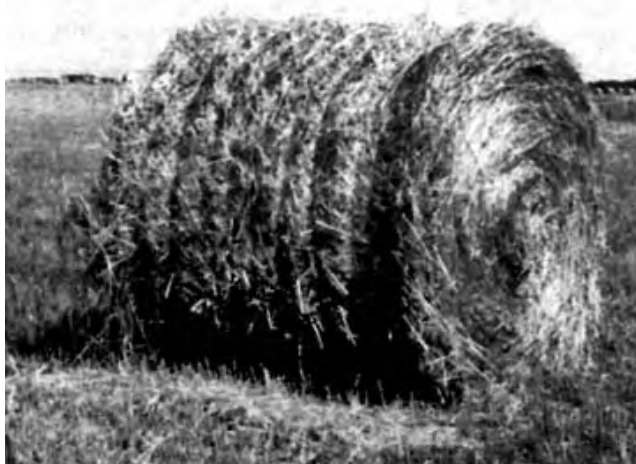
Bale Quality: The Hesston 5500 produced firm, durable bales (FIGURE 2) with flat ends and uniform diameter. Bales averaged 1.5 m in length and 1.6 m in diameter. Average hay bales weighed from 372 to 472 kg with an average density of 143 kg/m³. Density at the outer diameter was about twice as great as at the bale centre.

FIGURE 2. Typical Hay or Straw Bale.

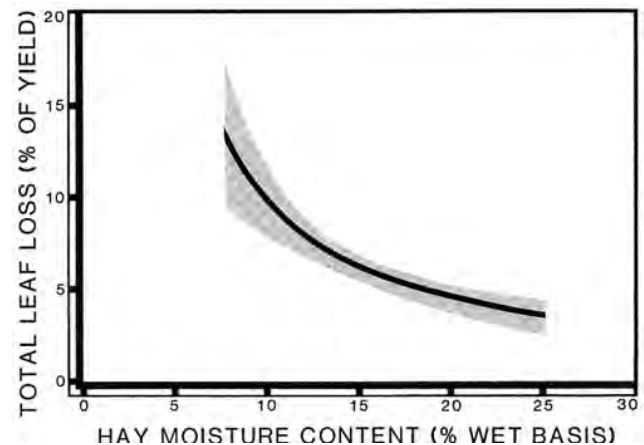
FIGURE 4 shows the importance of baling at high moisture contents. This figure shows the total measured leaf loss, over a range of hay moisture contents, in fields of mixed alfalfa, crested wheatgrass and bromegrass. The crop had been cut with a 3.7 m mower-conditioner. Yields ranged from 2.7 to 4.6 t/ha with an average of 3.5 t/ha. As can be seen, total leaf loss ranged from about 15% when baled at 8% hay moisture content to 3% when baled at 22% hay moisture content. At 8% moisture content, pickup loss was about 9% and bale chamber loss about 6% whereas at 22% moisture content pickup loss was about 1% and bale chamber loss about 2%.

FIGURE 4. Leaf Loss in Mixed Alfalfa, Crested Wheatgrass and Bromegrass.

Although FIGURE 4 represents an accumulation of data for several round balers, performance of the Hesston 5500 was within the range presented in this figure. FIGURE 4 represents nearly ideal baling conditions with relatively heavy windrows, which had been conditioned to enhance drying of the hay stems. Much higher leaf loss can be expected in light unconditioned windrows. While feedrate did not appreciably affect losses in the ideal conditions shown in FIGURE 4 loss tests in light unconditioned windrows have shown that round baler losses can be reduced by keeping the feedrate as high as possible to minimize time in the baling chamber. Bale chamber losses in light crops can also be reduced by running the tractor at a lower power take-off speed to reduce the number of turns needed to form a bale.

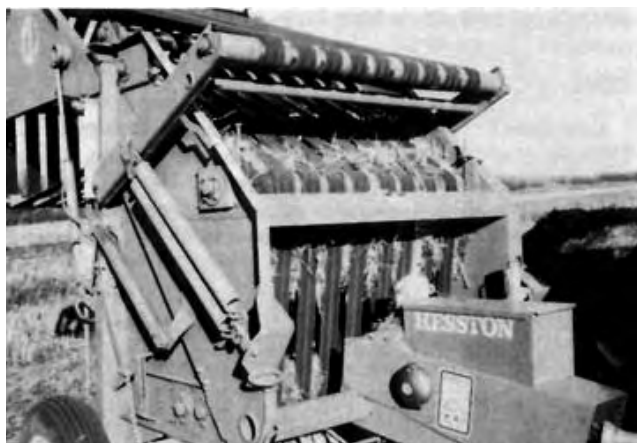
Some bale formation problems occurred in short straw. Short straw sometimes would not form a rotating core but would build up at the front of the bale chamber until it plugged the pickup. Once this occurred, the rear gate had to be opened and the straw removed by hand. During baling, the short straw also accumulated between the bale forming belts (FIGURE 6). The straw build up prevented full size bale formation due to interference with the bale forming belts. Modification to improve bale formation in short straw is recommended.

FIGURE 7 shows the position of the forming belts during bale formation.

FIGURE 6. Material Build Up Between Belts.

FIGURE 7. Stages of Bale Formation: (Left) Bale Core, (Centre) Half-Completed Bale, (Right) Completed Bale.

2. Modifications to improve twine cutter performance.
3. Modifications to reduce straw build up between the bale forming belts and to improve bale core formation in short straw.

1. A new high tensile clipper lace is now in production for the 5500 Rounder. This new splice is 40 percent stronger to resist bending and opening up.
2. Improvements to twine cutoff performance are under active consideration and development. To achieve best performance, make sure the knife edges are razor sharp.
3. The scraper over the front drive roller has been relocated to improve performance.
