# Evaluation Report

**Hesston Model 4600 Beeline Baler**

## HESSTON MODEL 4600 BEELINE BALER

### GENERAL DESCRIPTION

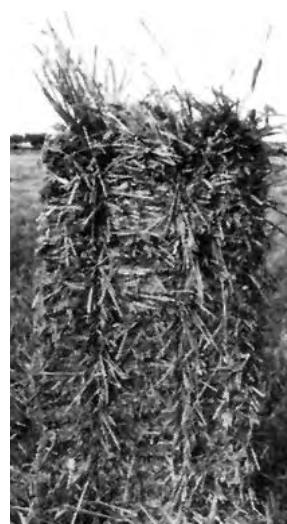
FIGURE 2. Typical Bales: (A) Alfalfa, (B) Bromegrass, (C) Greenfeed, (D) Straw.

**Bale Quality:** The Hesston 4600 was capable of producing firm, durable bales with square ends in most crops (FIGURE 2). Average hay bales weighed 21 to 41 kg (45 to 90 lb), while average straw bales weighed 21 to 24 kg (45 to 53 lb). Average bale density varied from 134 to 254 kg/m<sup>3</sup> (8.3 to 15.8 lb/ft<sup>3</sup>) in hay and from 127 to 146 kg/m<sup>3</sup> (7.9 to 9.1 lb/ft<sup>3</sup>) in straw.

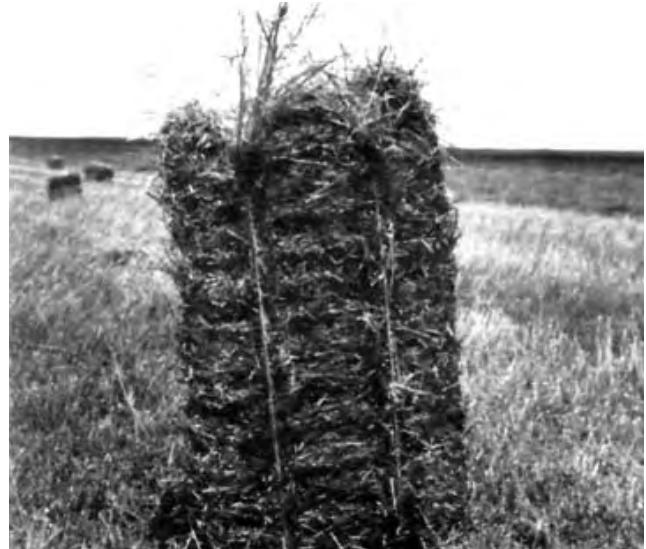
FIGURE 3. Ragged Bale Ends in Long Stemmed Crops.

At higher feedrates the Hesston 4600 continued to produce bales of adequate quality for bale wagon handling. In long stemmed crops, bales with ragged looking ends would occasionally be produced (FIGURE 3).
