# Evaluation Report

# 488

**New Holland 849 Round Baler**

# NEW HOLLAND 849 ROUND BALER

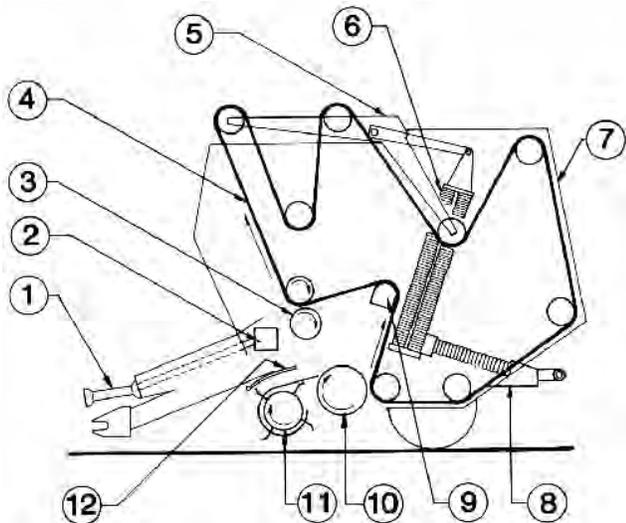
FIGURE 1. New Holland 849 Round Baler: (1) Drive Shaft, (2) Gearbox, (3) Stripper Roll, (4) Apron Chain, (5) Apron Chain Tension Pilot Arms, (6) Bale Tension Springs, (7) Tailgate, (8) Bale Ejector, (9) Core Forming-Cam Idler, (10) Floor Roll, (11) Pickup, (12) Windguard.

Detailed Specifications are given in APPENDIX I, while FIGURE 1 shows the location of major components.

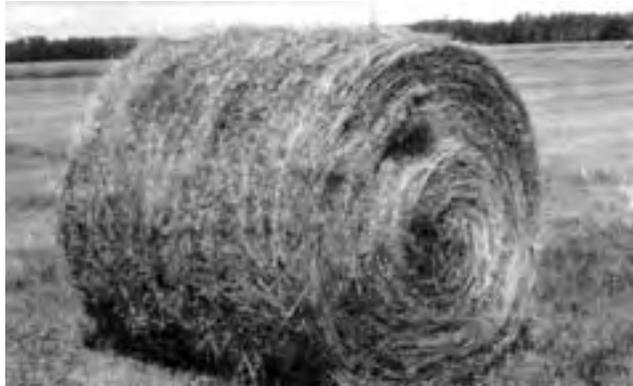
**Bale Quality:** The New Holland 849 produced firm, durable bales with flat ends and uniform diameter in all hay crops (FIGURE 2). Short straw generally resulted in a less durable bale for handling, however setting the twine wrap for maximum number of wraps (23) made a satisfactory bale. The overall bale quality depended greatly on the operator experience. Failure of the operator to evenly feed both sides of the baler in light windrows resulted in barrel or cone-shaped bales.

**FIGURE 2.** Typical Hay Bale.

A typical hay or straw bale averaged 4.8 ft (1.45 m) in width and 5 ft (1.52 m) in diameter. Bales usually settled to about 93% of their original height after 100 days. Average hay bales weighed from 850 to 1000 lb (385 to 454 kg) with average densities ranging from 9.1 to 10.7 lb/ft<sup>3</sup> (146 to 172 kg/m<sup>3</sup>). Average straw bales weighed from 570 to 650 lb (260 to 295 kg) with average densities ranging

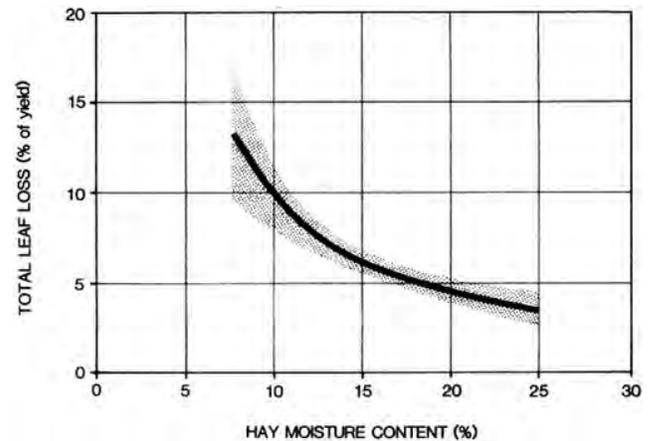
The importance of baling at a high moisture content on losses can be noted in FIGURE 3. This figure represents an accumulation of previous data for several round balers showing the total measured leaf loss over a range of moisture contents, in fields of mixed alfalfa-crested wheatgrass and bromegrass. Although the New Holland 849 was tested in a different crop, its performance was above that presented in the figure.

**FIGURE 3.** Leaf Loss in Mixed Alfalfa, Crested Wheatgrass and Bromegrass.

FIGURE 3 does not include relative effects of baling unconditioned or light windrows. Heavy, conditioned windrows are important to minimizing losses. Lower power take-off speed is also effective in reducing the number of times the bale turned in the chamber, and consequently reducing leaf loss.

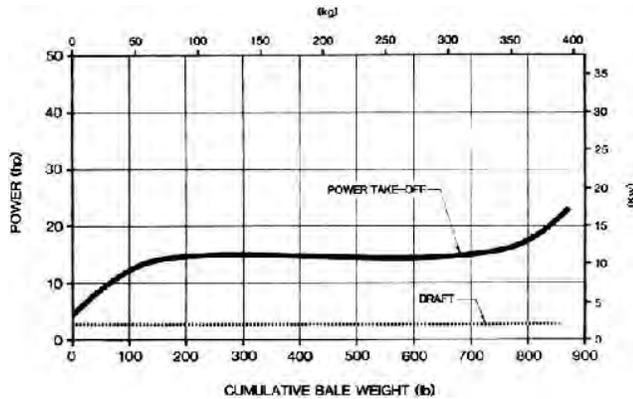
**Power Requirements:** FIGURE 4 shows the power takeoff and drawbar power requirements for the New Holland 849. The power input is plotted against bale weight to show the power requirements while a bale is formed. Power take-off input varied from 4 hp (3 kW) at no load to a maximum of 18 hp (13.4 kW) in alfalfa and barley straw. Drawbar requirements at 6.6 mph (10.6 km/h) on flat firm fields were about 3.0 hp (2.2 kW) when the bale reached maximum size. Although maximum horsepower requirements did not exceed 22 hp (16.4 kW), additional power was needed to suit field conditions. In soft, hilly fields, a 65 hp (49 kW) tractor would be needed to fully utilize baler capacity.

FIGURE 4. Power Consumption During Bale Formation in Alfalfa-Bromegrass.
