Evaluation Report

601

Rampak Silage Bagger

RAMPAK SILAGE BAGGER

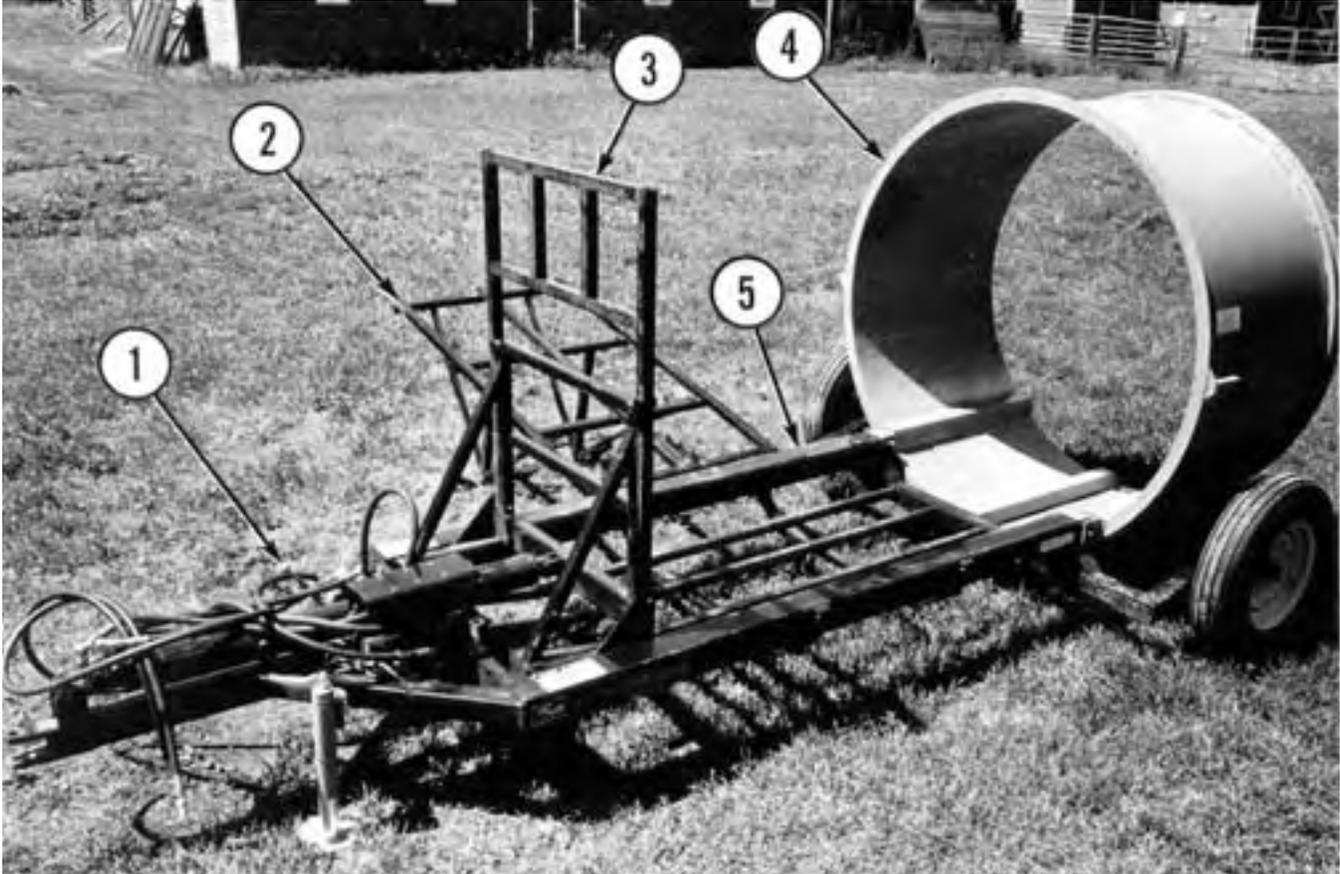
FIGURE 1. Rampak Silage Bagger: (1) Hydraulic Lever, (2) Ramp, (3) Bale Ram, (4) Drum, (5) Carriage.

The Rampak Silage Bagger (FIGURE 1) is a hydraulically driven round bale bagging system mounted on a two wheel trailer. A 3 ft (0.91 m) long by 5.5 ft (1.68 m) diameter drum holds the 100 to 125 ft (30.5 to 38.1 m) poly tubing sleeve. The plastic is held tight by a tension ring, which slips over the plastic sleeve and drum.

The high moisture bales are either set directly onto the carriage or set onto the bale ramp and allowed to roll onto the carriage. A hydraulic lever near the front of the Rampak operates the telescoping hydraulic cylinder to push the bale into the drum. The Rampak and tractor are pushed forward as successive bales are pushed through the drum and into the plastic tubing. A drop extension rail is used to push the last bale clear of the drum. One plastic sleeve will accommodate eighteen 5.0 ft (1.5 m) bales or twenty-three 4.0 ft (1.2 m) bales. Shear bolts located on the drum protected the drum from damage in the event a bale catches on the edge of the drum. Detailed specifications are given in Appendix I.

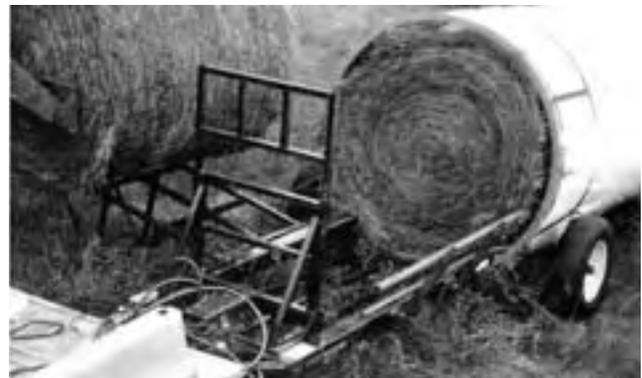
FIGURE 2. Bale from Expanding Chamber Baler being Set onto the Ramp.

Expanding chamber balers produced suitable well-formed bales for the Rampak. 'Round' bales, as opposed to ovated bales, were desired to optimize the capacity of the drum (FIGURE 2). Generally, operators would attempt to make bales very close to the diameter of the drum to effectively fill the bag. This aided in the bag weathering durability by helping to reduce air cavities within the bag and also provided a better return on the dollar invested per amount of hay stored.

Loading: Ease of loading was very good. Round bales were loaded onto the carriage or placed onto the ramp with a front-end loader. Bale forks were adequate when the ramp was used while grapples allowed setting the bale directly onto the carriage. When using the bale ramp (FIGURE 2) the Rampak operator was occasionally required to assist the bale down the ramp. The ramp could be attached to either side of the Rampak to suit storage site access limitations.

Using the grapples to drop slightly orated bales onto the carriage allowed the bales to roll off the loader one-quarter turn into the carriage and permitted matching the bale shape with the circular drum. Bales, which had settled slightly were then easily pushed into the drum without catching on the sides (FIGURE 2).

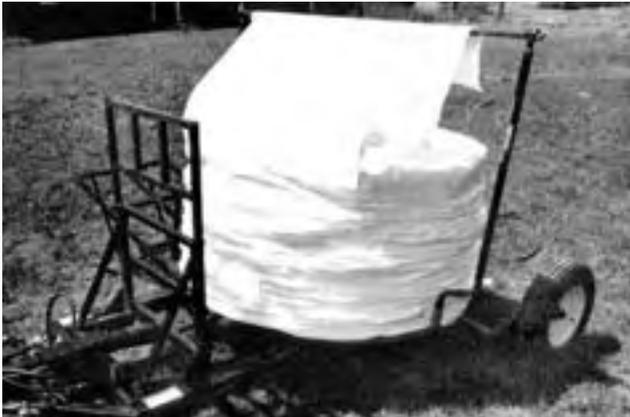
FIGURE 3. Installing Poly Tubing from Roll onto Drum.

Poly Tubing: Ease of installation of the poly tubing bags was fair for the rolls and very good for the folded tubing. Poly tubing sleeves were supplied either on rolls or prefolded. The poly tubing on the roll required using the tubing roll supports, which fitted into the support holders at either side of the drum. The roll of poly tubing was lifted into place and then pulled down over the turned up drum until the entire roll was in place around the drum (FIGURE 3). The drum was moved into the operating position and the end of the tubing was tied securely. The roll holder supports were then removed and the retaining ring was fitted around the poly tubing. It took two men to lift the cumbersome 70 lb (32 kg) roll into place on the drum. It is recommended that the manufacturer consider providing an easier method of lifting the poly tubing roll into place to install onto the drum. It took two men about 20 minutes to pull the poly tubing sleeve over the drum, provided there was little wind. Wind above 10 mph (16 km/h) caused the tubing to flap and unroll too quickly off the roll. During such windy conditions, the Rampak had to be taken into a shelter or a third person would have to hold the roll from unrolling too quickly or help pull the poly sleeve onto the drum.

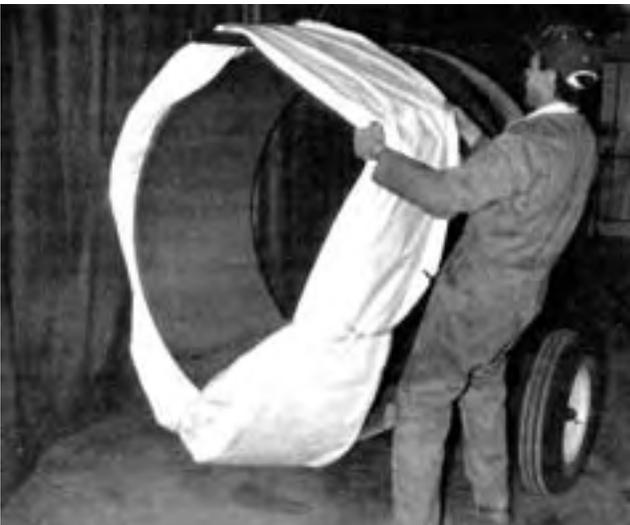
FIGURE 4. Installing Folded Poly Tubing onto the Drum.

1. We feel that the tool you made (FIGURE 4) to ease the mounting of the folded bag has merit and we will look at it further.
2. We have designed an optional bumper rail to mount on the frame opposite the loading ramp to assist in proper alignment of the 5 and 6 ft (1.5 m and 1.8 m) bales. This should cut down the instances of shearbolt replacement.

The folded poly tubing, on the other hand, was considerably easier to place onto the drum. One person could lift the bag from the box and slip it over the drum in about five minutes. A support bar was made to assist installing the poly tubing. Without this bar, two men were required to install the poly tubing onto the drum. The drum did not have to be dropped down onto the carriage (FIGURE 4).

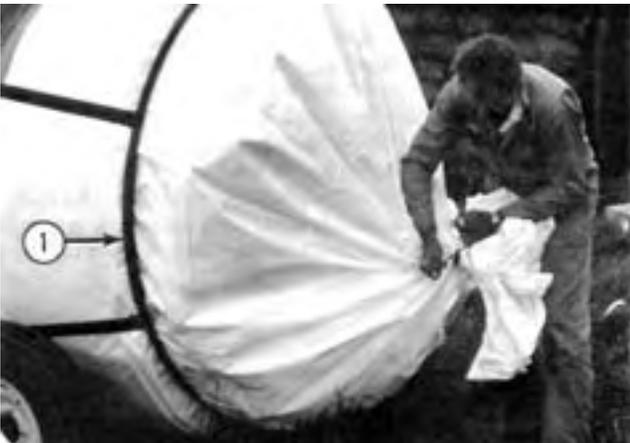
FIGURE 5. Poly Tubing Sleeve End Wrapped and Tied after Installation on Drum; (1) Tension Ring.

Final preparation of the Rampak, which included sliding the tension ring over the drum and poly tubing and tying off the end of the poly tubing, took one man about 5 minutes. Bale twine wrapped several times and tied provided a sufficient seal against spoiling (FIGURE 5).

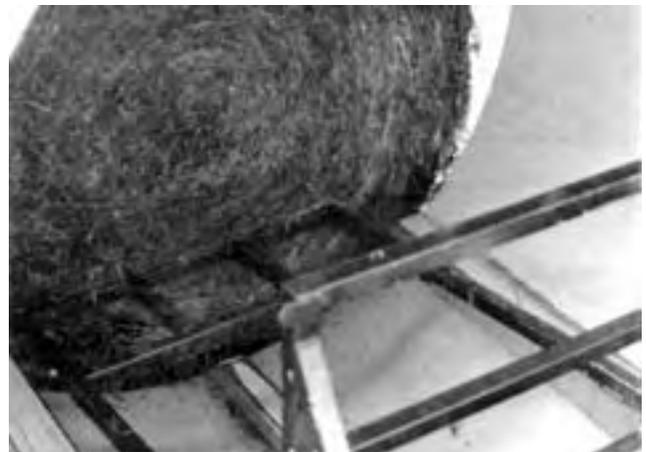
Drop Extension Rail: When the bag was filled to its capacity, the final bale was pushed clear of the drum with the drop extension rail. A stop on the rail was used to hold the extension rail about 12 in (300 mm) up on the bale. The stop caused the rail tubing to deform when used the first time. The bale pulled the extension rail down as the bale dropped to the ground from the drum (FIGURE 6). Repairs were made to the stop, however, the tubing again deformed (FIGURE 7). Eventually, tarp straps were used on the rail to permit it to spring back into its held up position after the bale was pushed through (FIGURE 8). It is recommended that the manufacturer consider providing a more durable method of holding the drop extension rail up when discharging the final bale from the drum.

FIGURE 6. Bale Wedged Against Drop Extension Rail.

1. Improving the ease of shear bolt replacement or alternately provide the safeguard device at the bale ram instead of at the drum. Providing a more durable method of holding the drop extension rail up when discharging the final bale from the drum.

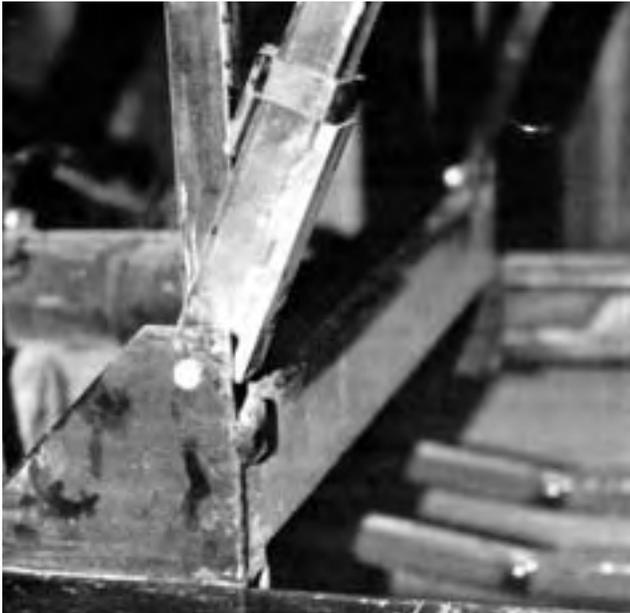
FIGURE 7. Reinforced Drop Extension Rail.

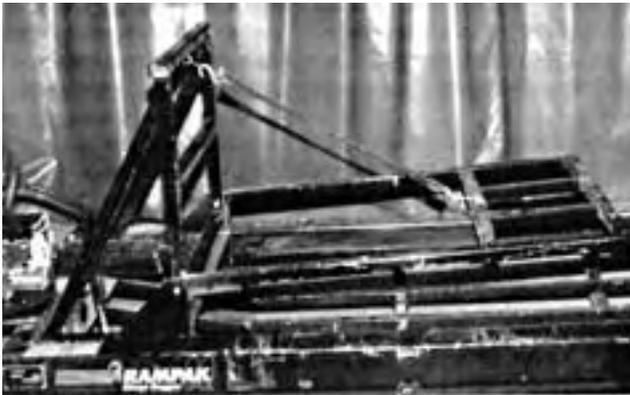
FIGURE 8. Drop Extension Rail Held Up With Tarp Straps.

Few mechanical problems occurred during the test. The drop extension rail stops caused the rail tubing to deform twice. Tarp straps were found to be a suitable method of supporting the rail (FIGURE 8).
