Evaluation Report

International Harvester 830 Forage Harvester

INTERNATIONAL HARVESTER 830 FORAGE HARVESTER

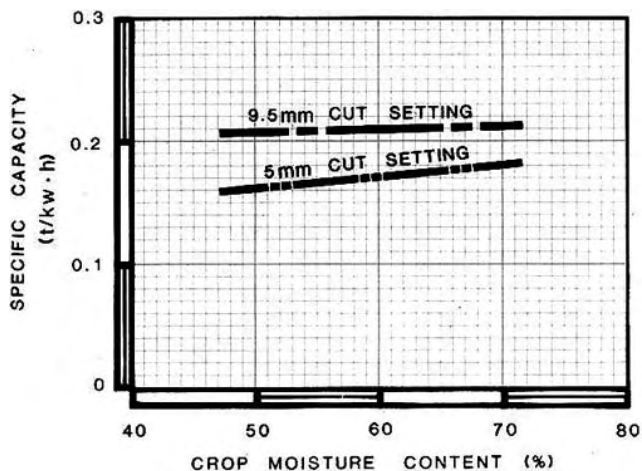
FIGURE 2. Specific Capacity in Alfalfa (based on dry-weight workrates).

As seen in FIGURE 2, a 20% increase in crop moisture content affected the specific capacity only marginally at the 9.5 mm cut setting, however there was a 12% increase in the specific capacity at the 5 mm cut setting.

Changing from 9.5 to 5 mm cut setting reduced specific capacity by about 20%.

Specific Capacity:² FIGURE 2 shows the specific capacity of the International 830 in alfalfa at 5 and 9.5 mm cut settings. Specific capacity is a measure of how efficiently a machine operates. A high

specific capacity indicates efficient energy use, while a low specific capacity indicates less efficient operation.

²Since the specific capacities presented in FIGURE 2 are based on dry-weight workrates, direct comparison to specific capacities of equipment such as balers is not valid. Bale d hay normally has a moisture content of about 20% and is not refined to the same degree as silage.

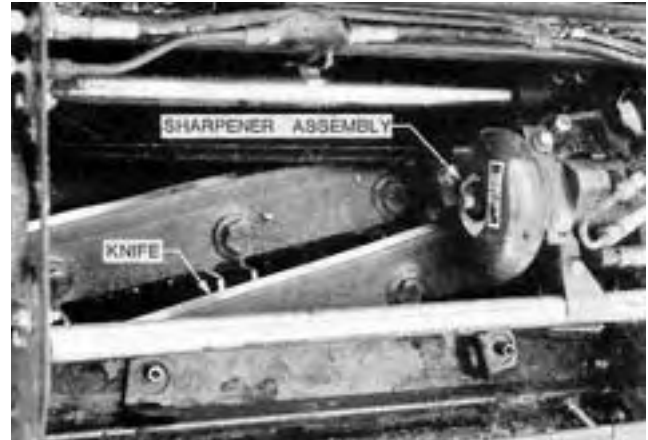
FIGURE 7. Cutterhead Knife Sharpener.

Knife Sharpening: The International 830 was equipped with a hydraulically driven cylindrical sharpening stone (FIGURE 7) that allowed each knife to be sharpened individually. The cutterhead drive is disengaged to permit the cutterhead to turn, allowing the sharpening stone assembly to follow the helical contour of each knife as the stone traverses the cylinder. Spring and guide rolls ensure proper contact between the knife and sharpening stone. Care had to be taken to ensure that residual crop material on the cylinder did not loosen and lodge in the cutterhead, and cause uneven sharpening.

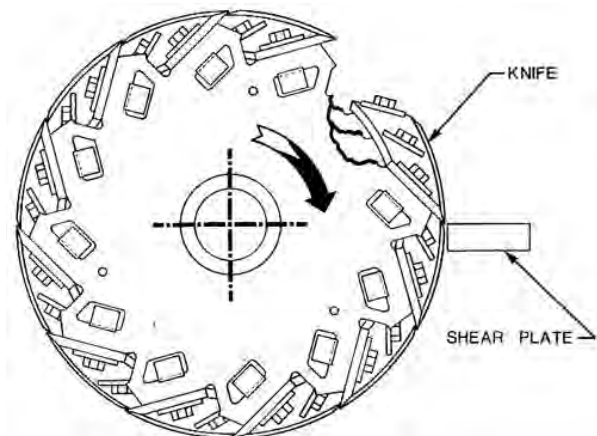
FIGURE 8. Cutterhead Assembly.

During testing, it was not necessary to reset the cutterhead knives, which were each held in place with four bolts. Setscrews would have made adjustments easier (FIGURE 8).

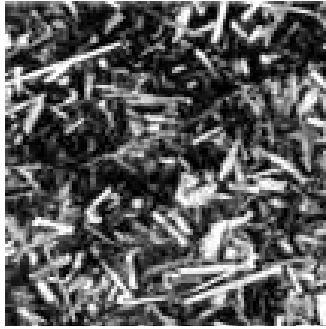
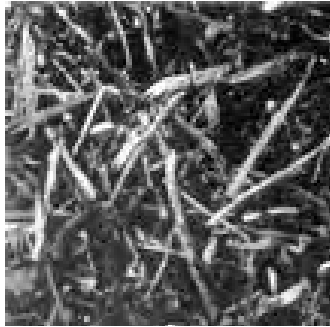
Figure 9. Typical Distrubution of Particule Lengths in Alfalfa (20 mm grid)

Uniformity of Cut:¹ TABLE 3 presents typical particle size distributions in second-cut, full-bloom alfalfa, harvested at 60% moisture content. Particle size variations are given for 5 and 9.5 mm cut settings, with and without the 76 mm recutter screen. At the 5 mm cut setting (APPENDIX IV, FIGURE 9) 2% of the silage had a length greater than 26 mm. The 76 mm recutter screen significantly reduced the particle lengths throughout the sample.

Particle Length	Percent of Total Sample Weight			
	Without Recutter Screen		With 50 mm Recutter Screen	
	5 mm Cut Setting	9.5 mm Cut Setting	5 mm Cut Setting	9.5 mm Cut Setting
Less than 4 mm	28 (Fig. 9a)	22	49	34
4 to 9 mm	40 (Fig. 9b)	36	30	31
9 to 13 mm	28 (Fig. 9c)	32	18	29
13 to 26 mm	2 (Fig. 9d)	6	2	4
26 to 100 mm	1 (Fig. 9e)	3	1	2
Greater than 100 mm	1 (Fig. 9f)	1	none	none

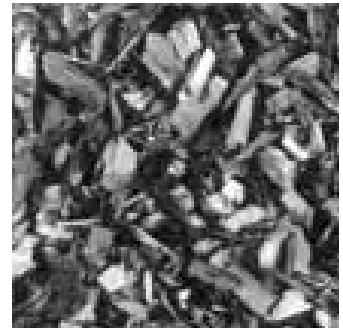
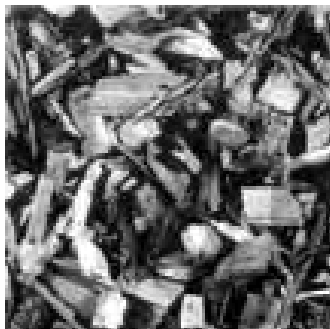
Figure 10. Typical Distrubution of Particule Lengths in Corn (20 mm grid)

Particle Length	Percent of Total Sample Weight	
	5 mm Cut Setting	9.5 mm Cut Setting
Less than 5 mm	13 (Fig. 10a)	10
5 to 7 mm	24 (Fig. 10b)	14
7 to 9 mm	51 (Fig. 10c)	62
9 to 13 mm	9 (Fig. 10d)	10
13 to 26 mm	2 (Fig. 10e)	3
Greater than 26 mm	1 (Fig. 10f)	1

Only 1% of the chopped corn had a length greater than 26 mm at the 5 mm cut setting (APPENDIX IV, FIGURE 10) and at the 9.5 mm cut setting. The smaller percentage of longer particles in corn, compared to alfalfa, was due to perpendicular feeding by the row crop head.
