Evaluation Report

151

Co-op Implements 660 Pull-Type Windrower

CO-OP IMPLEMENTS 660 PULL-TYPE WINDROWER

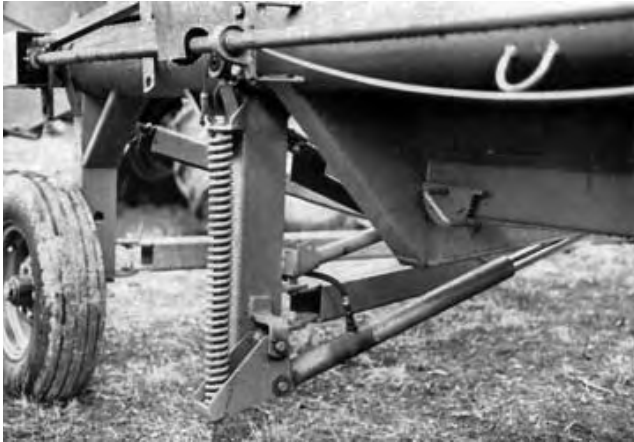
FIGURE 12. Table Flotation System.

Table Flotation: The CI 660 was equipped with a table flotation system, supplied as standard equipment (FIGURE 12). Table flotation was fair. The degree of flotation could not be adjusted.

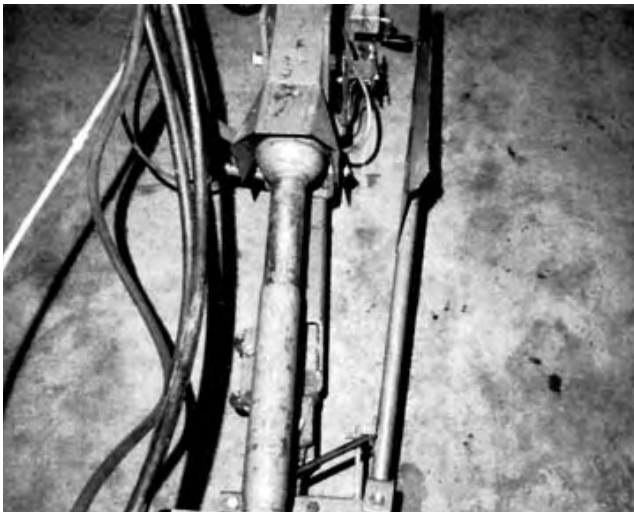
FIGURE 13. Side-Draft Eliminator Control.

Eliminator: The CI 660 was equipped with a side-draft eliminator to reduce skew on hillsides and in soft fields and to assist in making left turns. A control switch (FIGURE 13), mounted on the hitch tongue, is activated by a tractor mounted paddle. This switch engages an electromagnetic clutch, which applies power to the centre wheel of the windrower. It was important that the paddle not be set too close to the switch as continuous on-off operation could damage the drive belts and overheat the clutch.

Functional performance of the side-draft eliminator was good in soft fields and very good in firm fields.

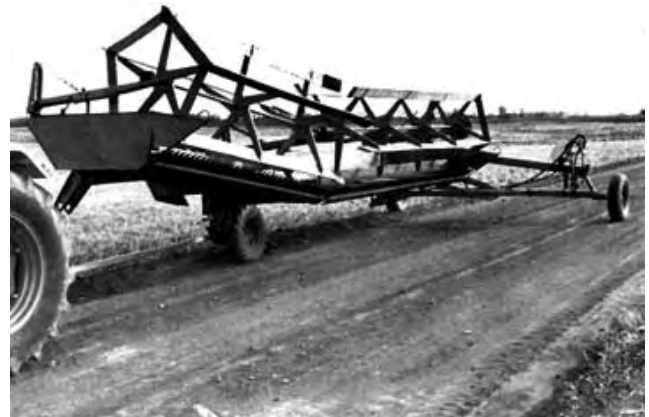
FIGURE 14. Full Transport Position.

Transporting: The CI 660 has two transport positions. In semi-transport position, the wing is lifted to provide a narrower tracking width. In full transport, the hitch and wheel positions are changed and the wing is raised permitting the windrower to be pulled from the right end (FIGURE 14). Rearward visibility was poor when transporting with a small tractor.

It took one man about five minutes to change to semi-transport position and about thirty minutes to change to full transport position. The large machine weight made the hitch jack difficult to adjust when changing the centre wheel into transport position. It is recommended that a heavier jack be provided to facilitate jacking at the centre wheel location.
