Evaluation Report

40

Co-op Implements 550SP Swather

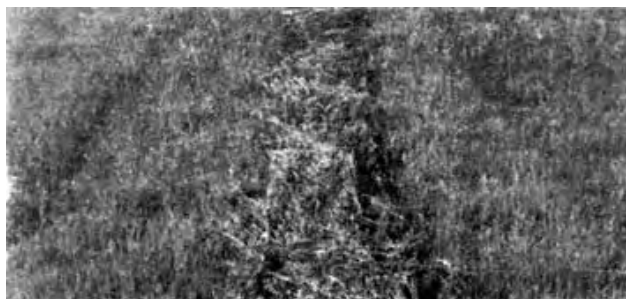
Figure 3. Brome and Alfalfa.

windrows in lighter crops. In leaning or lodged crops, angled parallel and fantail windrows were often formed. Photographs of some typical windrows are shown in Figures 3 to 11.

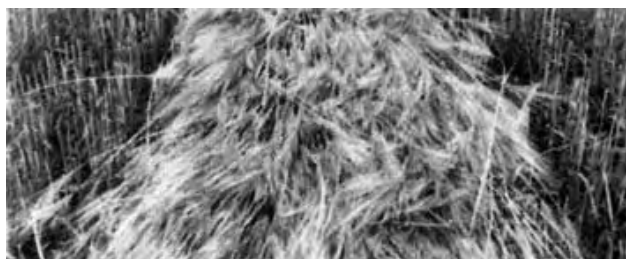
Figure 5. Barley (3.8 t/ha).

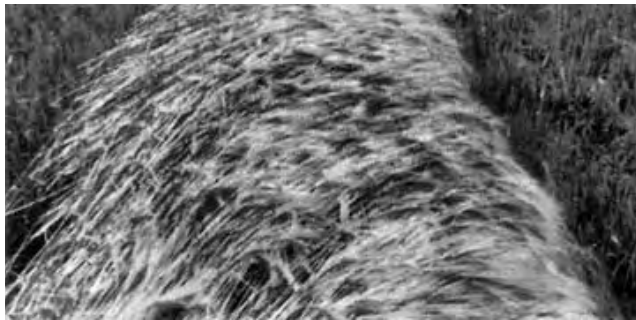
Figure 6. Barley (2.5 t/ha).

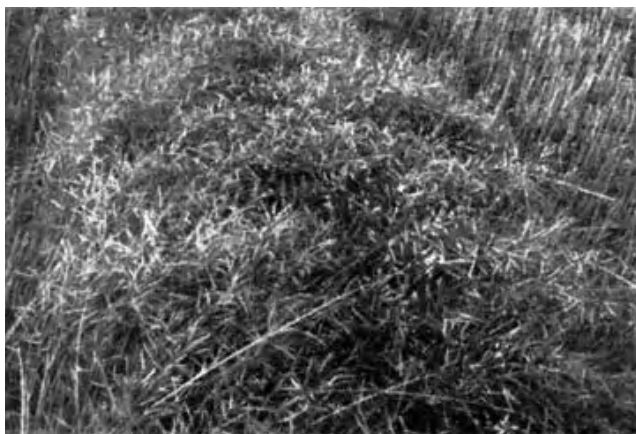
Figure 8. Rapeseed.

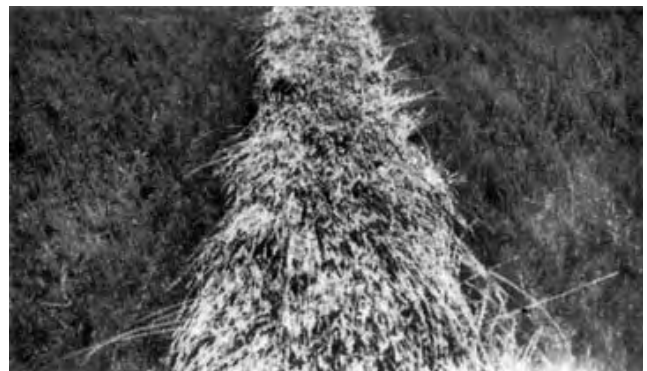
Figure 10. Wheat.

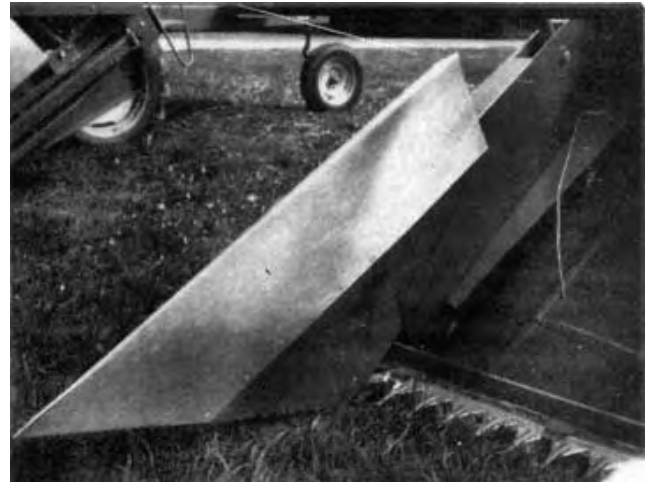
Figure 13. Modified Divider for Heavy Rapeseed.

Dividers: In average straight standing grain and hay crops, the standard divider was satisfactory. In sideways leaning grain crops or when cutting with a strong side wind, the standard divider occasionally allowed grain stalks to hairpin over the divider top resulting in bunched windrows. In tangled heavy rapeseed, the standard divider was unsatisfactory and field operation was not possible. Severe hair-pinning on the divider resulted in uprooting of whole plants and cutterbar plugging. It must be noted that this is a common problem with many windrowers. A modified divider (Figure 13) was fabricated by the Prairie Agricultural Machinery Institute. This divider performed satisfactorily in heavy rapeseed if the cutterbar was operated just below the lowest seed pods.
