Evaluation Report No. E1877A Printed: April, 1978 Tested at: Lethbridge ISSN 0383-3445

Evaluation Report

Wilger Model 804S Field Sprayer

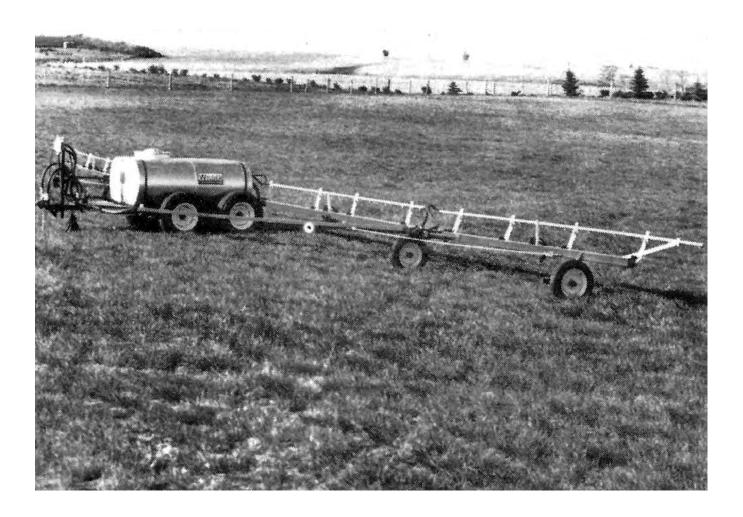
FIGURE 1. Flow Diagram for Wilger Model 804S: (A) Boom, (B) Boom Control Switch, (C) Pressure Gauges, (D) Line Strainer, (E) Shut-off Valve, (F) Drain, (G) Sump, (H) Lid, (I) Tank, (J) Aglitator, (K) Pump, (L) Aglitator Control, (M) Pressure Regulator, (N) Electric Boom Valves, (0) Nozzle.

FIGURE 1 presents a flow diagram for the Wilger 804S while detailed specifications are given in APPENDIX 1.

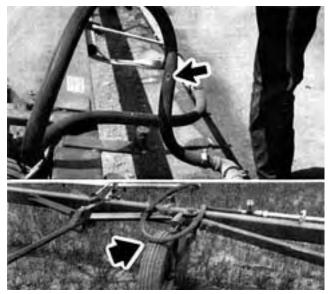
Boom Extension Hoses: The boom extension hoses rubbed on both the sprayer boom frame and on the boom tires (FIGURE 16), causing hose wear and leakage. It is recommended that hoses be properly secured to eliminate this problem.

FIGURE 16. Boom Extension Hose Wear Due to Rubbing on Frame and Tires.

1. Modifications to prevent the boom extension hoses from

rubbing on the boom tires and boom frame.

- With regard to recommendation number:
- 1. Nylon cord ties are supplied to prevent this problem but apparently were not supplied with the sprayer tested. Modifications on 1978 models will result in shorter boom extension hoses.
