Evaluation Report

526

CI Noble (Versatile) Model 5000 Blade Plow

CI NOBLE (VERSATILE) MODEL 5000 BLADE PLOW

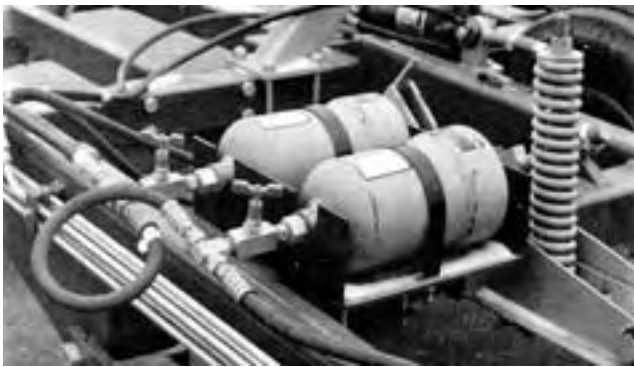
FIGURE 2. Nitrogen Charged Accumulators.

three way hydraulic standards. Each standard was held in position by a single hydraulic cylinder. The cylinders were pressurized by the tractor hydraulics and held under pressure by two nitrogen charged accumulators (FIGURE 2) controlled by the autotrip manifold (FIGURE 3). The system pressure and preload pressure were shown on gauges. The pressure of the hydraulic cylinders could be adjusted from 0 to 1000 psi (6900 kPa) by using an allen wrench on the manifold. The system pressure was drained using the drain valve. This procedure was explained in the operator's manual.

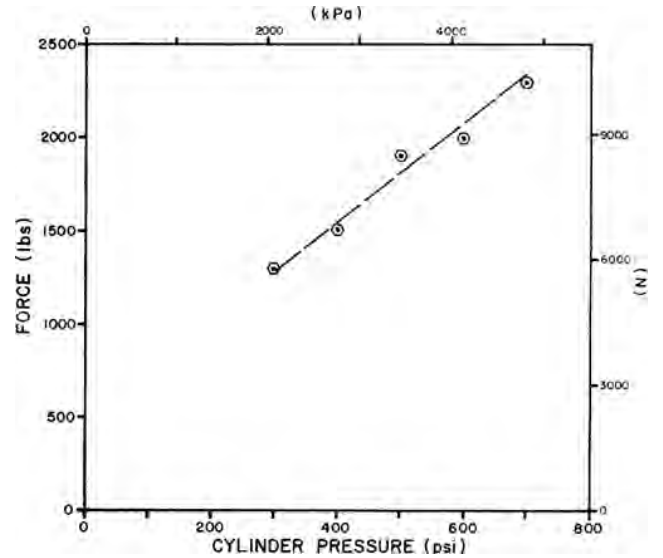
FIGURE 4. Standard Trip Forces at Various Cylinder Pressures.

FIGURE 4 shows the forces required to trip the standards at different cylinder pressures. The recommended cylinder pressure used during the test was 500 psi (3450 kPa), which gave a trip force of 1900 lb (8455 N). The forces continued to rise as the standards tripped back so the hydraulic cylinders acted as cushion springs.

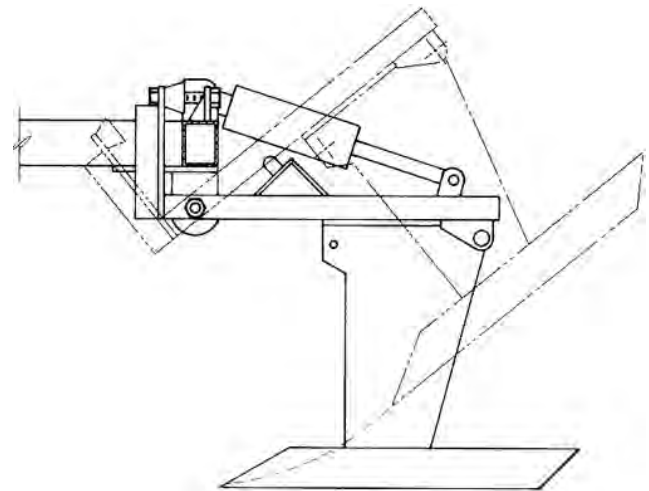
FIGURE 5. Blade Lifting Patterns.

FIGURE 5 shows the lifting pattern when a standard encounters stones or field obstructions such that the standard trips directly back. Maximum lift height of the standard, when tripped directly back, was 6 in (152 mm) at the nose and 28 in (711 mm) out on the end of the wing. The standards were also allowed to pivot from side to side, when tripped, as shown in FIGURE 6. Maximum lift height, when fully pivoted to one side, was 3 in (76 mm) at the nose and 13 in (330 mm) out on the end of the wing. The standard occasionally did not trip back into place when tripped by a large rock, because of the linkage binding as shown in FIGURE 7. The operator then

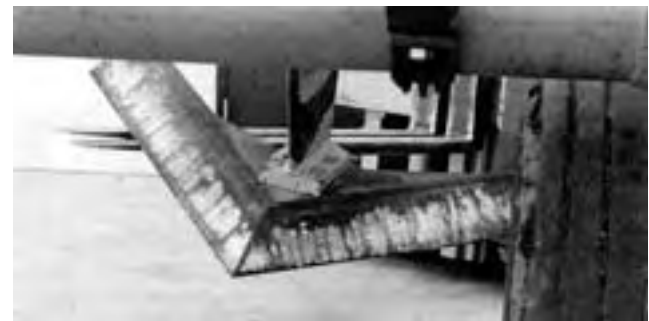
FIGURE 6. Side Tripping of Standard.

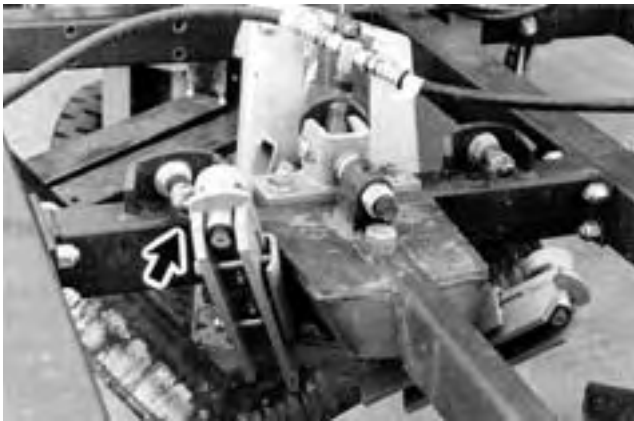
FIGURE 7. Binding Linkage with Side Tripping.

had to relieve the pressure on the trip and pry the linkage loose. It is recommended that the manufacturer consider modifying the standard autotrip mechanism to ensure the standard resets after tripping.

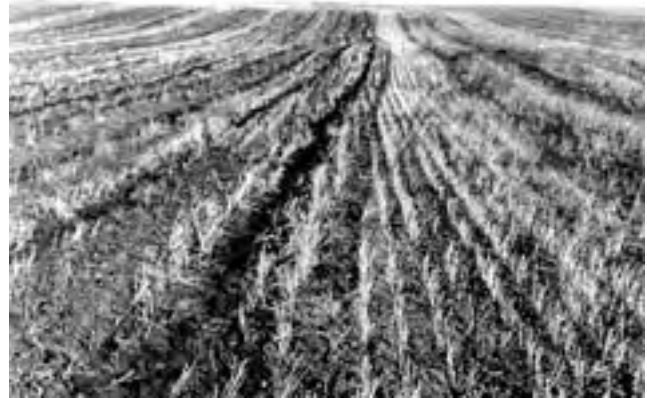
FIGURE 9. Trash Cover Before (Right) and After (Left) Tillage in Canola Stubble.

Trash Burial and Field Surface: The blade left most of the trash on the surface of the field. FIGURE 9 shows the trash cover in a canola field before and after tillage. Some trash was buried in the furrows left by the shanks. The amount of trash buried in the furrows depended on the depth, speed of tillage and the soil conditions. The size of the furrow left by the standard was dependant on the depth and the speed of tillage. Moist soil would also build up on the shanks and weeds would wrap around the shanks causing an increase in the size of the furrow. The coulters did not always cut the weeds ahead of the standard in weedy conditions. The coulters tended to push the weeds down in soft soil conditions. The field surface was left smooth when the blade was operated in normal field conditions.

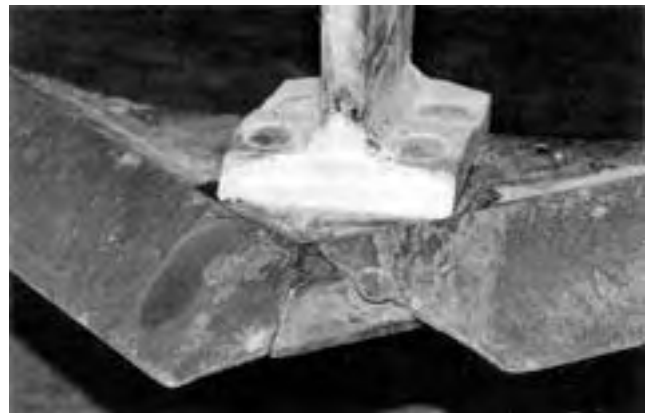
FIGURE 10. Nose Broken Off Blade.

Stony Conditions: Operation in stony conditions was very good. The autotrip system provided adequate protection during the test. A nose was broken off a blade (FIGURE 10) during testing but no damage occurred to the standard. None of the shear bolts broke during the test. Maximum trip height of the coulters was 5 in (127 mm) and no damage occurred to them during the test.

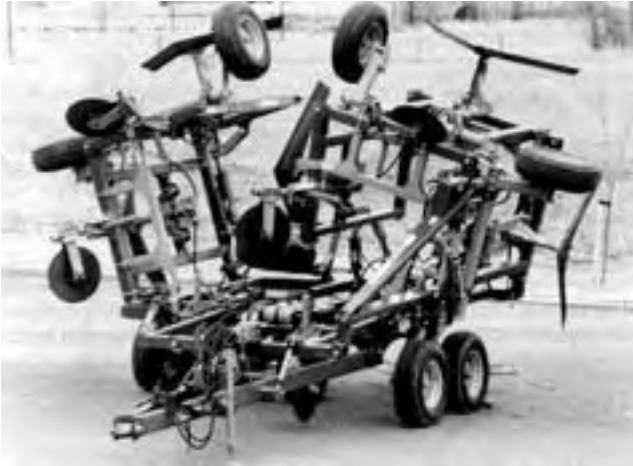
FIGURE 11. Transport Position.

Transporting: Ease of transporting the blade was very good. It took 5 to 10 minutes to place the unit in transport position (FIGURE 11). Transport locks on the cylinders were provided. They were easy to use but access to two of them required climbing on to the blade frame. Lock pins were provided for each wing with retaining holes for the pins in each hold up arm.

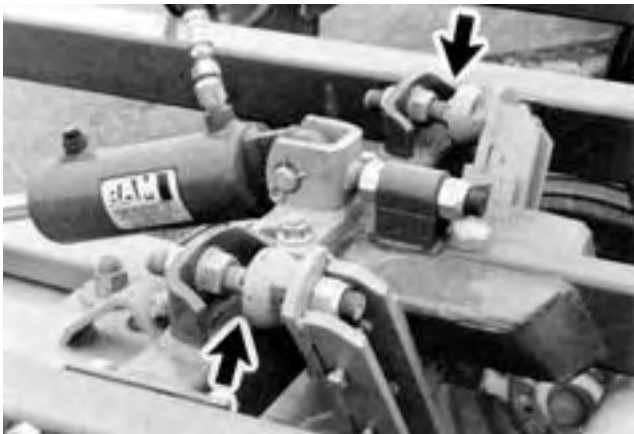
FIGURE 12. Adjustable Round Ended Socket Pins.

The autotrip blades were fore and aft levelled to the frame by moving the round ended socket pins (FIGURE 12). The pin mounts were slotted to adjust the side to side levelling. Shims were also used on the standard for side to side levelling if the socket pin slots did not have enough adjustment.

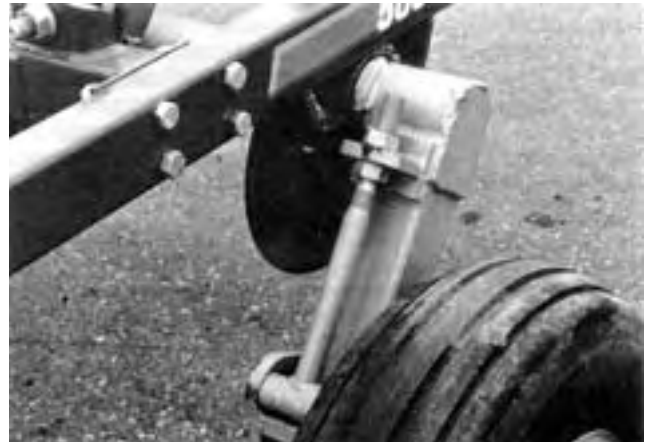
FIGURE 14. Adjustable Axle Tee-Bolts.

The blades were levelled to each other by adjusting the depth cylinder lugs (FIGURE 13), the tie-bolts on the axle of each wheel (FIGURE 14) and the axle linkage between each axle (FIGURE 15). The various measurements were given in the levelling instruction manual. Front to back levelling of the blade was done by adjusting the screw jacks on the hitch (FIGURE 16). Caution had to be taken not to tighten the two screw jacks against each other. Complete levelling of the blade took two people approximately three hours. Once initial levelling is completed only minor adjustments are required.

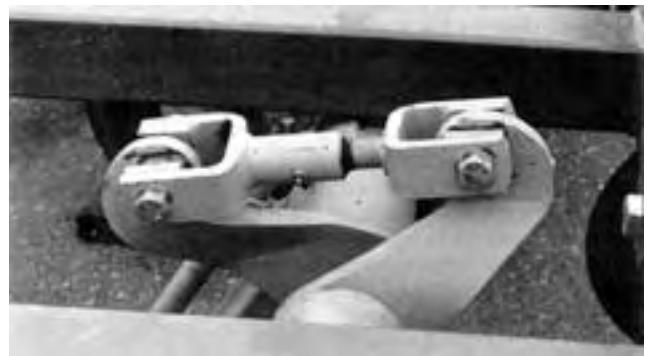
FIGURE 15. Axle Linkage.

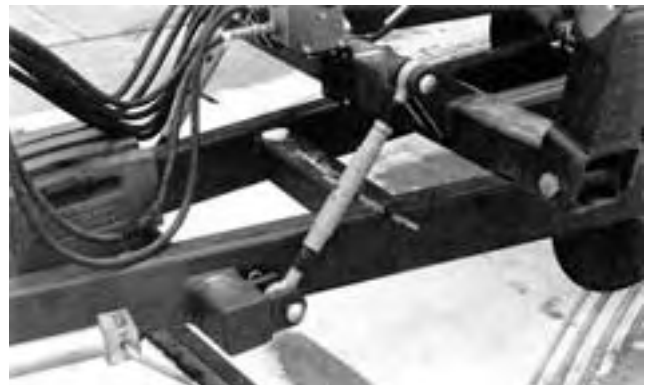
FIGURE 16. Hitch Screwjacks.

Levelling the blades took considerable time and involved several adjustments. A separate instruction manual for levelling was provided. Front to back levelling of the unit was done by adjusting screwjacks on the hitch.

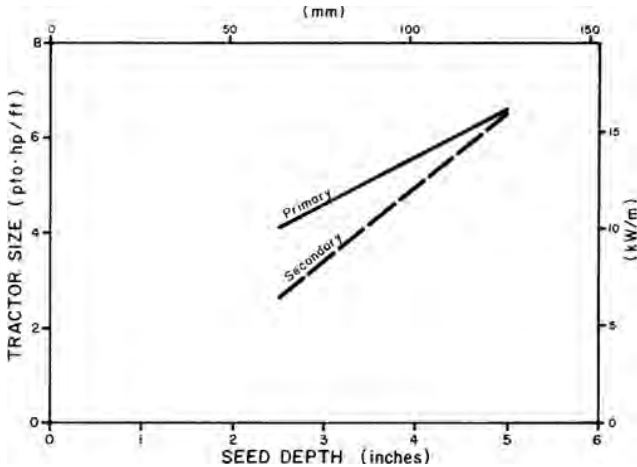
FIGURE 17. Average Horsepower Requirements for Blade Cultivators at 5 mph (8 km/h).

Tractor Size: FIGURE 17 shows the horsepower requirements for blade type cultivators in typical primary and secondary tillage, at a speed of 5 mph (8 km/h). Overall tractor size needed to pull the blade, at all tillage depths was 235 power take-off hp (176 kW). This tractor size has been adjusted to include tractive efficiency and represents a tractor operating at 80% of the maximum power take-off rating as determined by Nebraska tests or as presented by the tractor manufacturer. The tractor size given will have ample power reserve to operate in the stated conditions.

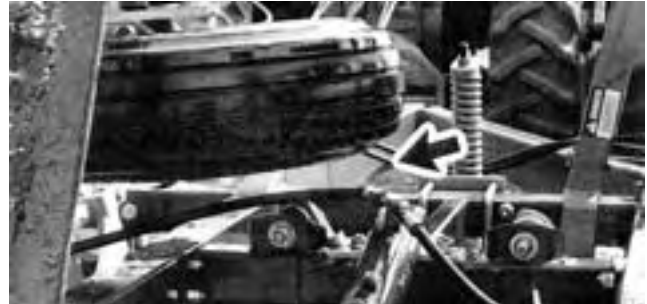
FIGURE 18. Small Clearance Between Tire and Hydraulic Tee at Start of Test.

Replacement of Hydraulic Tee: The hydraulic tee fitting on the center standard was damaged and replaced three times. The tee was damaged by the left hand end wheel tire, which interfered with the tee when the unit was in transport position. There was little clearance between the tire and tee (FIGURE 18) so when the unit flexed, the tire would rub on the tee. The manufacturer solved the problem by shifting some of the hold up arms and by replacing the center wing lift link. These changes increased the clearance between the tire and tee significantly so the problem did not occur during the rest of the test.

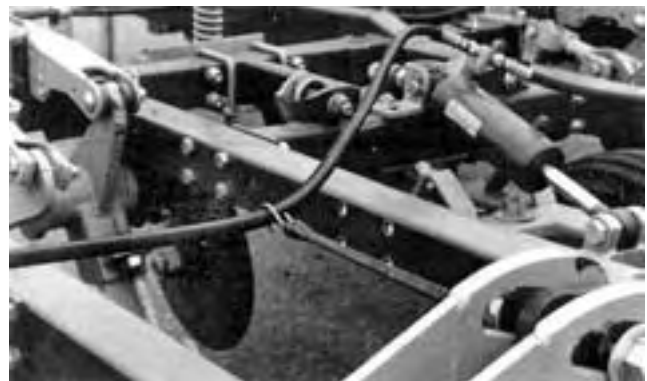
FIGURE 19. Tarp Strap Used to Keep Hydraulic Hose from Rubbing on Tire.

Hydraulic Hose Failure: The hydraulic hoses running between the autotrip cylinders would occasionally rub on the tires during field operation. One hose wore through and failed. Tarp straps were put on the hoses (FIGURE 19) to prevent this from occurring again. It is recommended that the manufacturer consider rerouting the hydraulic hoses to prevent them from rubbing on tires during field operation.

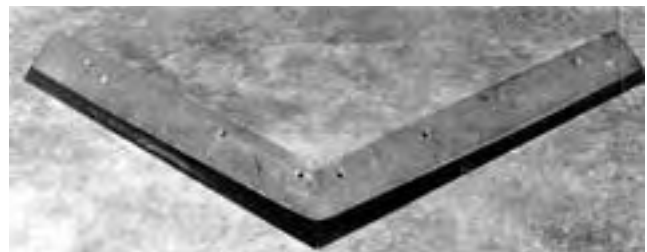
FIGURE 20. Wear on Typical Blade at End of Test.

Blade Wear: FIGURE 20 shows the wear on a typical blade at the end of the test. Each blade had tilled approximately 370 ac (148 ha) under conditions listed in TABLE 1. The blades were essentially worn out at this point.
