# Evaluation Report 639

## Cereal Implements 3000 Ultrasweep

## CEREAL IMPLEMENTS 3000 ULTRASWEEP

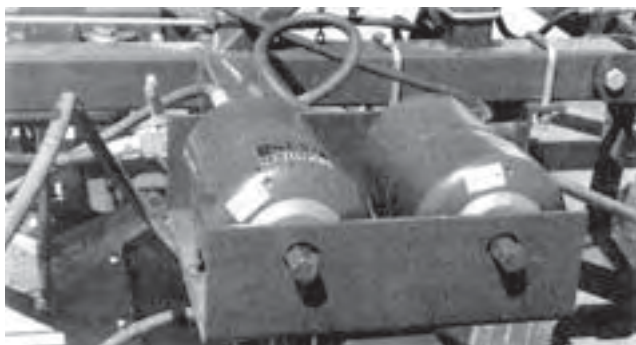
FIGURE 2. Nitrogen Charged Accumulators.

**Shank Characteristics:** The 3000 Ultrasweep tested was equipped with autotrip three way hydraulic standards. The standards tripped three ways: side-to-side or straight back. Each standard was held in position by a single hydraulic cylinder. The cylinders were pressurized by the tractor hydraulics and held under pressure by two nitrogen charged accumulators (FIGURE 2) controlled by the pressure reducing valve (FIGURE 3). The system pressure was shown on the gauge. The pressure of the hydraulic cylinders was varied from 0 to 1000 psi (6900 kPa) by adjusting the pressure reducing valve. The system pressure was released using the drain valve.

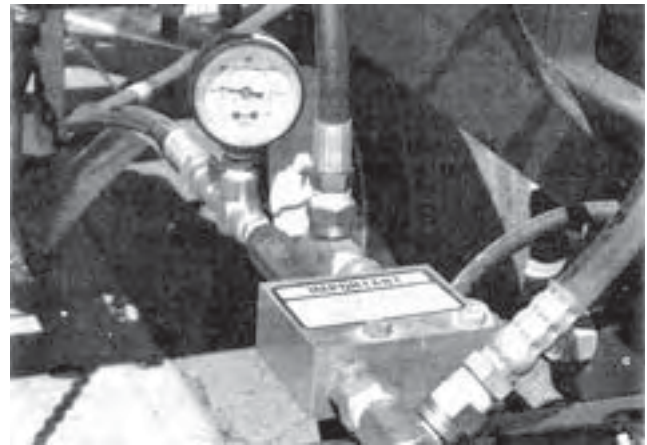
FIGURE 3. Pressure Reducing Valve.

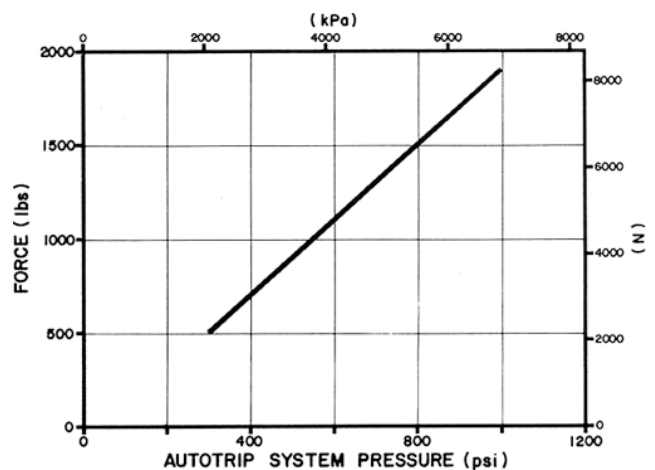
FIGURE 4. Standard Trip Forces at Various Cylinder Pressures.

FIGURE 4 shows the forces required to trip the standards at different system pressures. The recommended system pressure was 500 to 750 psi (3450 to 5175 kPa), which gave average standard trip forces of 900 to 1400 lbs (4005 to 6230 N). The hydraulic cylinders acted as cushion springs because the forces continued to rise as the standards tripped back. The standards, when tripped, were allowed to pivot from side to side or straight back.

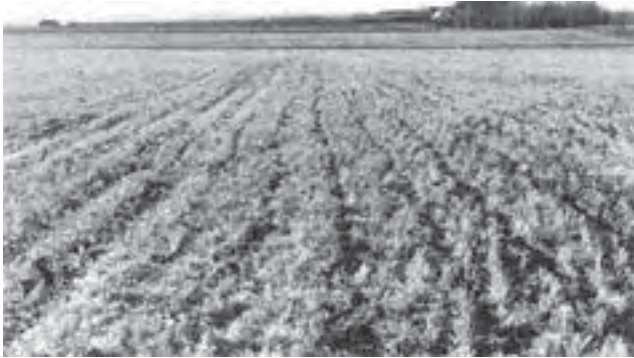
FIGURE 5. Field Surface after Operation in a Stubble Field with Silt Loam Soil.

**Soil Finishing:** Soil finishing of the 3000 Ultrasweep was very good. The majority of the trash was left on the surface in all test conditions. FIGURE 5 shows the trash cover in a tilled stubble field with silt loam soil. Some trash was buried in the furrows left by the standards. The size of the furrow left by the standard depended on

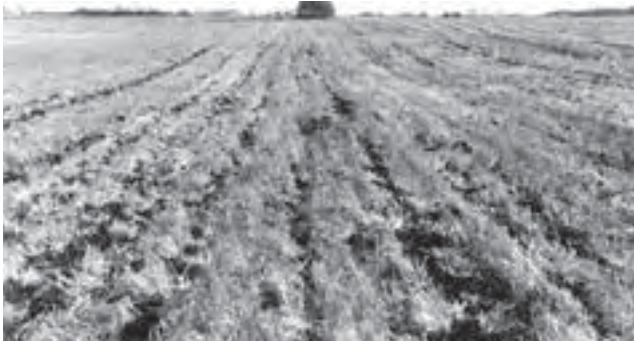
FIGURE 6. Field Surface after Operation in a Stubble Field with moist Black Loam Soil.

FIGURE 6 shows an example of large furrow sizes caused by operation in a moist black loam soil. The soil was built up around the standards. FIGURE 7 shows the soil surface before and after tillage in a previously tilled field.

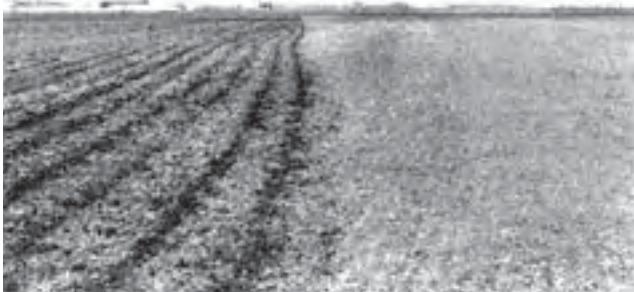
FIGURE 7. Field Surface Before and After Operation in a Previously Tilled Field.

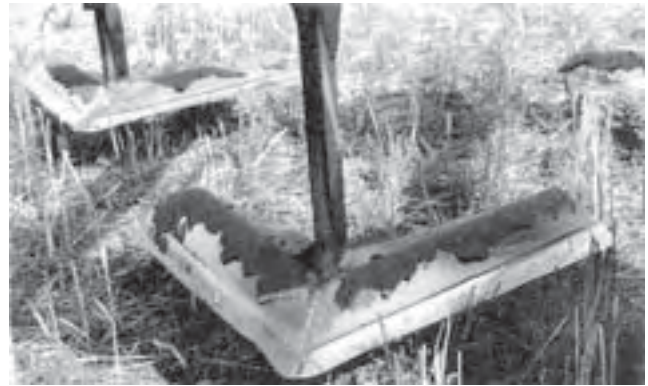
FIGURE 8. Poor scouring of sweeps.

In some moist soils and fields that required shallow operating depths the sweeps did not totally scour as shown in FIGURE 8. This poor scouring was caused by the lack of resistance of the soil while flowing over the sweep surface. Extended operation in poor scouring conditions might affect the wear of the sweeps. The sweeps scoured adequately during operation in black loam soil.

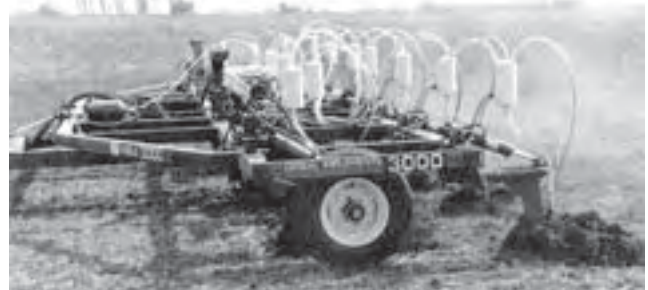
FIGURE 9. 3000 Ultrasweep Outfitted with Anhydrous Ammonia Fertilizer System.

**Fertilizer Application:** The 3000 Ultrasweep was used for 135.5 hours to apply anhydrous ammonia fertilizer on 2205 ac (882 ha) during the test. The unit was outfitted with a distribution manifold, hoses, converters and anhydrous tubes as shown in FIGURE 9. The distribution tubes fit under the top edge of the

sweep and were held in place by two of the sweep bolts. Spacing of the outlet holes on the distribution tubes was 7.5 in (191 mm).

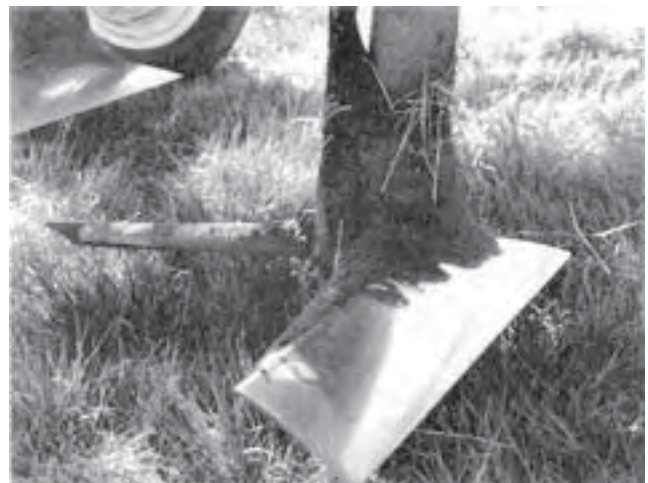
FIGURE 10. Soil Built Up Around Standard and Fertilizer Distribution Tube.

Adding fertilizer distribution tubes to the standards caused moist soil to easily build up around the standards as shown in FIGURE 10. This caused the size of the furrow left by the standard to increase.

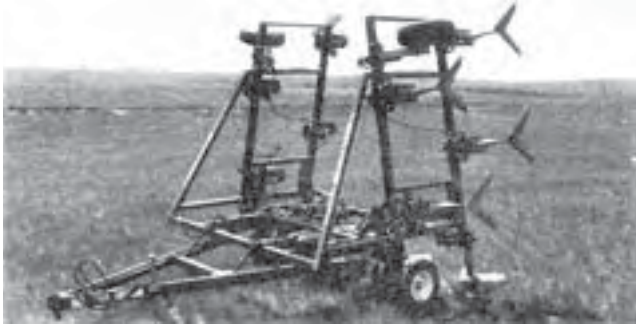
FIGURE 11. Transport Position.

**Transporting:** Ease of transporting the 3000 Ultrasweep was very good. Five minutes were required to place the unit in transport

position (FIGURE 11). Pins were provided to lock the wings in transport position. Hold-out bars (FIGURE 12) were provided to lock the depth cylinders on the center section in transport position.

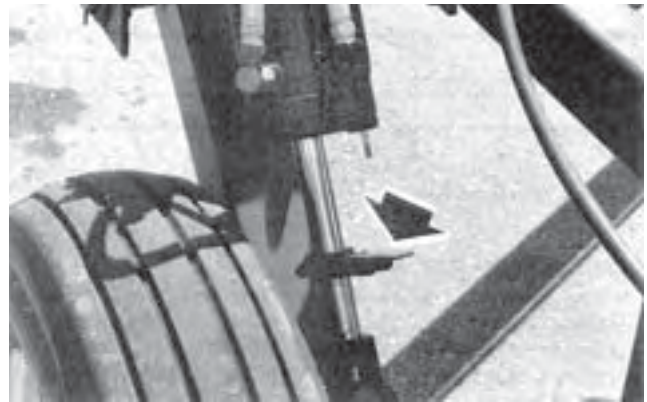
FIGURE 13. Depth Adjustment on Master Cylinder.

**Depth Adjustment:** Ease of setting the tillage depth was very good. Tillage depth was controlled by the four hydraulic cylinders located along the blade plow frame. Depth adjustment required positioning the stop plate for the hydraulic shut valve (FIGURE 13) located on the master cylinder. The master cylinder was located on the left wing.

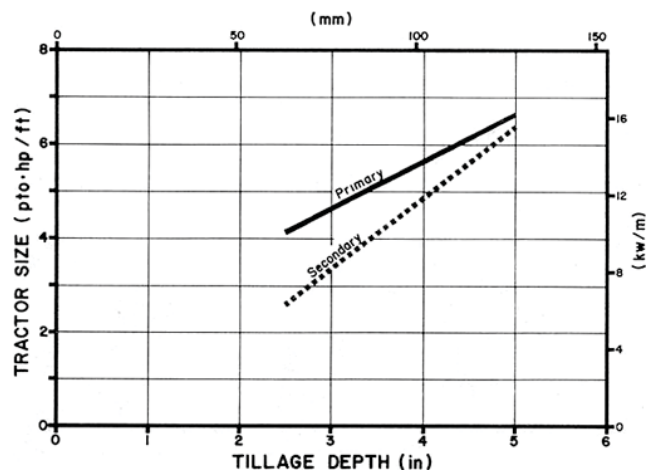
FIGURE 14. Average Horsepower Requirements for Blade Plows at 5 mph (8 km/h).

**Tractor Size:** FIGURE 14 shows the horsepower requirements for blade plows in average primary and secondary tillage at a speed of 5 mph (8 km/h). Tractor size needed to pull the test unit at all tillage depths was 215 power take-off hp (161 kW). This tractor size has been adjusted to include tractive efficiency and represents a tractor operating at 80% of the maximum power take-off rating. This rating was determined by Nebraska tests or presented by the tractor manufacturer. The tractor size given will have ample power reserve to operate in the stated conditions.

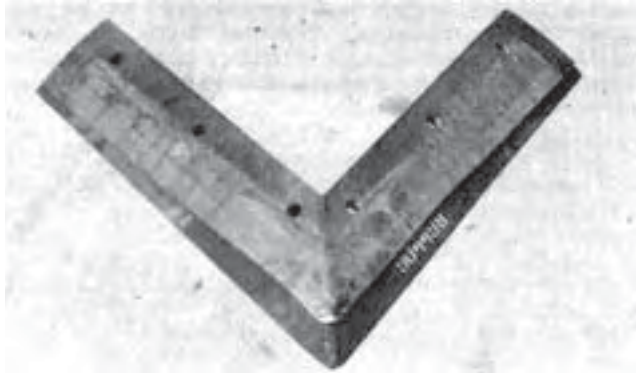
FIGURE 15. Typical Wear on the Top Hardfaced Sweep During the Test.

**Sweep Wear:** FIGURES 15 and 16, respectively, show the average wear of the top hardfaced and plain sweeps during the test. The top hardfaced sweeps were used for 2545 ac (1018 ha) or 196 ac (78 ha) per sweep. The plain sweeps were used for 2205 ac (882 ha) or 170 ac (68 ha) per sweep. The plain sweeps were worn out and the hard-surfaced sweeps were still useable at the end of the test. The amount of wear on the sweeps behind the tractor tire tracks was higher than the average wear. Suggested retail cost, 1990, for the plain sweep was \$49.50 and for the top hardfaced sweep was \$89.75.

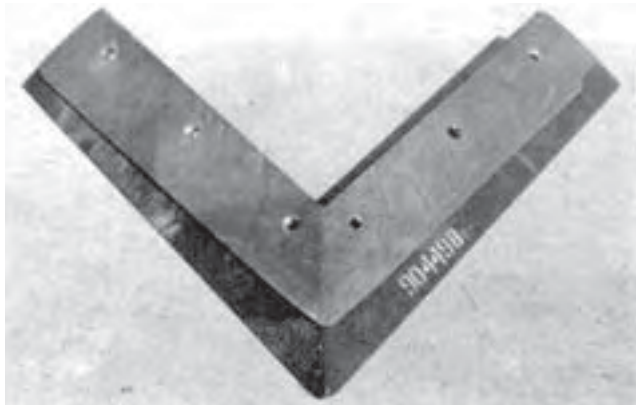
FIGURE 16. Typical Wear on Plain Sweep During the Test.
