# Evaluation Report

# 641

## **Tye Paratill Model 118-610**

A Co-operative Program Between

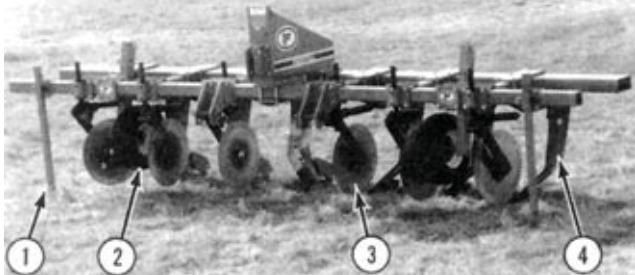
FIGURE 1. Tye Paratill (1) Support Stand, (2) Depth Control Wheels, (3) Disk Coulters and (4) Shear Bolt Leg.

The Tye Paratill is a Category II - III three-point hitch, 45 degree angled leg deep soil loosener suitable for primary tillage operations. The unit is equipped with disc coulters, ductile cast points, two support stands and either shearbolt or mechanical trip legs. The Paratill is available in 2, 4, 6 and 8 leg models and leg spacing is infinitely adjustable from 22 to 40 in (560 to 1020 mm).

reversible landsides, pull type models and third bar kits. FIGURE 1 shows the location of major components while detailed specifications are given in APPENDIX I.

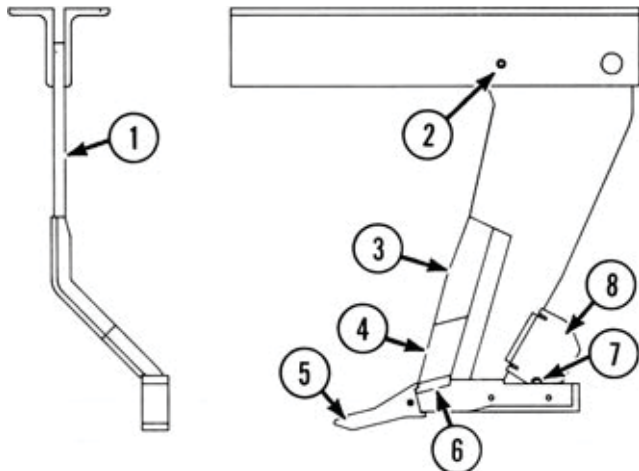
FIGURE 2. Paratill Leg (1) 45° Leg, (2) Shear Bolt, (3) Upper Shin, (4) Lower Shin, (5) Reversible Point, (6) Instep, (7) Wedge, and (8) Shatter Plate.

**Penetration:** Penetration was very good. The Paratill legs (FIGURE 2) were able to penetrate into untilled clay, loam and sand soil conditions. Worn points caused poor penetration. Uniform penetration across the width of the toolbar required proper leveling using the tractor's three-point hitch lift arms and top link. The automatic hydraulics of the three-point hitch were set to maintain a constant draft while deep tilling. In heavy draft areas the three point hitch raised the Paratill to maintain a constant draft.

**Soil Surface:** FIGURE 4 shows the soil surface after deep tilling into an untilled loam soil condition. Very little soil surface disturbance occurred, with the majority of the straw left standing. Increased soil disturbance occurred by increasing the shatter plate (FIGURE 2) angle.

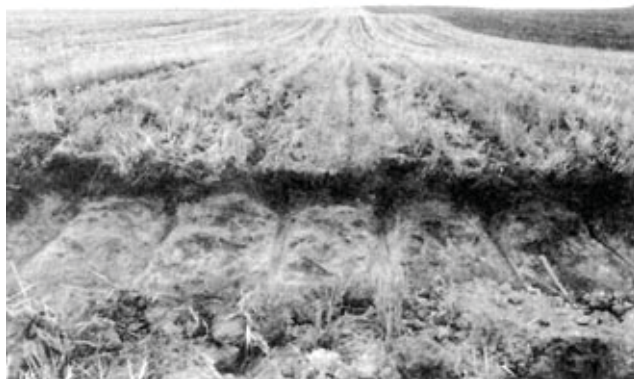
FIGURE 3 shows the soil fracture pattern in an untilled soil condition. The dry and hard soil provided ideal deep tillage conditions. The tillage depth measured 16 in (406 mm). Average soil fracture depth between the centre legs was 11 in (279 mm), resulting in 5 in (127 mm) of undisturbed soil. The average depth of soil fracture between the other legs was 10 in (254 mm), leaving 6 in (152 mm) of undisturbed soil. Adjusting the angle of the Shatter plates had little effect on the soil fracturing pattern.

FIGURE 3. Soil Fracture Pattern In Primary Loam Soil.

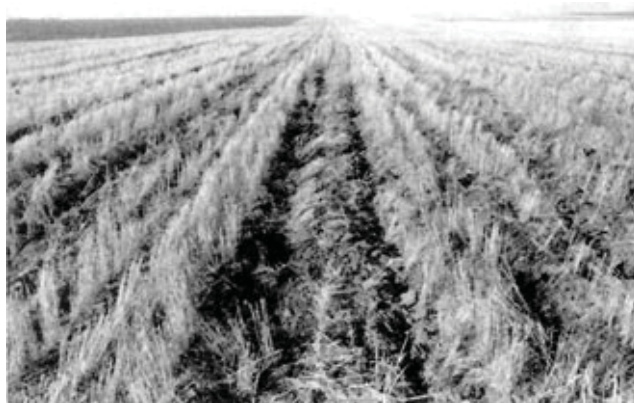
FIGURE 4. Soil Surface Left by Tye in Primary Loam Soil.

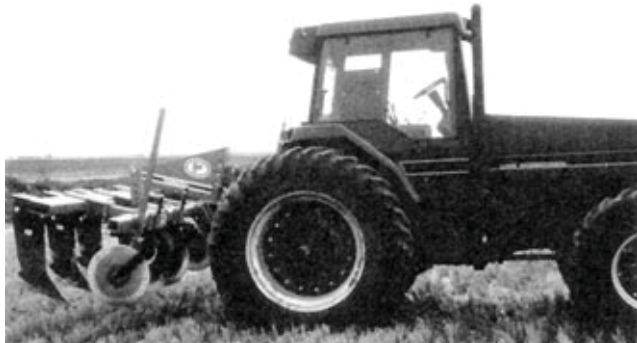
**Transporting:** Ease of transporting the Tye Paratill was very good. The unit was placed into transport position (FIGURE 5) by the tractor's hydraulics. The transport lock on the tractor's three-point hitch hydraulic system locked the unit in transport position.

FIGURE 5. Transport Position.

The transport width was 17.5 ft (5.3 m). The overall weight of the unit was 4110 lbs (1868 kg). Caution had to be taken when transporting because of the width and weight of the unit. When travelling above 18 mph (29 km/h) the front tires of the test tractor would bounce making transporting unsafe. It is recommended the manufacturer consider indicating safe operating speeds and proper ballasting required while transporting the Tye Paratill.

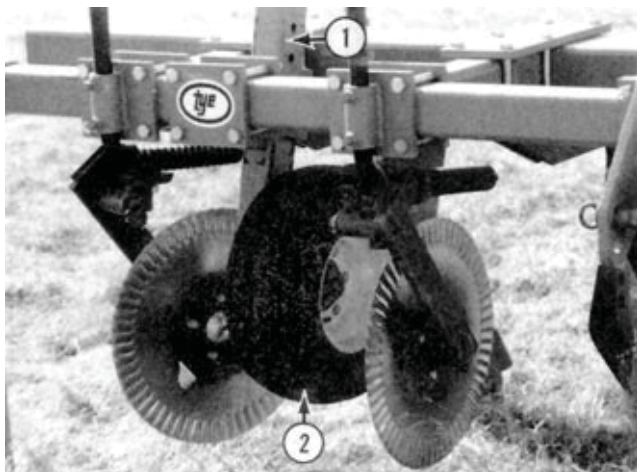
**Depth Adjustment:** Ease of setting the tillage depth was good. Tillage depth was set by adjusting the height of the depth control wheels (FIGURE 6) and the three-point hitch hydraulics. Five adjustment holes on the control arm and three on the support bracket gave a total of eleven depth settings.

FIGURE 6. Depth Control Wheel: (1) Control Arm and (2) Gauge Wheel.

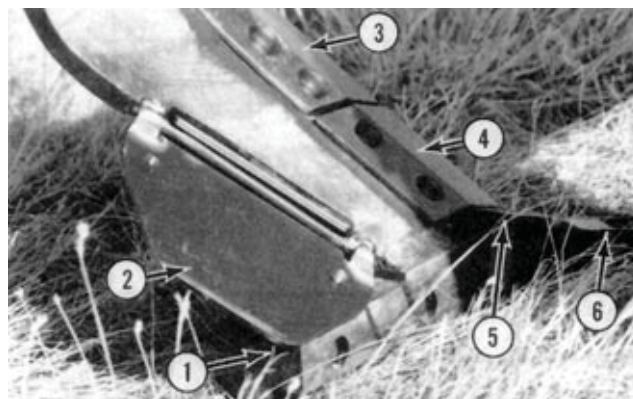
**Wear Part Replacement:** Ease of changing the reversible points and wear parts was very good. Turning the six points took one person twenty minutes. FIGURE 7 shows the location of the replaceable wear parts.

FIGURE 7. Wear Parts, (1) Landside, (2) Shatter Plate, (3) Upper Shin, (4) Lower Shin, (5) Instep and (6) Reversible Point.

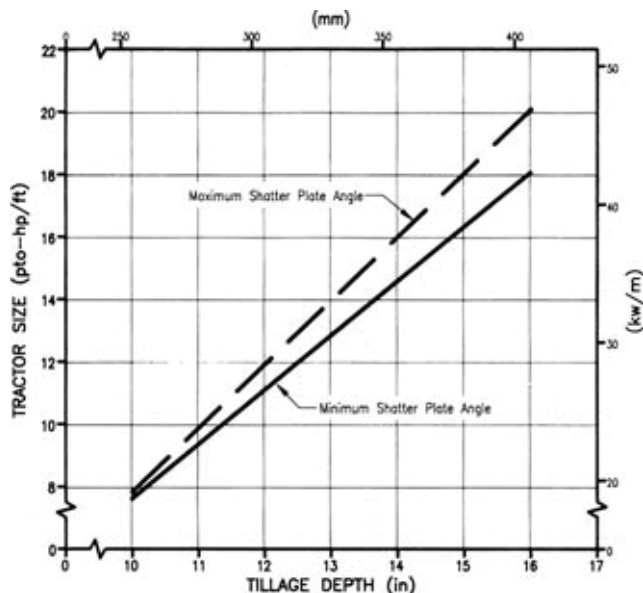
**Draft Characteristics:** Draft (drawbar pull) requirements depended on operating depth, field conditions, soil type and moisture content. Variation in speed did not affect draft. Average draft was 11905 lbs (53 kN) for the 12.2 ft (3.7 m) unit at a 16 in (406 mm) tillage depth and 4.5 mph (7.2 km/h) in an untilled loam soil with the shatter plates set at the minimum angle. Average draft was 13220 lbs (58.8 kN) with the shatter plates set to the maximum angle. Tractor Size: The power take-off horsepower requirements per unit of working width for untilled soil conditions, with varying tillage depths and shatter plate angles for a 4.5 mph (7.2 km/h) speed, are given in FIGURE 8. Requirements varied from 7.7 PTO hp/ft (18.8 kW/m) at a 10.0 in (254.0 mm) tillage depth with a minimum shatter plate angle to 20.1 PTO hp/ft (49.2 kW/m) at a 16.0 in (406.4 mm) tillage depth with a maximum shatter plate angle. Overall tractor size needed to operate the Tye Paratill test unit at all tillage depths, varied from 94 PTO hp (70 kW) to 246 PTO hp (183 kW). Tractor sizes have been adjusted to include tractive efficiency and represent a tractor operating at 80 percent of maximum power take-off ratings as determined by Nebraska tests or as presented by the tractor manufacturer. Tractor size included ample power reserve to operate in the stated conditions.

FIGURE 8. Average Horsepower Requirements for a 4.5 mph (7.2 km/h) Speed.

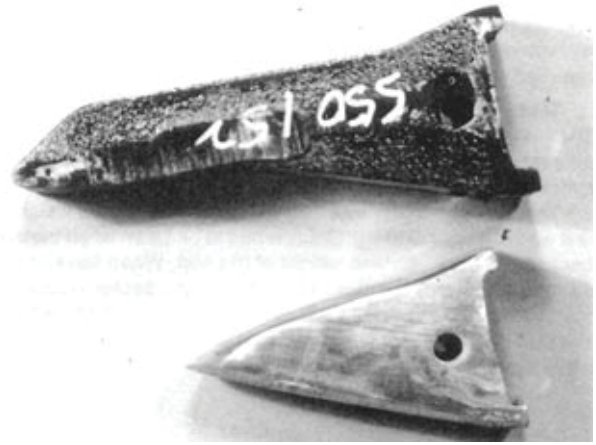
**Wear Parts:** FIGURE 9 shows a new point compared to a worn point. The worn points were changed after deep tilling 337 ac (135 ha) or 56 ac (22 ha) per point wear. The replacement cost of a ductile point was U.S. \$31.05. Three chrome carbide points broke in the subsurface stony conditions after 61 ac (24.7 ha). The manufacturer recommended that the chrome carbide points not be used in subsurface stony conditions. The other wear parts on the legs showed very little wear.

FIGURE 9. Point Wear: Top - New Point, Bottom - Worn Point.

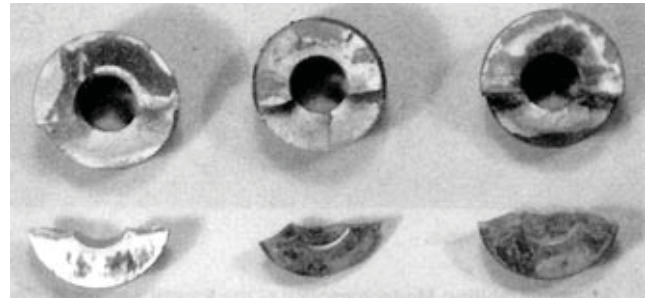
**Shear Bolt Bushing Failure:** At the end of the test the three shear bolt bushings were replaced on each of the six legs. Continuous failure of shear bolts during the test eventually damaged the bushings (FIGURE 10). It is recommended that the manufacturer consider improving the durability of the shear bolt bushings.

FIGURE 10. Shear Bolt Bushing Failure.

1. Indicating safe operating speeds and ballasting required when transporting the Paratill.
2. Supplying a slow moving vehicle sign as standard equipment.
3. Modifying the coulters assembly to eliminate weld failure.
4. Improving the durability of the shear bolt bushings.

4. Shearbolt bushing hardness has been reviewed and amended by the vendor. Shearbolt protected legs are not recommended for stony conditions. Mechanical trip leg protection models are available and should be used in such conditions.
