Evaluation Report

Leon CP77-334 (10.4 m) Chisel Plow

LEON CP77-334 CHISEL PLOW

MANUFACTURER AND DISTRIBUTOR:

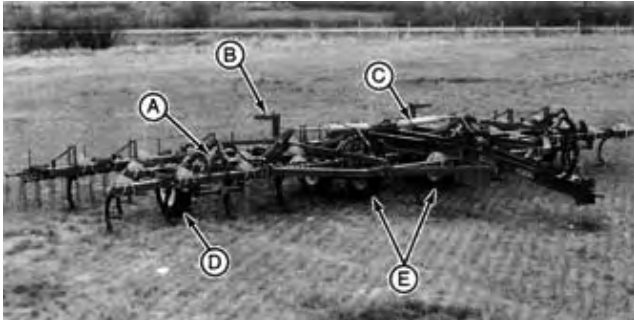
FIGURE 1. Leon CP77-334: (A) Depth Control Cylinders, (B) Wing Safety Stops, (C) Wing Lift Cylinders, (D) Wing Wheels, (E) Centre Wheels.

The centre frame is carried on two optional tandem wheel sets, while each wing is supported by a single wheel. Four hydraulic cylinders, connected in series, control the tillage depth. The wings fold into upright position, with two hydraulic cylinders, connected in parallel. Detailed specifications are given in APPENDIX I while FIGURE 1 shows the location of major components.

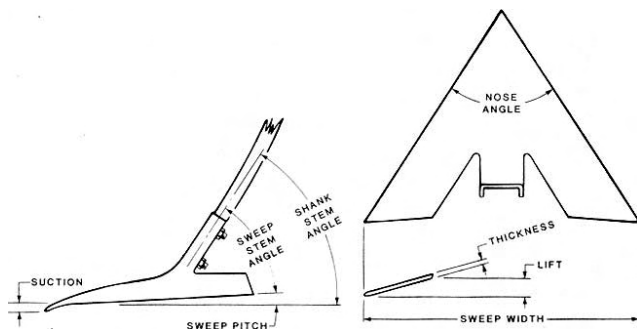
Shank Characteristics: There is a large variation in shank and sweep stem angles (FIGURE 2) on cultivators from different manufacturers. Sweeps and shanks must be matched to obtain sufficient sweep pitch to achieve and maintain penetration. Usually manufacturers recommend sweeps with a stem angle from 0 to 5 degrees less than the shank stem angle to result in a slightly positive no load sweep pitch.

FIGURE 2. Shank and Sweep Terminology.

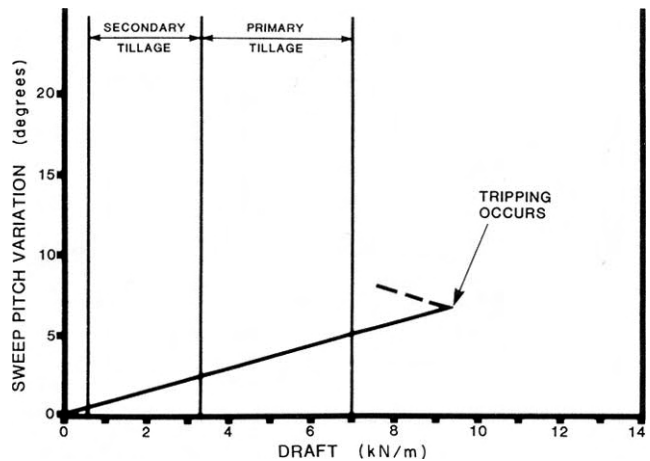
FIGURE 3 shows pitch characteristics of the Leon CP77-334 shank assembly. The low end of the pitch curve results from shank flexing. Sweep pitch varied about 5 degrees over the full range of draft normally occurring in primary tillage. When equipped with 51 degree sweeps, as used during the test, sweep pitch varied from minus 5 to 0 degrees over this draft range. At the manufacturer's setting, the shank trips began to release and shank force decreased at drafts greater than 9.3 kN/m, as shown on the graph. Tripping occurred well beyond the normal draft range, indicating that the Leon CP77-334 was well suited for heavy primary tillage.

FIGURE 3. Sweep Pitch Variation over a Normal Range of Draft (305 mm shank spacing).

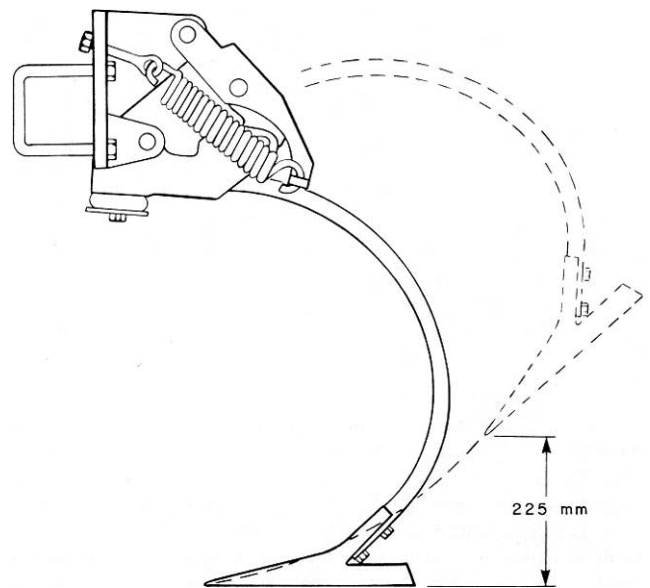
FIGURE 4 shows the lifting pattern when shanks encounter stones or field obstructions. Maximum lift height was 225 mm. The shanks were mounted with rubber cushions to reduce recoil shock and to allow sideways sweep movement around obstructions. The shank trip assembly performed well during the test. One shank bent during the 210 hour test period.

FIGURE 4. Shank Lifting Pattern.

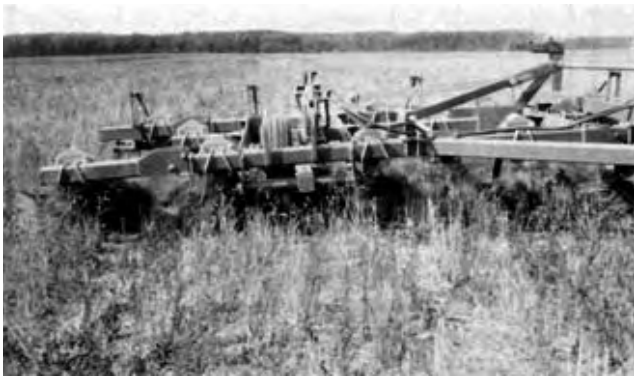
Depth differences between the front and rear rows of shanks were slight in normal soil conditions, once the frame had been properly levelled. In heavy primary tillage, twisting of the wing frames caused the outer front sweeps to penetrate about 60 mm deeper than the outer rear sweeps.

FIGURE 5. Excessive Wing Penetration in Heavy Primary Tillage.

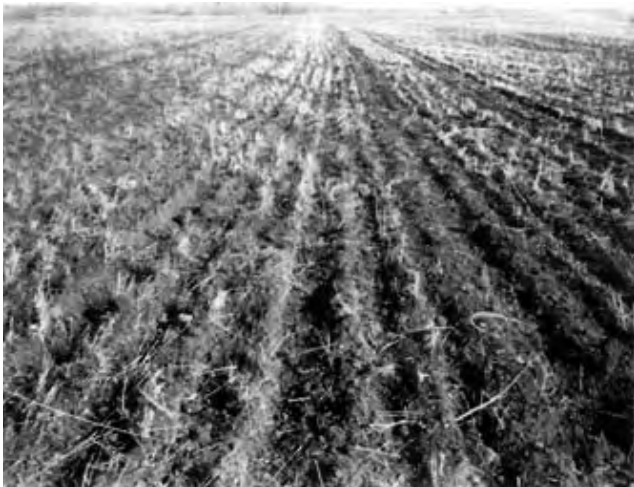
Trash burial with chisel points (FIGURE 6) in heavy crop residue was good. The action of the chisel points moved enough soil for adequate trash burial while leaving some standing stubble for snow retention.

FIGURE 6. Typical Trash Burial with Chisel Points.

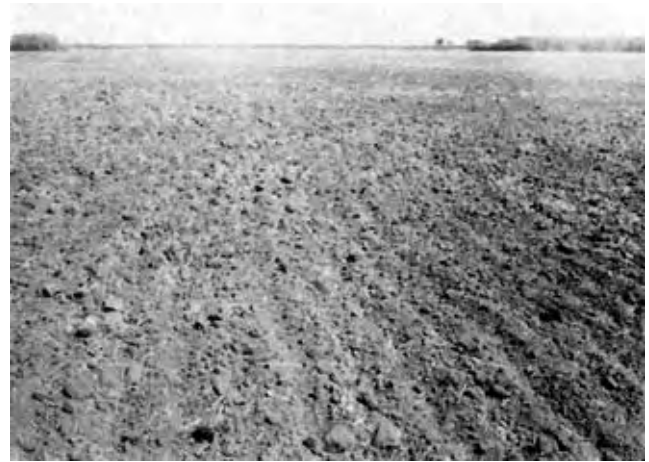
Surface ridging varied from 25 to 50 mm. The optional mounted harrows were effective in smoothing these ridges (FIGURE 7).

FIGURE 7. Typical Field Surface when using Optional Mounted Harrows.

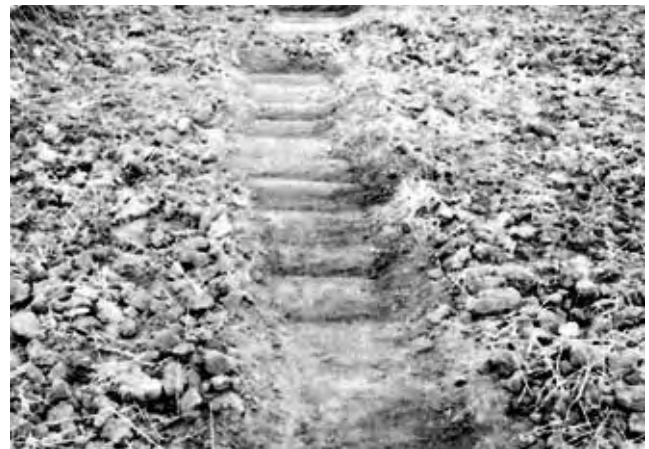
Furrow Bottom Ridging: In normal soil conditions, furrow bottom ridging was caused by the sweep nose curvature and was less than 15 mm (FIGURE 8). Greater furrow bottom ridging occurred in hard soils, especially at the wing ends due to wing frame twisting.

FIGURE 8. Typical Furrow Bottom.

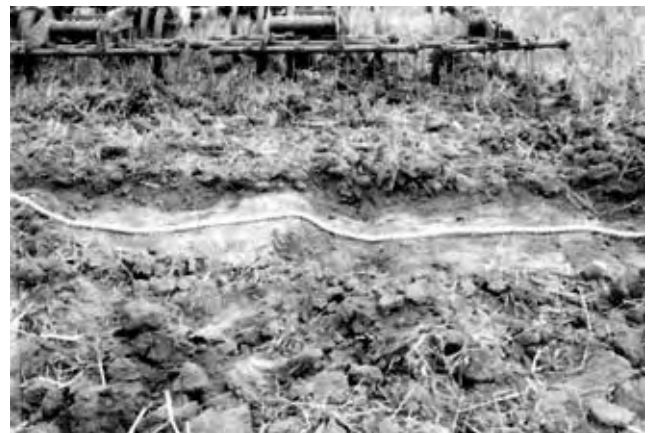
Some sweeps were not held level because of faulty shank holders. This resulted in random furrow bottom ridging (FIGURE 8). This problem was corrected after the faulty shank holders were shimmed or replaced.

FIGURE 9. Furrow Bottom Ridging caused by Faulty Shank Holders.

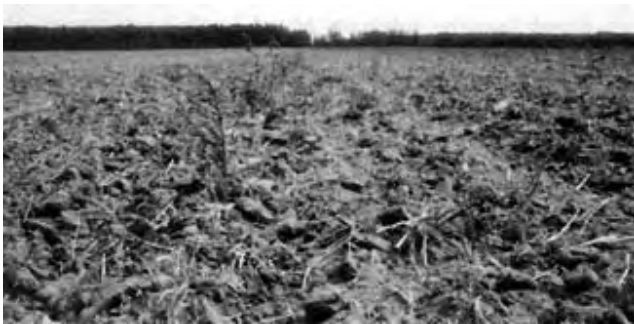
Skewing and Stability: The Leon CP77-334 was quite unstable. It skewed significantly on side slopes and in heavy draft conditions when encountering soil that varied in hardness across the machine width, resulting in weed misses. The sweep pattern (FIGURE 10) however was symmetrical and did not pose any resultant side forces on the cultivator during normal tillage. The shanks adjacent to depth control wheels were fitted with 356 mm sweeps to prevent tire interference. The minimum skew angle for weed misses between these sweeps and the adjacent 406 mm sweeps was 2.4 degrees. At several other locations shanks could not be spaced at 305 mm, due to interference of shank holders with

FIGURE 11. Weed Misses Caused by Skewing.

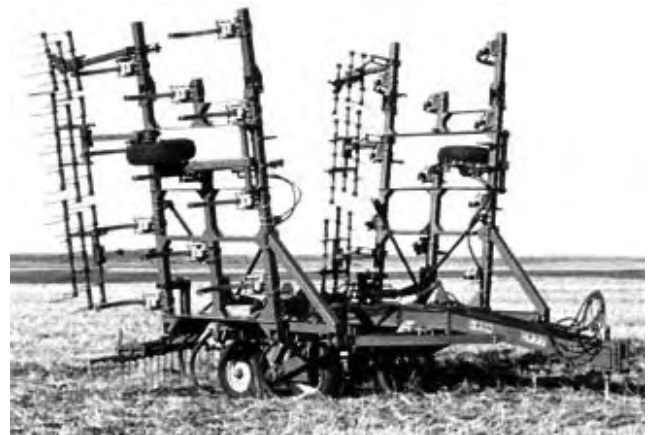
Transporting: The Leon CP77-334 was easily placed in transport position (FIGURE 12) using the hydraulic wing lift system supplied as standard equipment. Transport locks were provided

FIGURE 12. Transport Position.

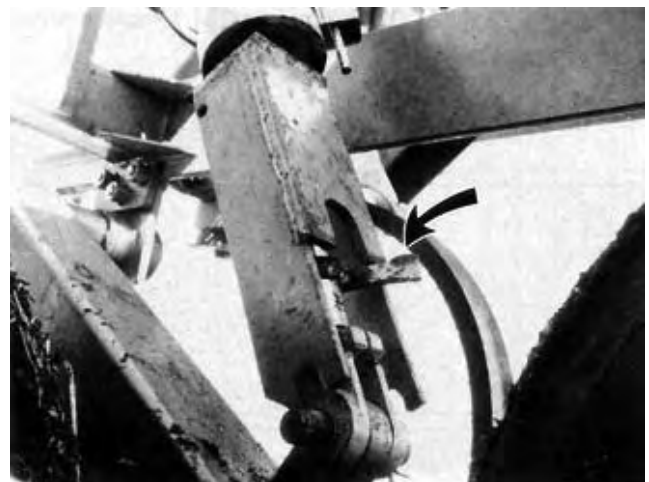
for both the wings and the centre section depth control wheels. It usually took one man less than 5 minutes to place the Leon CP77-334 in transport position. The master depth control cylinder transport lock interfered with the depth control stop (FIGURE 13). It is recommended that the safety lock be modified to eliminate this interference. The wing lock pin retainers were difficult to remove by hand. It is recommended that more functional retainers be used.

FIGURE 13. Interference of Safety Lock with Depth Control Stop.

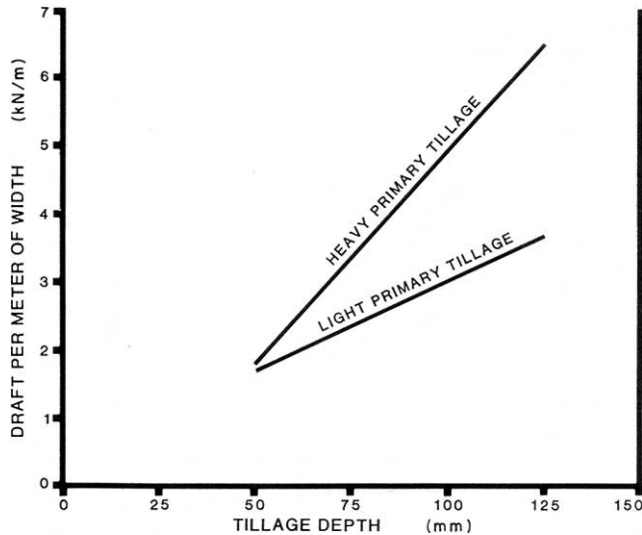
Draft Characteristics: FIGURE 14 shows draft requirements for heavy duty cultivators in typical primary tillage, at a speed of 8 km/h. This figure gives average requirements based on tests of 10 makes of heavy duty cultivators in 40 different field conditions.

FIGURE 14. Average Draft Requirements for Heavy Duty Cultivators at 8 km/h.

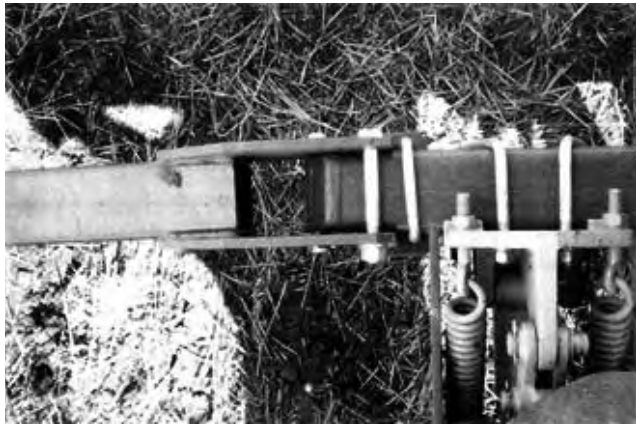
Extension Stubs: The frame extension stubs deformed during operation as shown in FIGURE 15. It is recommended that the stubs be modified to eliminate field deformation problems.

FIGURE 15. Stub Deformation.

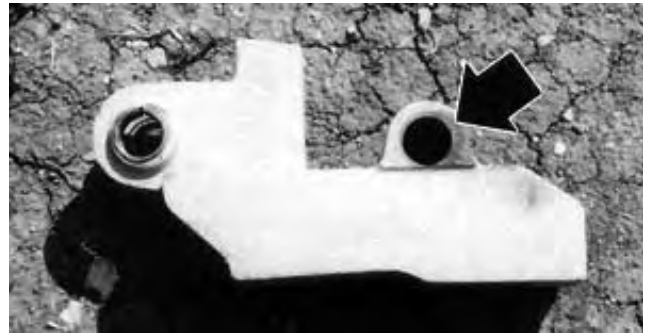
Shank Holders: The release shoes of the faulty trip mechanisms had improperly drilled main pivots (FIGURE 16). This resulted in misaligned shanks and excessive pivot pin wear. The faulty release shoes were replaced by the manufacturer with re-designed shoes that were properly drilled and which were bushed (FIGURE 17). The new shoes held the shanks properly, while the bushings reduced pivot pin wear. It is recommended that similar release shoes, complete with bushings be used in the trip mechanisms.

FIGURE 16. Original Shank Trip Release Shoe Showing Improperly Drilled Main Pivot.

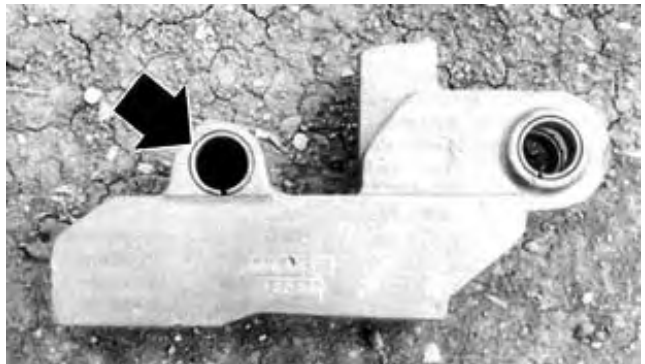
FIGURE 17. Re-designed Release Shoe Showing Properly Drilled and Bushed Main Pivot.

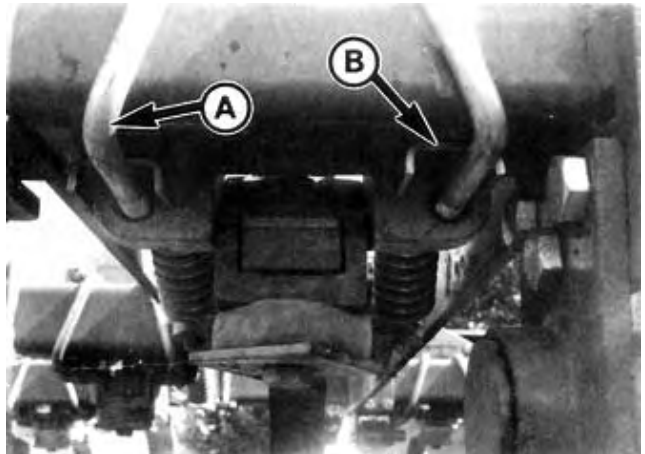
The trip-mechanism base blocks, because of oversized U-bolt fasteners, could rotate laterally causing improper shank alignment.

Four base block U-bolts (FIGURE 18) broke during the 210 hour test period.

FIGURE 18. Trip Mechanism Base Block (A) U-bolt Fasteners, (B) Shims.

Shims were added to all blocks to hold them in proper position (FIGURE 18). It is recommended that all base blocks be properly shimmed during assembly to ensure proper shank alignment.
