Evaluation Report

Wil-Rich 13CPW (11.3 m) Heavy Duty Cultivator

WIL-RICH 13CPW CHISEL PLOW

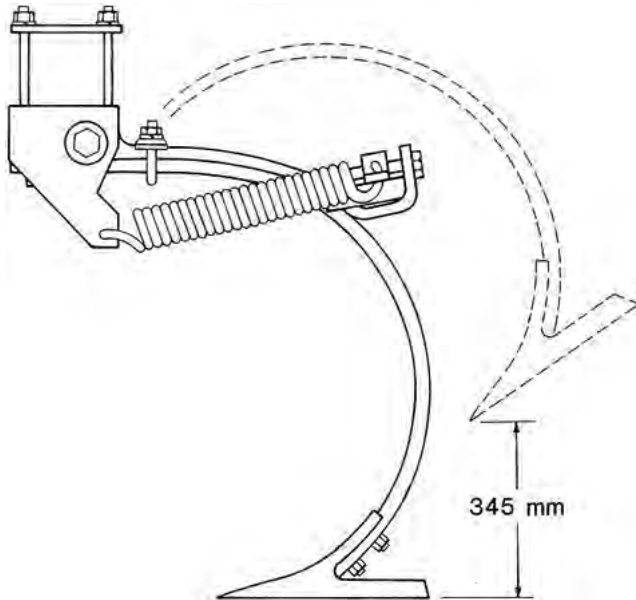
FIGURE 4 shows the lifting pattern when shanks encounter stones or field obstructions. Maximum lift height was 345 mm (13.5 in). One shank bent and one sweep broke during the 154 hour test period. The spring cushioned shank holders performed well during the test and the failures that occurred do not represent a serious problem.

FIGURE 4. Shank Lifting Pattern.

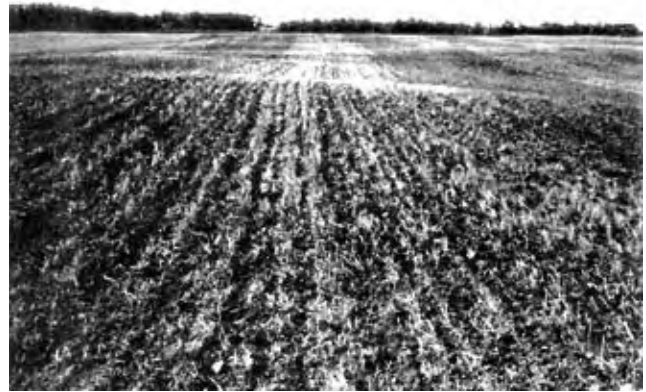
Trash burial with chisel points in heavy crop residue was good (FIGURE 5). The action of the chisel points moved enough soil for adequate trash burial while leaving some standing stubble for snow retention.

FIGURE 5. Typical Trash Burial with Chisel Points.

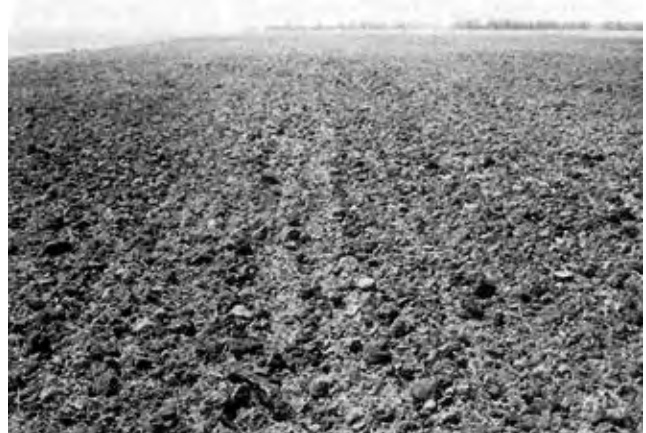
Functional performance of the optional mounted harrows was fair. The harrows were effective in smoothing out surface ridges, leaving a slightly ridged surface condition (FIGURE 6). In heavy trash conditions, the mounted harrows tended to plug easily.

FIGURE 6. Typical Field Surface when using Optional Mounted Harrows.

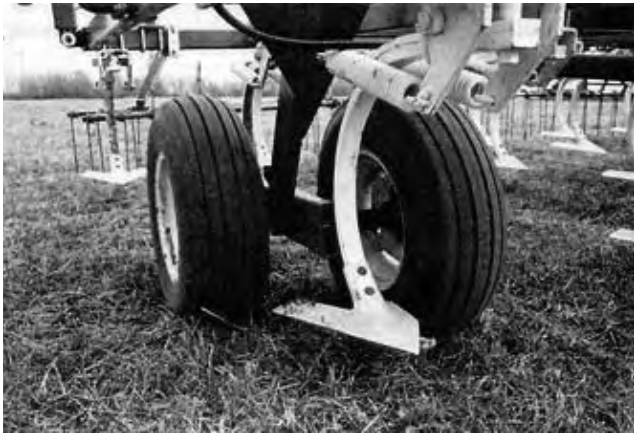
Weed Kill: Weed kill was fair in normal soil conditions when the cultivator was equipped with 406 mm (16 in) sweeps at a lateral spacing of 305 mm (12 in). Shanks adjacent to the wheels had trimmed sweeps which gave minimal overlap and frequent weed misses occurred during sideways skewing on uneven ground. Sweeps were located behind the depth control wheels to uproot weeds in the wheel tracks.

FIGURE 8. Trimmed Sweep.

It is recommended that shanks be arranged on the cultivator to avoid the use of trimmed sweeps adjacent to wheels.

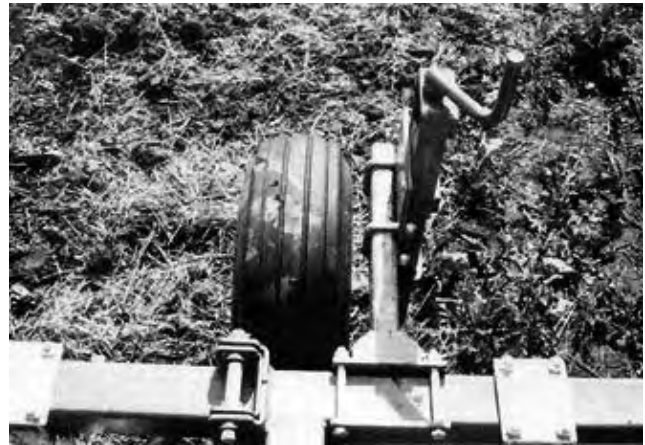
Stabilizer Wheels: The stabilizer wheel mount twisted during operation, resulting in moderate wheel misalignment (FIGURE 12). It is recommended that the stabilizer wheel mount stub be strengthened to retain proper wheel alignment during operation.

The stabilizer wheels rubbed on their mounts during operation. It is recommended that the stabilizer axles be extended to give

adequate clearance between the wheels and mounts.

FIGURE 12. Stabilizer Wheel Mount Stub.

1. Improving quality control and set up inspection to guard against frame misalignment.
2. Eliminating interference between the stabilizer wheels and their mounts, and strengthening the mount members to maintain wheel alignment during operation.

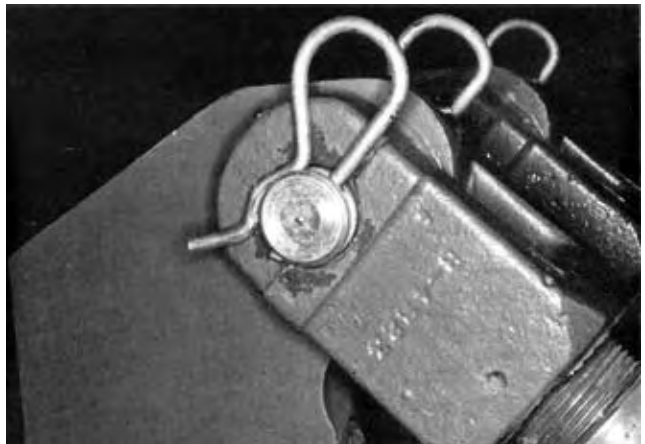
Pin Retainer Clips: Retainer clip damage was caused by forced rotation of the cylinder pins during operation (FIGURE 13). It is recommended that the pins be firmly anchored in the cylinder yokes to prevent clip damage from rotation.

FIGURE 13. Damaged Retainer Clips on Cylinder Yokes.

8. Modifications to reduce pin retainer clip failures on the hydraulic cylinders.
9. Supplying tires which comply with the Tire and Rim Association toad rating.

8. Redesigned hydraulic cylinder yoke pins, which prevent damage to the retainer clips, are in production.
9. Various tire sizes and ratings are available from Wil-Rich. Tires and wheels are supplied according to dealer order. We find the tire and rim association ratings to be quite conservative, but refuse dealer requests when the tire overload is severe.
