# Evaluation Report

# 24

**McKee Bale-rustler**

## McKee Bale-rustler

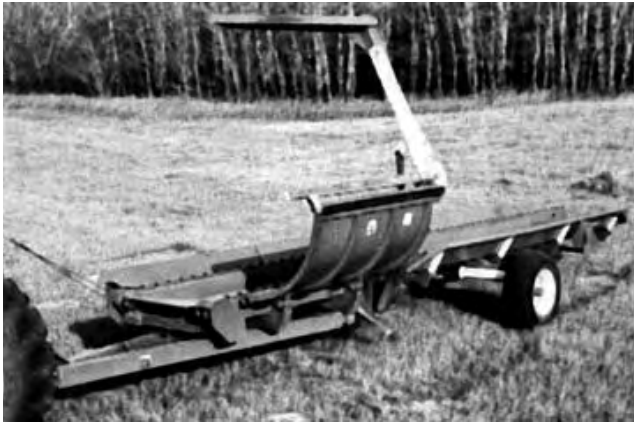
Figure 1. McKee Bale-rustler in Transport Position.

The McKee Bale-rustler (Figure 1) is a self-loading, tilting bed, two wheel trailer for use with tractors 30 kW (40 hp), or larger, equipped with dual hydraulics. Bales are picked up on the left side at the tractor with an hydraulic cradle pickup and are placed lengthwise on the bed.

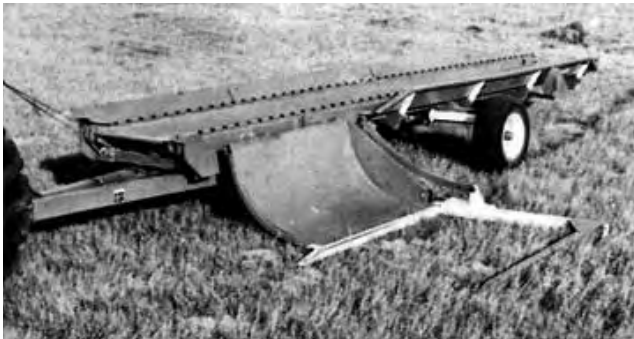
Figure 2. McKee Bale-rustler in Loading Position.

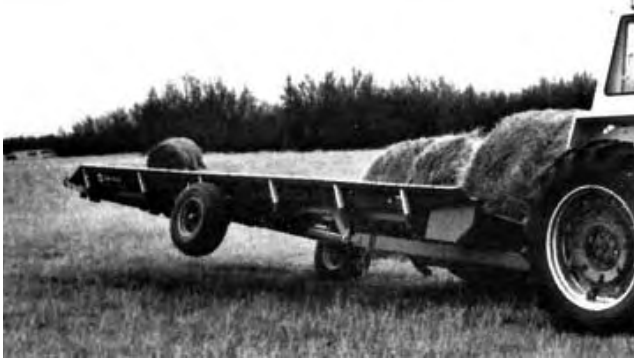
Figure 3. Sideways Tipping of the Bale-rustler when the First Bale Loaded Weighs More than 680 kg (1500 lb)

The first bale could not be loaded, without stopping the tractor, if the bale was heavier than 680 kg (1500 lb). The weight of the bale in the cradle caused the right wagon wheel to lift off the ground (Figure 3) as the bale was loaded. The wheel continued to lift until the tractor drawbar restrained further tipping and the bale could be lifted onto the bed. Once one bale had been placed on the bed, the weight of this bale prevented tipping when loading successive bales. Fluid was added to the front tire but this helped only slightly. Since many bales weigh more than 680 kg (1500 lb) it is recommended that the optional automatic outrigger (not tested) be supplied as standard equipment with the Bale-rustler. The outrigger supports the wagon and eliminates tipping regardless of the weight of the first bale.

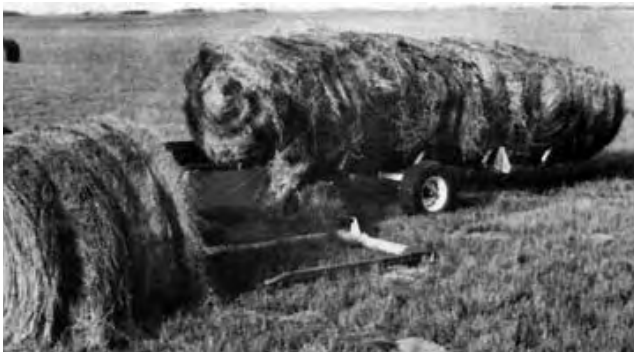
Figure 4. Bale-rustler Approaching the Fifth Bale.

Once the first bale has been loaded, the cradle is left in raised position while travelling to the next bale. The bed chains are engaged to move the first bale rearward on the bed to give room for the second bale. Successive bales are loaded in the same way (Figure 4). Bales had to be placed tightly together on the bed to permit loading five bales.

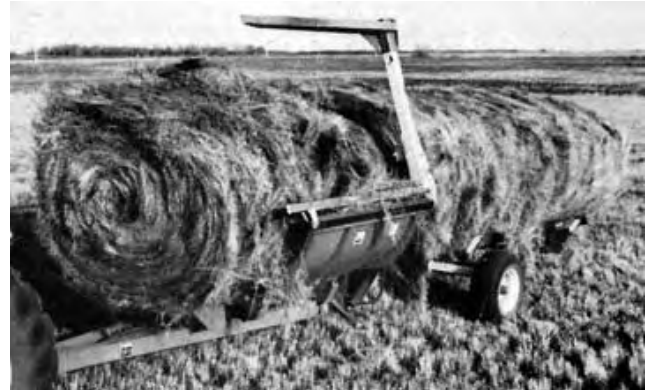
Figure 5. Fully Loaded Bale-rustler. Bales are Rotated During Loading Leaving the Weathered Side Down.

Slight damage occurred to old bales, which had settled forming flat spot at the bottom. When bales are loaded from the front each bale is rotated as it is placed on the bed (Figure 5) leaving the flat spot up. Rotation during loading disturbed the ragged edges of poorly formed bales. Loose bales, which had not been wrapped with twine, unfurled during loading resulting in significant losses.

**Transporting:** When the bed is fully loaded (Figure 5) the cradle is left in raised position and safety channel is installed on the cradle lift cylinder for safe road transport. A permanent slow moving vehicle sign was located at the rear of the mover.

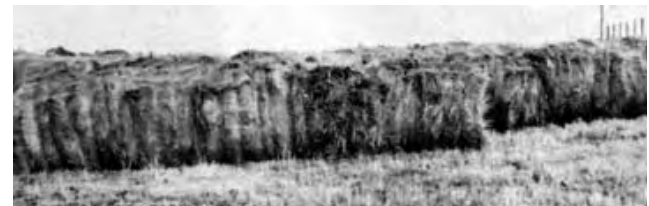
Figure 6. Bales Placed Tightly Together in a Row.

**Placement:** The Bale-rustler is unloaded from the rear. With the bed tilted rearward the rail chains are engaged as the tractor advances forward slowly. It was very easy to place tight rows of bales (Figure 6). Sometimes, the bale twines snagged on the bolt heads on the bed side sheets, damaging or breaking the twines. The use of carriage bolts in bed assembly would eliminate this problem.

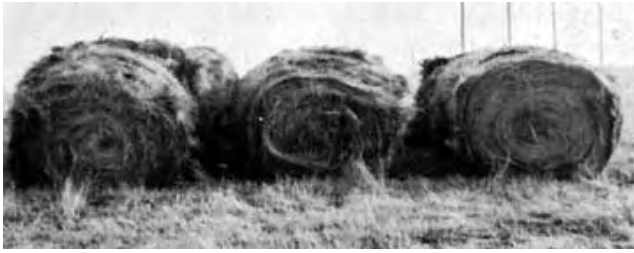
Figure 7. Rows of Bales Placed Closely Together.

Depending on operator preference, rows of bales could easily be spaced or could be placed tightly together (Figure 7).
