# **Evaluation Report**

536

**Mumby Round Bale Mover**

### **MUMBY ROUND BALE MOVER**

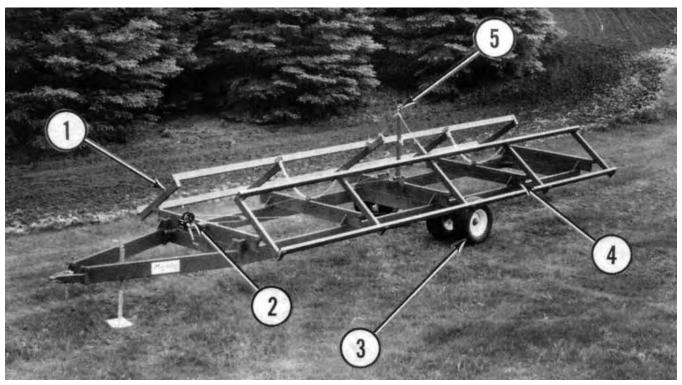
FIGURE 1. (1) Tilting Bale Beds, (2) Hand Winch, (3) Dolly Wheels, (4) Main Frame, (5) Cable Mast.

The Mumby round bale mover is a four wheeled trailer designed to transport and place round bales. It consists of a rectangular steel frame with a v-hitch attached to the front and a suspension arranged around two wheels per side mounted slightly aft of centre in a dolly configuration. Five steel cross members equally spaced are welded perpendicular to the main frame rails. Two steel bale beds are hinged to the ends of the cross members and run the full length of the frame. The bale beds are tiltable to allow bales to be unloaded and are activated when the operator turns the handle of a cable winch. Complete specifications are presented in APPENDIX I, and FIGURE 1 shows the location of major components.
