# **Evaluation Report**

97

**Hesston 5400 Rounder**

A Co-operative Program Between

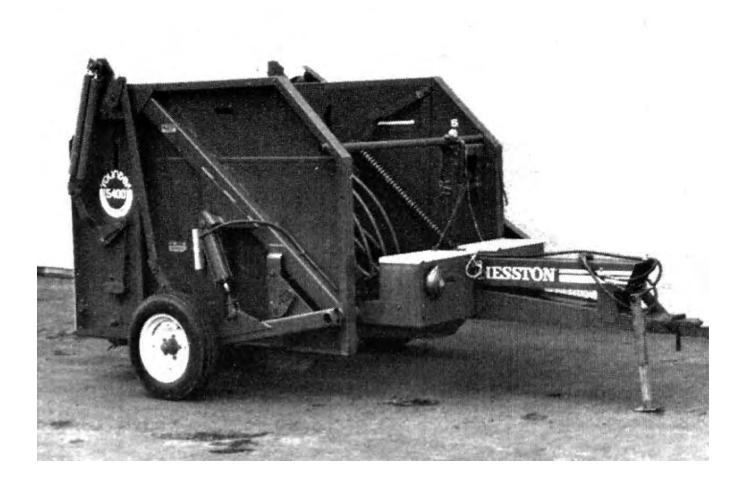
FIGURE 1. Hesston 5400 Rounder: (A) Pickup Drive Roller, (B) Pickup Belts, (C) Bale Forming Grids.

The Hesston 5400 is a pull-type, ground roll baler with spring loaded steel bale forming grids and a power take-off driven belt pickup. Twine wrapping is controlled with the tractor hydraulic system, while the twine is manually cut with a rope control.

The bale rolls on the ground, on top of the incoming windrow. The pickup, which is xed at the rear of the bale chamber, lifts the windrow upward and forward, around the rolling bale, forcing it beneath three sets of spring loaded, curved bale forming grids. The pickup has nine 98 mm (3.9 in) wide belts with spring steel teeth.
