Research Update 698

Hog Lagoon Odour Control -A Treatment Using Floating Straw

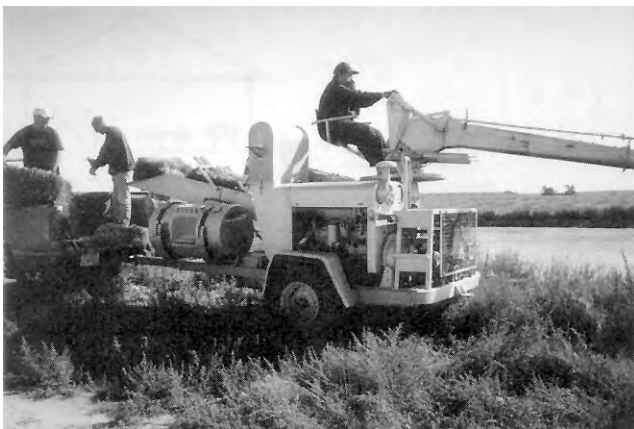
FIGURE 1. Straw Applicator.

Straw Application: Straw was applied for both flotation supported covers and non-supported covers by using a device initially designed to spread straw for surface erosion control in road construction (FIGURE 1).

The applicator consists of a conveyor moving square bales through a flail shredder into a paddle fan blower which blows the straw through a moveable spout.

Straw Applicator: The straw applicator used in these tests needed a strong wind to improve throwing distance. The average application rate was 2 square bales per minute. The straw was blown 150 ft (45 m) with wind assistance and 80 ft (25 m) in calm conditions. The applicator shredded the straw to 6 to 8 in (150 to 200 m) which would tend to reduce flotation time slightly.

Straw applied directly to the lagoon surface is free to drift with the wind to cover areas which are well beyond the applicator's range. In this case, the applicator's coverage doesn't have to extend over the entire surface area. When applying onto a flotation system, the straw must be uniformly placed by the applicator over the entire area of the lagoon. To operate successfully in this case, the applicator's range must extend further and the straw stream must be easily and accurately controlled.

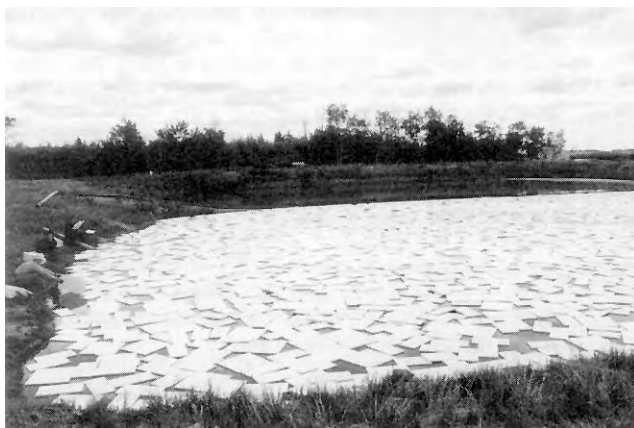
FIGURE 2. Floats in Place on Liquid Cell.

Straw Flotation Devices: Two flotation devices under the straw layer were tested; polystyrene sheets 1 in (25 mm) thick (FIGURE 2), and plastic engine oil bottles (FIGURE 3). They were simply dumped onto the lagoon and allowed to drift into position to provide a uniform covering of the liquid surface. A floating barrier was used to keep them in the liquid cell of the 2-cell lagoon.

Straw Flotation Devices: The polystyrene floats kept the straw cover supported and dry for nearly the entire season, with excellent odour control.

Since the cover floats downwards at pump-out and back to the surface on refill, multiple-year usage of the floats is possible. Reapplication of straw may be required each year to repair damaged areas.

With a liquid cell, using a polystyrene float and straw system, a transfer pump was used to pump the liquid into the dry cell and no auxiliary agitation was required. As the liquid was removed, the straw/float cover settled, intact, to the bottom of the cell. The floats and the straw could be used for the next season.

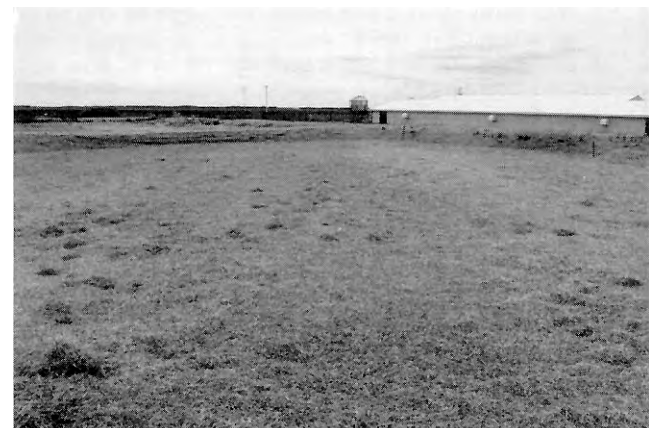
FIGURE 4. Unsupported Straw Cover.

FIGURE 4 shows a lagoon immediately after covering with barley straw. FIGURE 5 shows the same lagoon several weeks later. The damp areas will have effective, although not excellent, odour control, while open liquid areas will provide no odour control. When about 15% of the lagoon area has open liquid because of straw sinkage, odour will be significant enough to require reapplication of straw.
