Evaluation Report

690

Brandt 852 Super-Charged Grain Auger

BRANDT 852 SUPER-CHARGED GRAIN AUGER

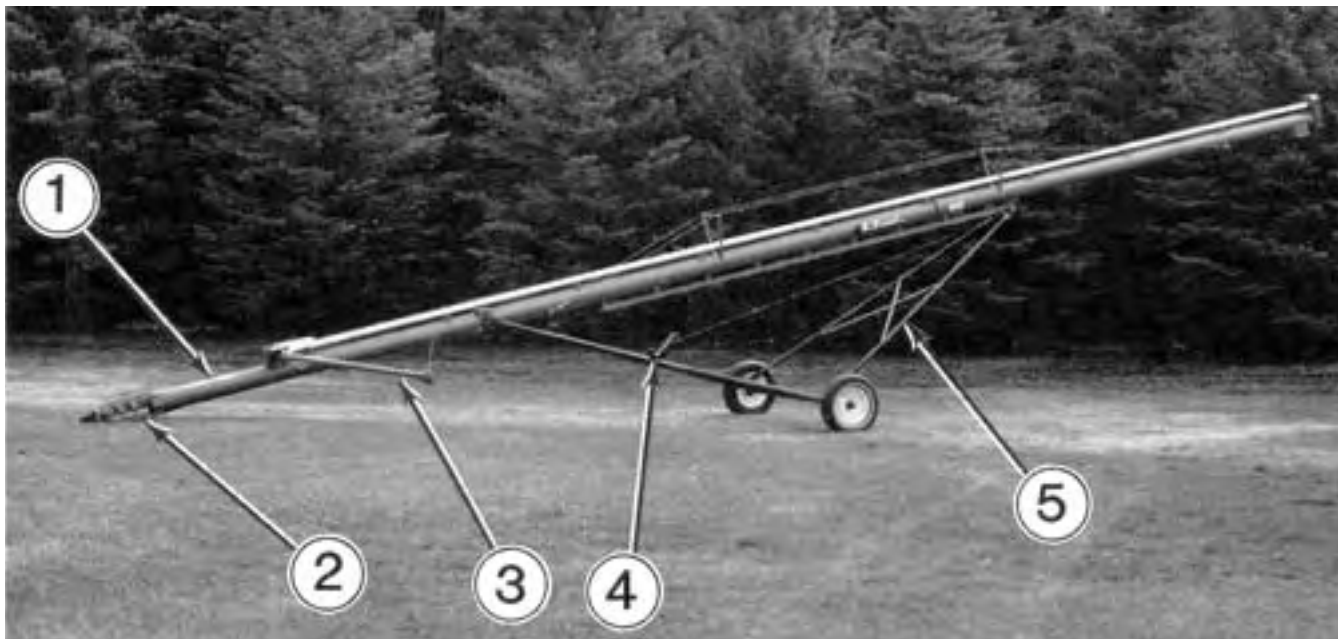
FIGURE 1. Brandt 852 Super-Charged: (1) Main Auger Tube, (2) Super-Charger Inlet, (3) PTO Drive, (4) Lift Winch, (5) Undercarriage.

The Brandt 852 Super-Charged Grain Auger is an 8 in (203 mm) diameter 52 ft (15.8 m) long portable screw conveyor. The auger tube is mounted on a tubular steel undercarriage and is raised or lowered mechanically with a hand winch and cable. The inlet end of the auger is supplied with a removable hitch that is used for towing, while the undercarriage is supported by two wheels with rubber tires.

The machine evaluated by PAMI was configured as described in the General Description, FIGURE 1 and the specifications section of

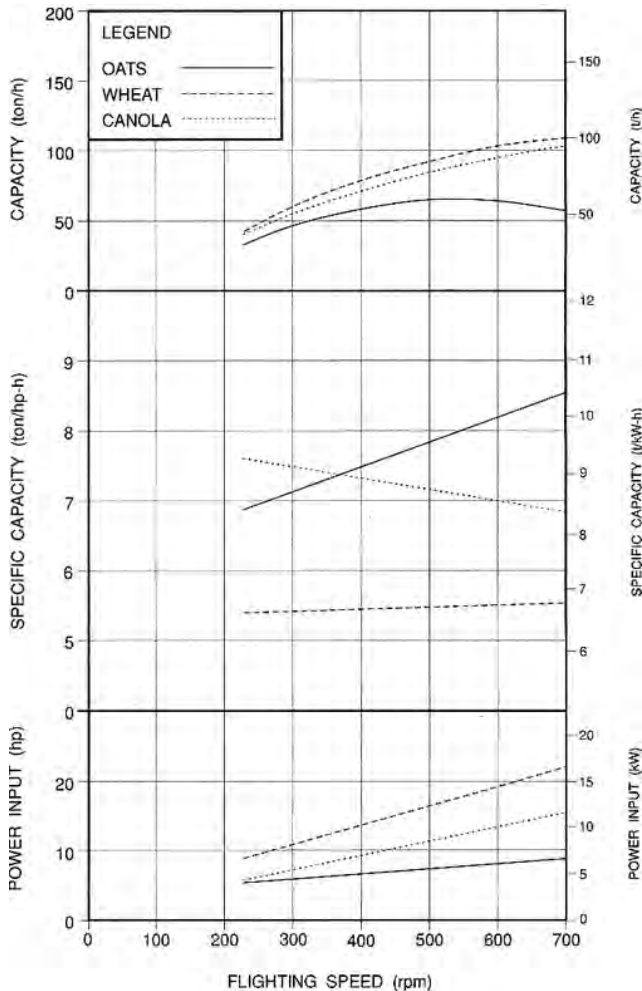
FIGURE 2. Capacity, Specific Capacity and Power Requirements for various flighting speeds at 30°.

Capacity: FIGURE 2 shows the capacities of the Brandt 852 in various grains at 30° elevation angle. Maximum capacities at this angle were 3590, 3580, 3775, 3040 bu/h (103, 68, 99, 66 t/h) in wheat, oats, canola, and standard material respectively. As flighting speeds are increased, the capacity of screw conveyors increases to a peak, then levels off or decreases. Maximum or peak capacities for the Brandt 852 occurred at flighting speeds between 440 and 600 rpm.

Power requirements for the Brandt in dry wheat (FIGURE 2) ranged from 7.4 to 18.8 hp (5.5 to 14.1 kW). The Brandt 852 required a tractor with a PTO shaft capable of 540 rpm and at least 30 hp (22 kW).

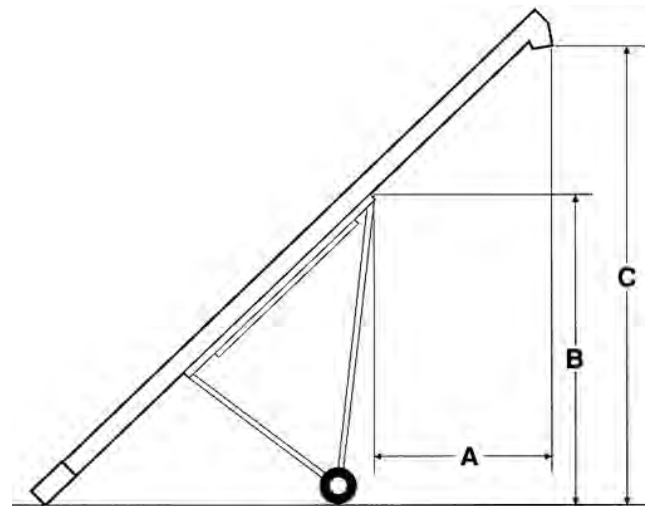
FIGURE 3. Dimensions: (A) Horizontal Reach, (B) Bin Eave Clearance, (C) Discharge Height.

The discharge height (FIGURE 3) could be varied from 12.3 to 33.3 ft (3.7 to 10.1 m) with the mechanical cable winch mechanism. Corresponding elevation angles varied from 13° to 41°.

Auger Reach: The bin eave clearance and horizontal reach (FIGURE 3) of the Brandt 852 are shown in TABLE 2. Bin eave clearance, measured from the ground to the auger tube at the foremost part of the undercarriage, varied from 8.1 to 17.3 ft (2.4 to 5.3 m) at 13° and 41° respectively. The reach, measured from the foremost part of the undercarriage to the centre of the discharge, varied from 15.3 to 24.0 ft (4.7 to 7.3 m) at 13° and 41° respectively.

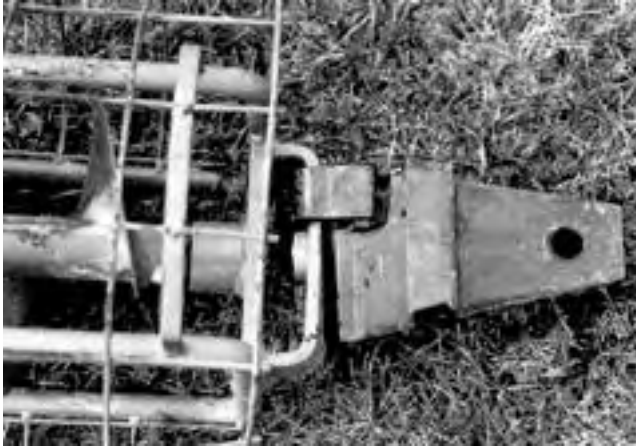
FIGURE 4. Hitch Assembly.

The Brandt 852 was prepared for transporting by lowering the auger tube angle to its lowest position of 13° and attaching the hitch assembly in its bracket (FIGURE 4). The power shaft was secured in transport position with a chain that held the shaft more or less parallel to the auger tube. Clearance under power lines was ample when fully lowered. The transport height was 14.6 ft (4.3 m).

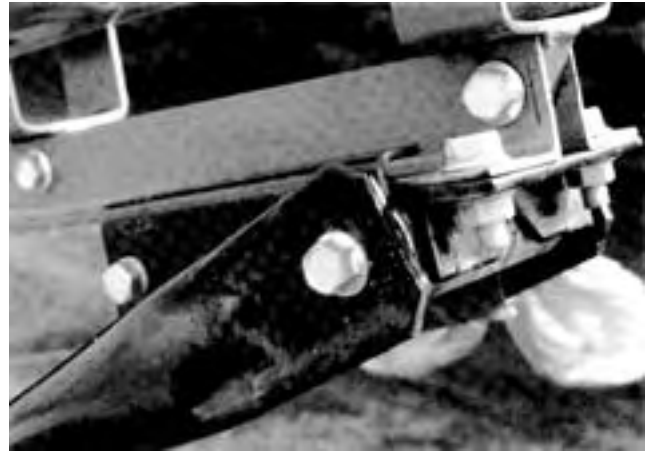
Adjustments: Ease of adjusting the discharge height was fair. Turning the crank for the cable winch was tiring. The crank required 146 complete turns to raise the auger tube from minimum angle of elevation to maximum, while requiring a force of 51 lbs (227 N). When lowering the auger tube, a faulty roller assembly caused the auger tube support frame to bind (FIGURE 4). The support frame had to be winched with a come along toward the discharge end of the auger to free the roller assembly. It is recommended that the manufacturer consider a modification to the slide roller assembly that pushes up the auger tube that would prevent the slide roller assembly from binding.

During the 30 hours of operation only one minor mechanical problem occurred. The auger was supplied with a faulty slide roller assembly (FIGURE 5). The faulty assembly would bind and would not allow the auger tube to be lowered from its maximum height position. The roller was replaced and the problem did not recur.

FIGURE 5. Slide Roller Assembly.

1. A modification to the slide roller assembly that pushes up the auger tube that would prevent the slide roller assembly from binding.
2. A modification that would prevent a top heavy imbalance when grain is concentrated in the top portion of the auger tube during clean out.

1. The slide roller was redesigned in May, 1991 to combine the roller with the double pull. This removes the twisting force experienced during the testing.
2. The auger axle frame was redesigned in May, 1992. The new balance point increases the hitch weight to approximately 80 lbs (depending on the drive option of the auger).

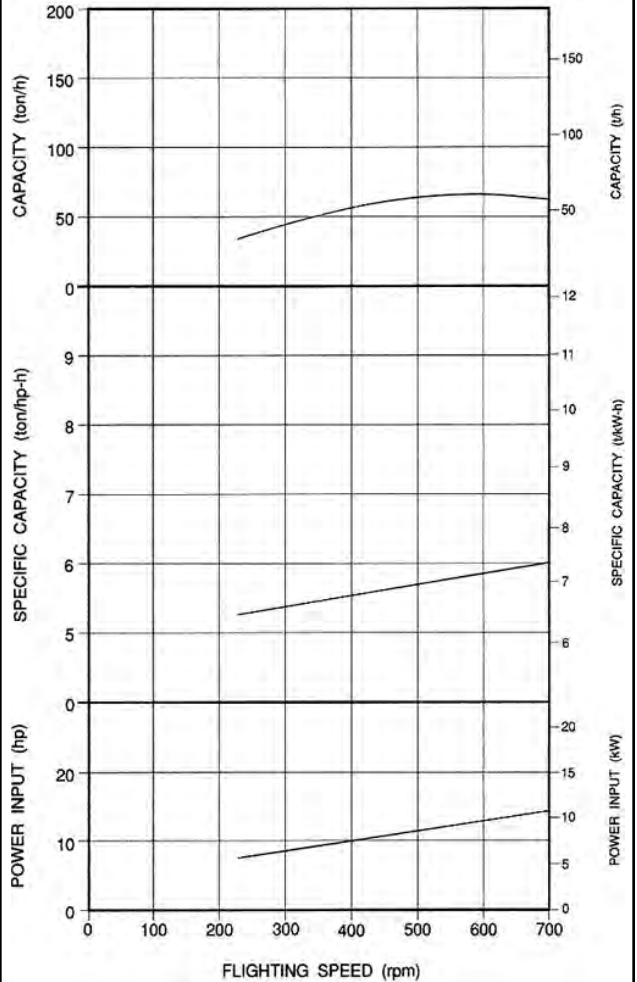
FIGURE 6. Capacity, Specific Capacity, and Power Requirements with Standard Test Material at 30° of elevation angle.

The standard test material is a high density granular polyethylene. The material is consistent and not subject to damage or changes in physical properties as are grains. FIGURE 6 gives the capacity, specific capacity, and power requirements for the Brandt 852 Super Charger in a standard test material. This data may be used for comparison of different grain augers.
