Evaluation Report

666

FG Auger Alert

F.G. MANUFACTURING AUGER ALERT

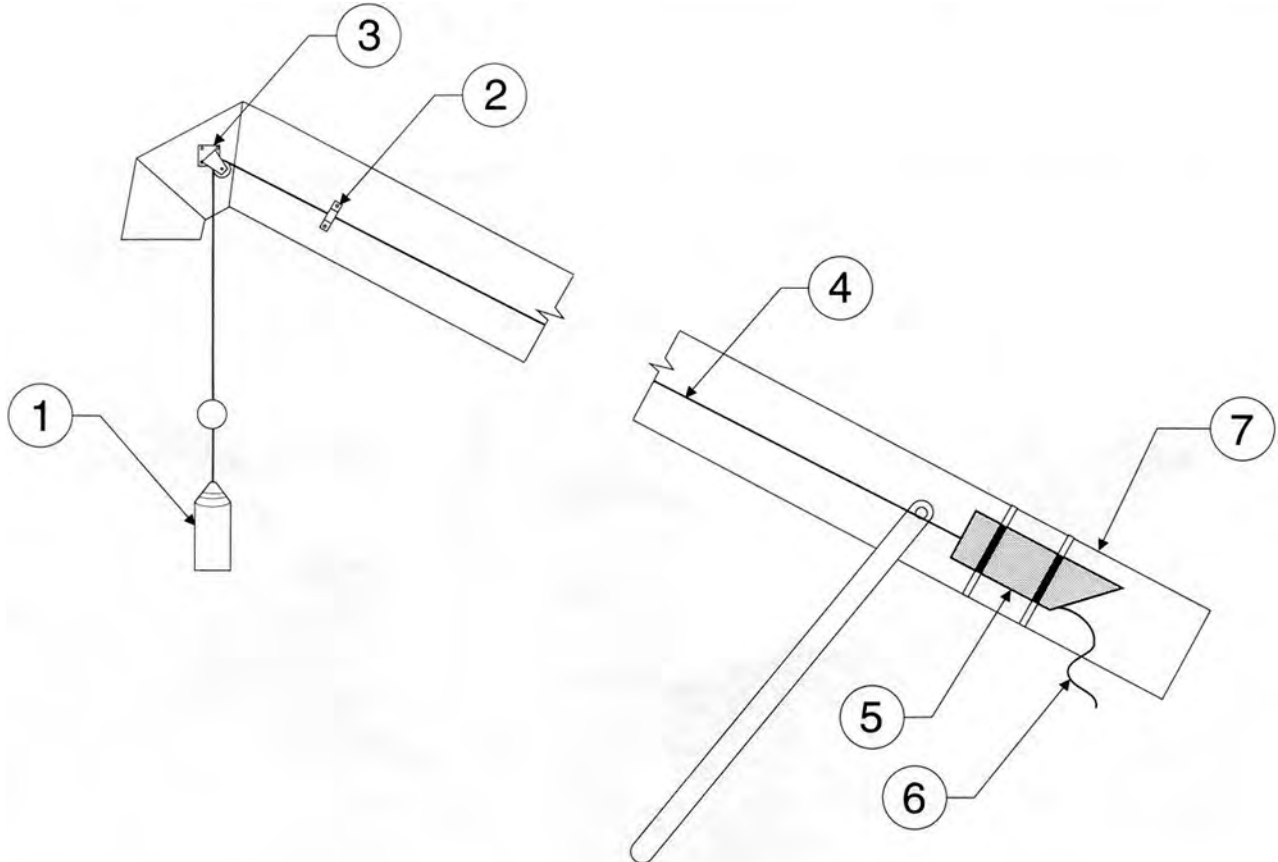
FIGURE 1. F.G. Auger Alert: (1) Switch Can, (2) Cable Guide, (3) Pulley, (4) Power Cable, (5) Electronics Container, (6) 12 Volt Power Source Cables, (7) Auger Tube.

The Auger Alert consists of a mechanical switch arranged as a pendulum within a rubber coated can. The switch sensor can is suspended from the discharge end of the grain auger by a power cable. The cable passes through a pulley which is fastened to the side of the auger at the discharge. The cable is connected to an electronics pod which is attached to the outside of the auger tube in a position where it can be reached by the auger operator. The electronics pod contains the audio horn and the necessary electronics to power the device. Two power cords, a positive and negative, supply the 12 volt electrical power from a remote source.

Detailed specifications are given in APPENDIX I, while FIGURE 1 shows the location of major components.

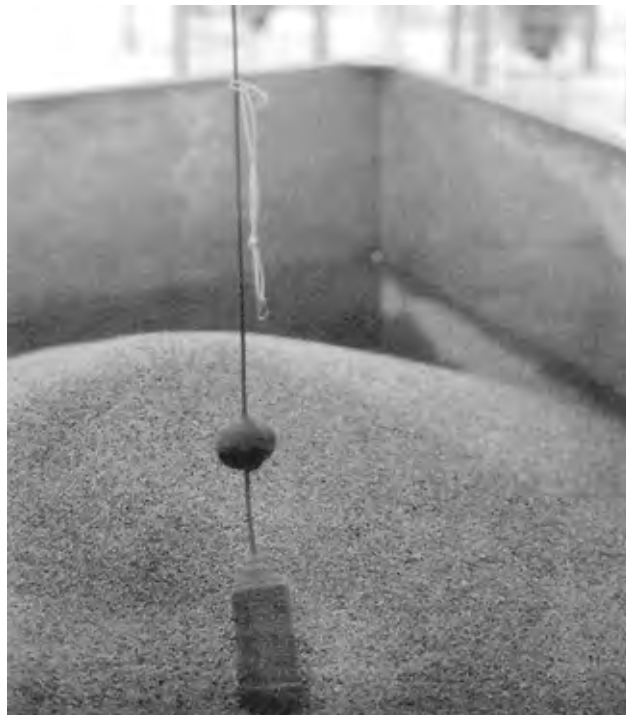
FIGURE 2. Sensor Can Lowered into Bin.

Adjustment: Adjustment was very good and took one person minimal time. The Auger Alert was adjusted by raising or lowering the sensor switch to the desired height within the bin. The adjustment was done by passing the sensor wire through the discharge pulley, and tying the wire at the electronics pod. The Auger Alert was supplied with 70 ft (21 m) of sensor wire and allowed a wide range of adjustment (FIGURE 2).
