Evaluation Report

Inland Model FT 56 Field Sprayer

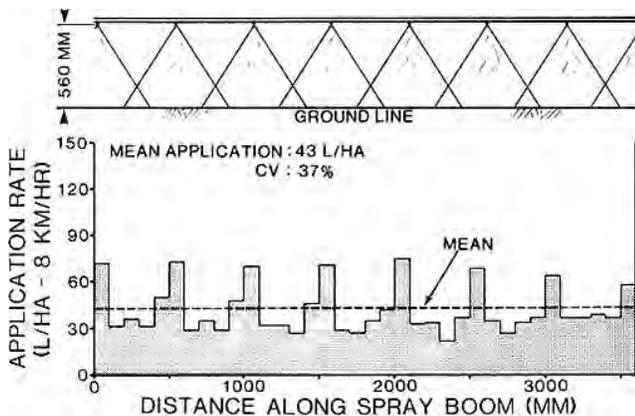
Figure 2. Distribution Pattern for a Section of Spray Boom at 140 kPa (20 psi) with Tee Jet 6501 (65°) Nozzle, 560 mm (22 in) above Ground.

Distribution Patterns: Figures 2 and 3 show the spray distribution pattern along the length of the boom when equipped with the 65° TeeJet 6501 nozzles supplied with the sprayer and operated at 140 and 310 kPa (20 and 45 psi) respectively. The coefficient of variation¹ at 140 kPa (20 psi) was 37% with application rate along the boom varying from 22 to 75 L/ha (2.0 to 6.7 gal/ac) at a forward speed of 8 km/h (5 mph). High concentrations of spray were delivered directly below each nozzle, with inadequate coverage between nozzles due to insufficient overlap. Operation at 310 kPa (45 psi) resulted in improved distribution and spray overlap. The CV in this case was 12% with application rates varying from 48 to 76 L/ha (4.3 to 6.8 gal/ac). Higher pressures improved the distribution pattern but resulted in more spray drift.

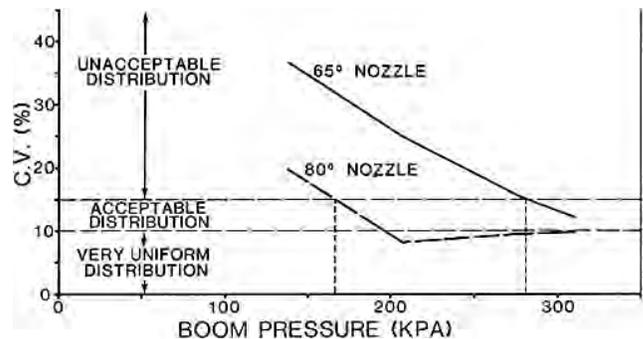
Figure 4. Spray Pattern Quality at Various Boom Pressures, with 65° and 80° Nozzles.

Figure 4 compares spray pattern uniformity at various boom pressures for the 65° TeeJet 6501 nozzles supplied with the sprayer and for nozzles of the same capacity but with a spray angle of 80° (TeeJet 8001). Spray distribution was unacceptable at pressures below 280 kPa (41 psi) for the 65° nozzles. Spray distribution was acceptable above 250 kPa (41 psi) but it was not possible to obtain very uniform distribution (CV less than 10%) in the acceptable operating range below 310 kPa (45 psi).

When equipped with 80° nozzles, spray distribution was

acceptable at pressures from 165 to 195 kPa (24 to 28 psi) and was very uniform at pressures above 195 kPa (28 psi). It is evident that 80° nozzles would greatly improve nozzle distribution and allow spraying at lower pressures to reduce drift.

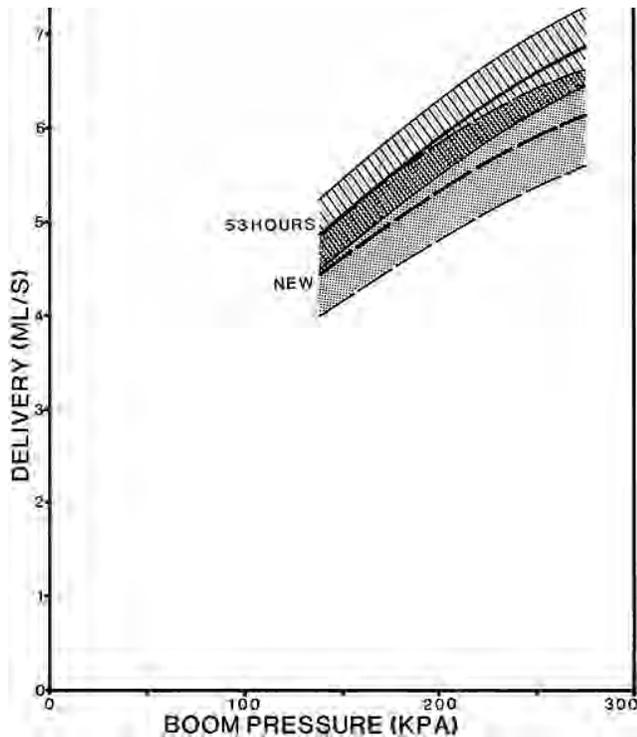
Figure 5. Delivery Rates of TeeJet 6501 Nozzles - New and Used 53 Hours.

Nozzle Calibration and Wear: Figure 5 compares the delivery rates of the brass 65° nozzles when new and after 53 hours of operation.

Delivery from new nozzles was the same as the manufacturer's rated capacity. Nozzle wear during the field operation caused the output of the nozzles to increase by 11%. Some researchers indicate that a nozzle needs replacement once delivery has increased by more than 10%. The excessive increase in capacity was attributed to wear caused by abrasive material in some of the water that was used for spraying.

Figure 5 also shows the variability among individual nozzles. The shaded areas represent the range over which the deliveries from 10 nozzles varied when new and after field tests. A narrow range indicates that nozzle discharges are very similar while a wider range indicates more variability among individual nozzle deliveries. Variability among individual nozzle deliveries on the FT 56 was low. The coefficient of variation of the nozzle deliveries was 4.7% when new and decreased to 3.4% after the field tests.

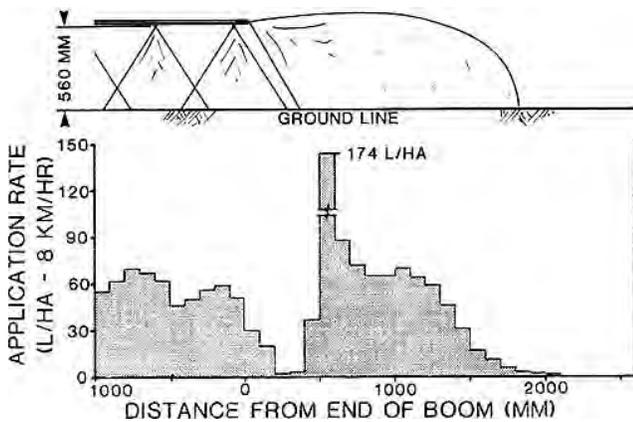
Figure 6. Distribution Pattern at the Boom End at 275 kPa (60 psi) using End Nozzles, 560 mm (22 in) above Ground.

Use of End Nozzles: Figure 6 shows a typical distribution pattern at the end of the boom when using end nozzles. The end nozzle distribution was unacceptable due to improper overlap between the end nozzle and the nozzles on the spray boom.

Application varied from 3 to 174 L/ha (0.3 to 15.5 gal/ac). The use of the end nozzles resulted in increased drift because the spray was directed out from the boom where wind had a greater effect. End nozzles should be restricted to use along fence lines, and roadsides on calm days.

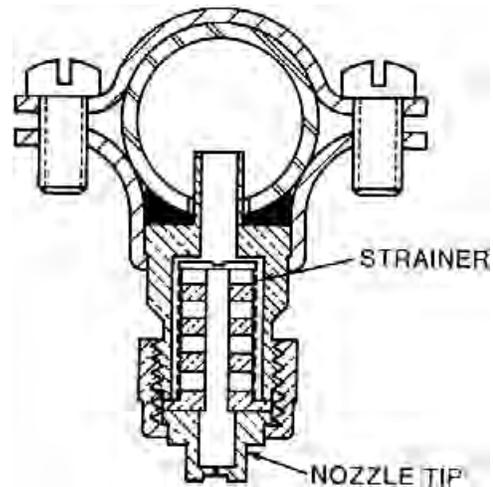
Figure 7. Cross Section of Nozzle.

Use of Optional Nozzles: The FT 56 sprayer was equipped with standard TeeJet nozzle body assemblies (Figure 7) so a wide range of nozzle tips could be used on the sprayer. Flat fan, flooding or cone type nozzles could be used since boom height and nozzle angle were adjustable.

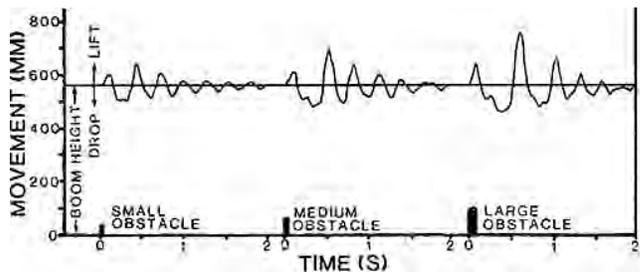
Figure 8. Vertical boom Movement at Boom End (lift and drop) when the Boom Castor Wheel is Driven over Different Obstacles at a Forward Speed of 9 km/h (5.6 mph).

Figure 8 shows vertical boom movement (bounce) when the castor wheel was driven over the obstacles at 9 km/h (5.6 mph). The maximum movement at the end of the boom was a lift of 200 mm (7.9 in) and a drop of 100 mm (3.9 in). This resulted in a variation in boom height above the ground from 460 mm (18.1 in) to 760 mm (29.9 in), compared to the correct boom height of 560 mm (22 in). Figure 9 compares the nozzle overlap at these three boom heights.

The lift and drop at the centre of the boom was slightly less than that at the boom end. Operations at 6 km/h (3.7 mph) or 12 km/h (7.5 mph) over the obstacles caused vertical boom movements about the same as those at 9 km/h (5.6 mph).

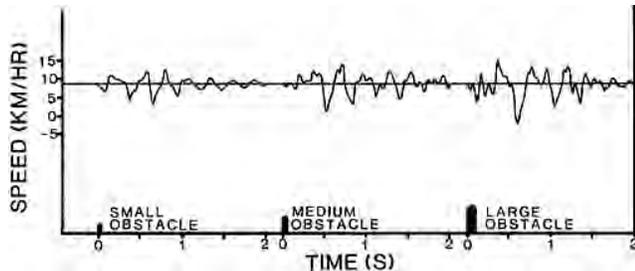
Figure 10. Variation in Boom End Speed when the Boom Castor Wheel is Driven over Different Obstacles at an Average Forward Speed of 9 km/h (5.6 mph).

Driving over an obstacle with the boom wheels also caused the forward speed of the boom to vary in relation to the tractor speed since the boom initially deflects rearward and then springs forward. Figure 10 shows the forward speed of the boom end, relative to the ground when the boom wheel was driven over the standard obstacles. Boom forward speed is important since the application rate is inversely proportional to speed (doubling the forward speed cuts the application rate in half). Assuming that the nozzle spray follows boom movement, the traces of speed in Figure 10 illustrate the resultant variation in application rates. High application rates occur at low speeds and low application rates occur at high speeds. Extremely high variations in application rate can result for short periods of time due to horizontal boom movement. For example, at a forward speed of 9 km/h (5.6 mph) driving over the 65 mm (2.6 in) obstacle caused boom speed to vary from 1 to 15 km/h (0.6 to 9.3 mph). Respective application rates would vary from 468 to 30 L/ha (41.7 to 2.7 gal/ac). This variation occurred in only 0.2 second during which time the sprayer travelled 500mm (20 in). Speed changes due to horizontal vibration were very similar on the FT 56 at all operating speeds.

The data presented in Figure 10 are based on the assumption that the nozzle spray output follows boom movement over very short periods of time (0.2 second). The extreme variations in application that are suggested due to boom movement indicate that more research is required on boom stability and its effect on nozzle discharge and spray distribution.

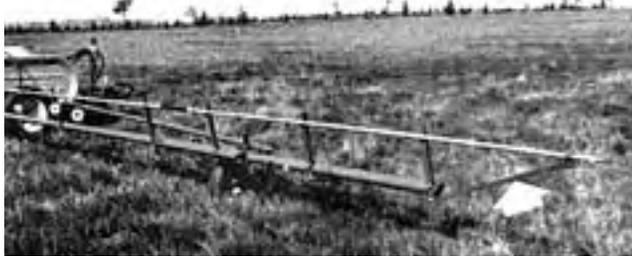
Figure 11. Boom End Braces.

Measurements of boom stability and field observations

indicated that the boom end braces (Figure 11) appreciably reduced boom movement at the boom end. The booms operated satisfactorily on rolling terrain and across gullies.

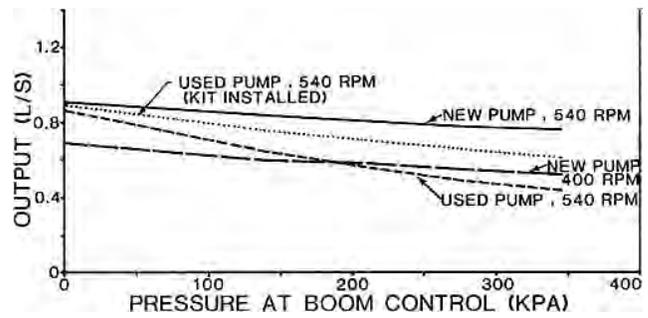
Figure 12. Pump Curves.

Agitation Capability: The pump, when new, had a total delivery of 0.78 L/s (10.3 gal/min) at 276 kPa (40 psi) and 540 rpm (Figure 12). This was adequate to apply 130 L/ha (11.6 gal/ac) of emulsifiable concentrates or 56 L/ha (5 gal/ac) of wettable powders

Operation at Reduced Speed: Figure 12 shows that reducing pump speed from 540 rpm to 400 rpm resulted in a 30% decrease in pump output. Reduction in pump speed could occur when reducing tractor speed to turn a corner or when operating at reduced engine speed to obtain a correct ground speed to suit nozzle calibration.

Pump Wear: Pump capacity decreased by 37% after 53 hours of field operation. The excessive reduction in capacity was attributed to wear caused by abrasive material in some of the water used for spraying.

The pump was disassembled and inspected for wear. The pump rollers were worn, but very little wear on the pump case was evident. After new rollers were installed, pump delivery was 16% lower than when it was new (Figure 12).

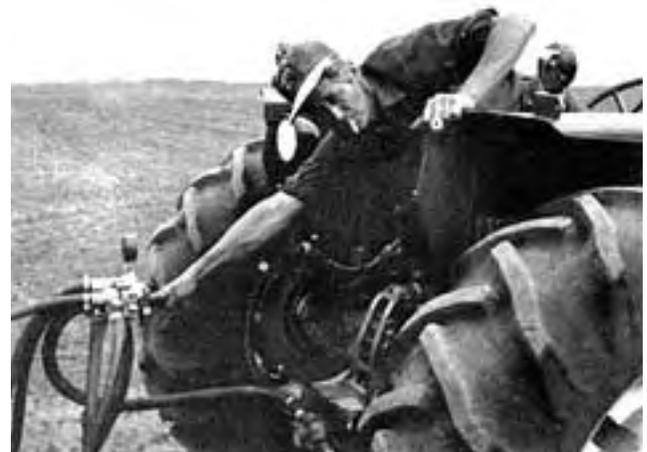
Figure 13. Awkward Location of Controls.

The pressure gauge was visible, however, controls were impossible to reach from the seat of most tractors (Figure 13). The pressure and boom controls should be relocated so that they can be reached from the tractor seat.

1. Supplying 80° nozzle tips as standard equipment.
2. Supplying finer (100 mesh) nozzle strainers for use with smaller capacity nozzle tips.
3. Supplying a finer (100 mesh) screen at the tank filler opening.
4. Relocating the controls so that they can be reached from the tractor seat.
5. Supplying a slow moving vehicle sign.
6. Providing calibration and servicing instructions in the operator's manual.
7. Modifications so the hitch ball can be attached securely to all tractor drawbars.
8. Modifications to prevent ball joint coupler failure.
9. Modifications to prevent boom support brace failure.
10. Modifications for trouble-free castor wheel service.
11. Modifications to prevent hose holder failure on the top of the tank.
12. Supplying a metric or dual calibrated pressure gauge or suitable conversion charts to facilitate sprayer operation after conversion to the SI system.

4. The control stand will be modified so that controls can be more easily reached from the tractor seat.
5. A bracket will be provided to which a slow moving vehicle sign can be attached.

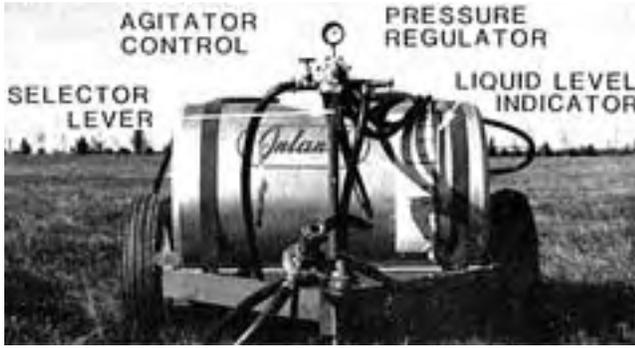
Figure 14. Controls.

Chemical flow to the booms was conveniently controlled with the selector lever (Figure 14). The tank liquid level indicator was easily read if the solution in the tank was opaque. With clear solutions such as Banvel, the level was difficult to read. The gauge was only a rough indicator of liquid remaining in the tank since operation on hills and movement of liquid in the tank caused the level in the tube

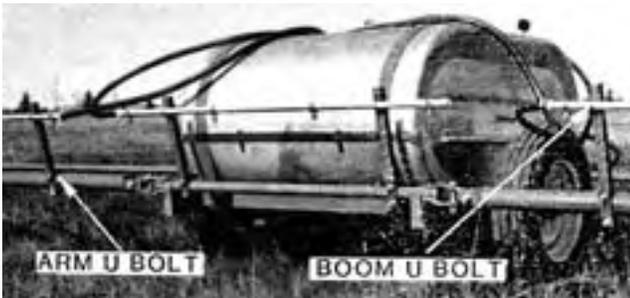
Figure 15. Boom Adjustments.

Boom Adjustment: Boom height was inconvenient to adjust. Removal and replacement of 14 boom U-bolts was required to adjust nozzle height (Figure 15). This was time consuming, even when specialized tools such as a deep socket and spinner were used. Nozzle angle adjustment required the loosening of the boom U-bolts and rotating the boom to the desired angle.

When directing the nozzles to spray ahead at 45°, the arm upright had to be rotated back on the boom support arm to prevent spray interference with the boom support arm. This caused interference with the center and outside booms when folding into transport. The arm upright had to be rotated up for transporting. This was inconvenient since 14 arm U-bolts (Figure 15) had to be loosened and tightened to rotate the arm upright.

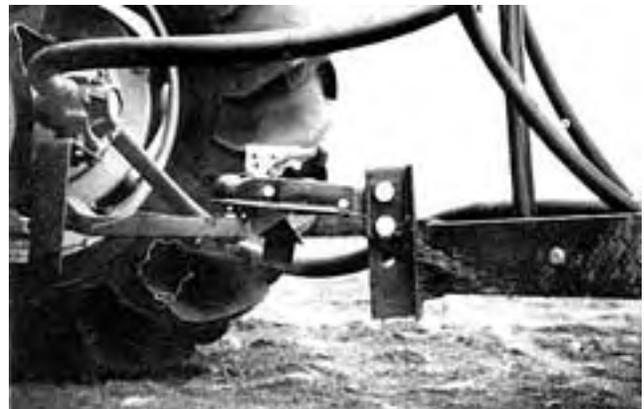
Figure 16. Weak Ball Joint Coupler.

Ball Joint Coupler: The ball joint coupler deformed at the bolt hole on top of the coupler (Figure 16). A reinforcing plate was welded to the top of the coupler. No further problems occurred.

6. Additional calibration and servicing information will be included in our instruction sheets.
7. The hitch ball bolt will be lengthened.
8. The ball joint coupler will be strengthened.

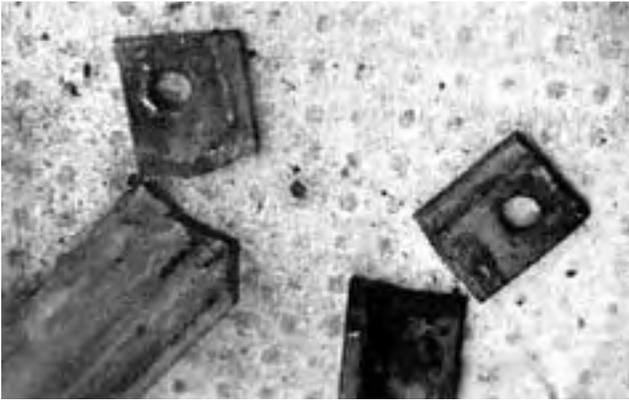
Figure 17. Boom Support Brace Failure.

Boom Support Braces: The boom end support braces (Figure 11) broke at the ends of the boom arms. Failure occurred at the notched out section of the angle iron brace (Figure 17). The braces were welded and reinforced.

9. The boom support brace has been modified and strengthened for 1977 sprayers.
10. Modifications, which have been made to 1977 sprayers are expected to overcome problems of wear on castor wheels.

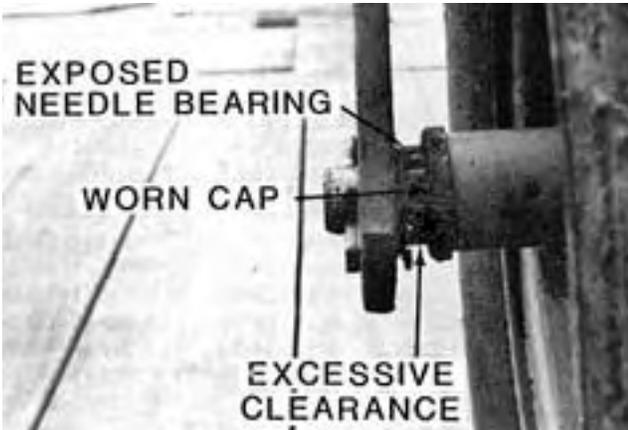
Figure 18. Worn Castor End Cap.

Castor Wheel End Cap: The castor wheel end caps wore due to excessive clearance between the castor wheel hub and castor fork. The hub moved back and forth on the spindle causing the castor end cap to wear and expose the bearing (Figure 18).

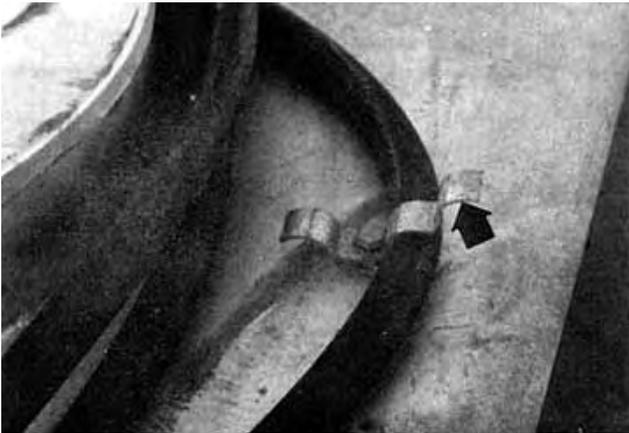
Figure 19. Hose Holder Deformation.

Hose Holder: The hose holder used to secure the boom hoses to the top of the tank was fabricated from light gauge steel, which bent easily (Figure 19). When the hose holder bent, the hoses fell out of the clamp. Modifications are required.

11. The hose holder at the top of tank will be fabricated from heavier material.
12. The availability of a dual calibrated pressure gauge will be discussed with the gauge supplier.
