# Evaluation Report

# 598

## Spraymaster Model GN 40-60 Field Sprayer

# SPRAYMASTER MODEL GN 40-60 FIELD SPRAYER

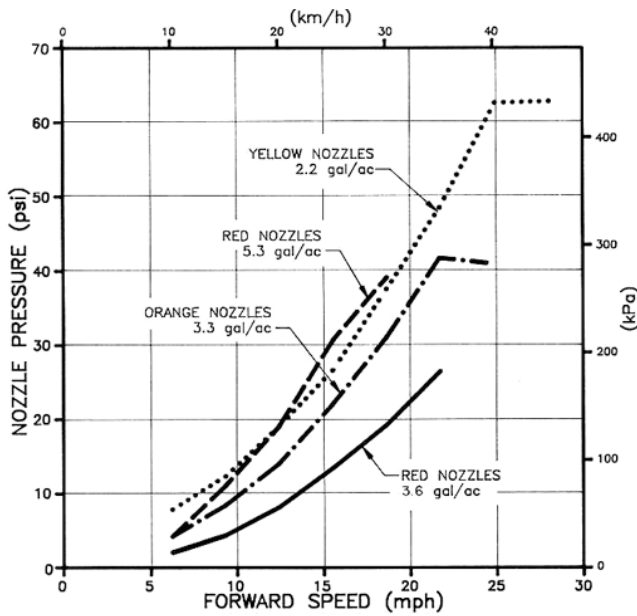
Changing forward speed also changed nozzle pressure. FIGURE 3 shows resulting nozzle pressures at various forward speeds using different sized nozzles and application rates. Nozzle pressure increased as forward speed increased. Forward speed used depended on field conditions, workrate required and desired nozzle pressure for proper spray droplet size and distribution patterns. To ensure proper spray deposition characteristics, forward speed should be adjusted to operate at nozzle pressures between 15 and 44 psi (100 and 300 kPa). Unacceptable spray distribution patterns occurred at nozzle pressures below 15 psi (100 kPa). FIGURE 4 shows a typical, spray distribution pattern along the boom using Albus yellow nozzle tips at pressures of 15 psi (100 kPa). The coefficient of variation (CV)<sup>1</sup> was 20%, with application rates along the boom varying from 1.2 to 3.4 gal/ac (13 to 38 L/ha). Operating at nozzle pressures above 43.5 psi (300 kPa) could result in excessive spray drift and evaporation due to smaller droplet sizes.

FIGURE 3. Nozzle Pressure At Various Forward Speeds Using Yellow, Orange and Red Nozzle Tips.

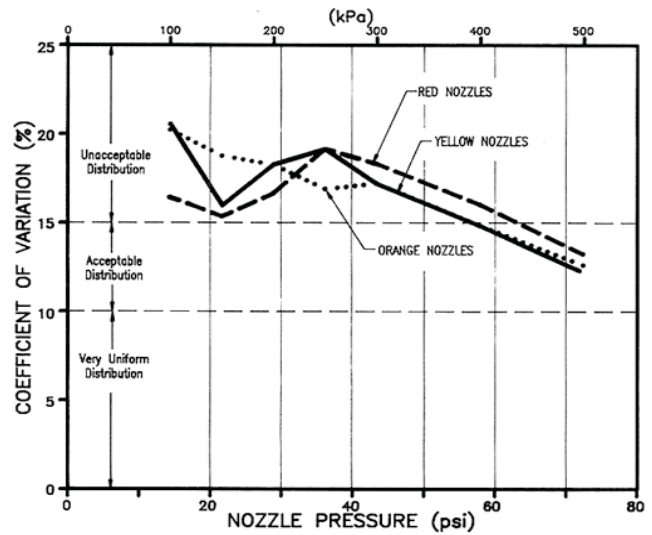
**Distribution Patterns:** Nozzle spray distribution patterns were fair. FIGURE 6 shows nozzle spray pattern uniformity for the 110 degree Albus yellow, orange and red nozzle tips. The spray distribution pattern coefficient of variation varied from 12.3 to 20.2%. The nozzles produced unacceptable spray distribution patterns between 15 and 44 psi (100 and 300 kPa). The nozzles had to be operated above 55 psi (379 kPa) to produce acceptable spray distribution patterns. The Spraymaster could not produce nozzles pressures above 55 psi (379 kPa) at application rates above 2.2 gal/ac (25 L/ha).

FIGURE 6. Spray Pattern Uniformity for Albus Yellow, Orange and Red 110 Degree Ceramic Nozzles Operated at a 15.7 in (400 mm) Nozzle Height.

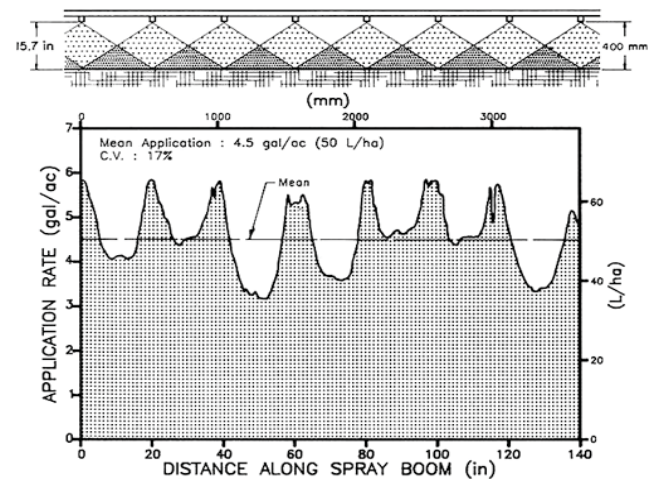
FIGURE 7 shows a typical spray distribution pattern along the boom operating Albus red nozzles at a normal nozzle pressure of 43.5 psi (300 kPa) pressure and a 15.7 in (400 mm) nozzle height. The coefficient of variation was 17%, with application rates along the boom varying from 3.1 to 5.7 gal/ac (35 to 64 L/ha). High spray concentrations occurred below the nozzles and was rated unacceptable. It is recommended the manufacturer modify nozzle spacing and height to produce acceptable spray distribution patterns at pressures between 15 and 44 psi (100 to 300 kPa).

FIGURE 7. Typical Spray Distribution Pattern Along the Boom at a 44 psi (300 kPa) Nozzle Pressure Using Albus Red Ceramic Nozzles, at an 15.7 in (400 mm) Nozzle Height.

1. Modifying nozzle spacing and height to produce acceptable spray distribution patterns at pressures between 15 and 44 psi (100 to 300 kPa).
2. Indicating actual nozzle pressure at the remote console pressure indicator.
3. Modifications to prevent the front agitator from plugging.
4. Modifications to make it easier to adjust nozzle height.
5. Modifying the foam marker system to improve operator convenience when filling with water and foam concentrate.
6. Modifying the line strainer plumbing components to prevent leaking and valve failure.
7. Modifying the chemical inductor for easier handling and better durability.
8. Modifying the boom skid assembly to prevent the lock collars from loosening.
9. Modifying the motor to prevent stalling and to improve starting.

1. We recommend that the sprayer boom be operated at a 12 - 14 in height above the target. The manufacturer of the nozzle recommends that Albus nozzles be operated at pressures between 20 and 60 PSI to ensure accurate spray patterns and accurate double overlap at the target area. In addition the ball check valves in the nozzle body assemblies have been replaced with diaphragm units to reduce the pressure at the nozzle.

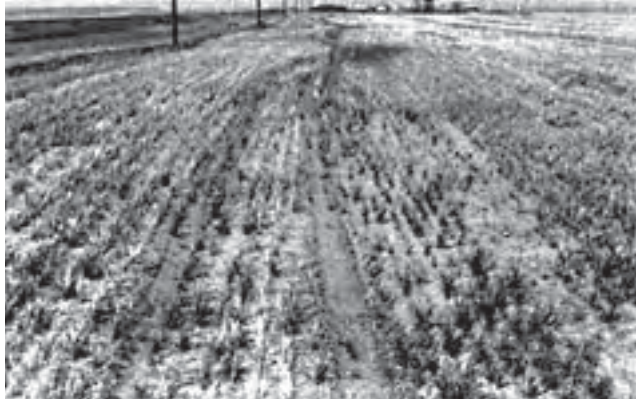
**Weed Control:** Weed control was good. General field observations indicated weed control was reduced in and around the wheel tracks, boom leaf spring skids and boom ends. The truck and sprayer wheels created excessive dust. The dust reduced the chemical's effectiveness. FIGURE 8 shows voluntary crop in and around the wheel tracks after spraying the non-selective chemical Sweep on a summerfallow field.

FIGURE 8. Weed Control In and Around Wheel Tracks.

The boom skid and foam discharge hoses interfered with the nozzle spray. The spray interference contributed to the poor weed control in the boom skid and boom end vicinities.

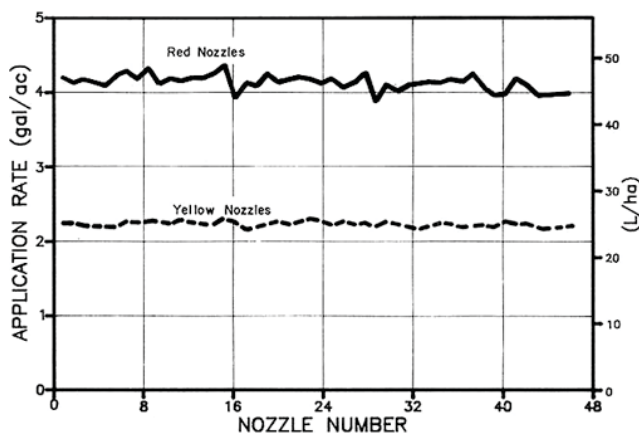
**System Pressure:** System pressure variations, losses and nozzle pressure indication accuracy were excessive and rated as fair. Pressures in the plumbing system were measured at the pump, controller and booms using the yellow, orange and red sized nozzles. Nozzle pressures at the left boom were higher than at right boom, resulting in higher application rates (FIGURE 9). The pressure difference was negligible using the low volume yellow nozzles, but significant using the high volume red nozzle tips.

FIGURE 9. Application Rate Along the Boom Using Albus Yellow and Red Nozzle Tips.

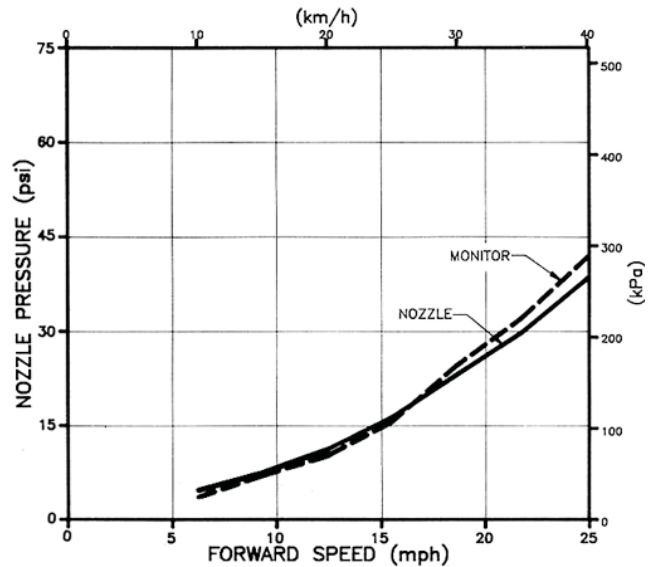
The pressure gauge on the sprayer was accurate. The remote control console pressure indicator received with the sprayer was inaccurate and was replaced. The new pressure indicator was accurate and reliable throughout the rest of the test. However, the pressure indicator in the remote control console did not indicate nozzle pressure. This pressure difference affects nozzle spray distribution patterns and droplet size since it was not detected by the sprayer pressure indicator. FIGURES 10 and 11 show actual nozzle pressure and the pressure indicated by the remote control console using the yellow and red nozzles at 2.2 and 4.5 gal/ac (25 and 50 L/ha), respectively. The pressure difference was more significant at the high application rates. For example, at 18.6 mph (30 km/h), the actual nozzle pressure was 30.7 psi (212 kPa) using

the high volume red nozzles. The console pressure indicated 40.6 psi (280 kPa). Therefore the operator had to increase forward speed to operate about 10 psi (70 kPa) higher than indicated to obtain the desired spray nozzle pattern and droplet size. It is recommended the manufacturer make modifications to indicate actual nozzle pressure at the remote console pressure indicator.

FIGURE 10. Actual Nozzle and Indicated Pressure Using Albus Yellow Nozzles at 2.2 gal/ac (25 L/ha).

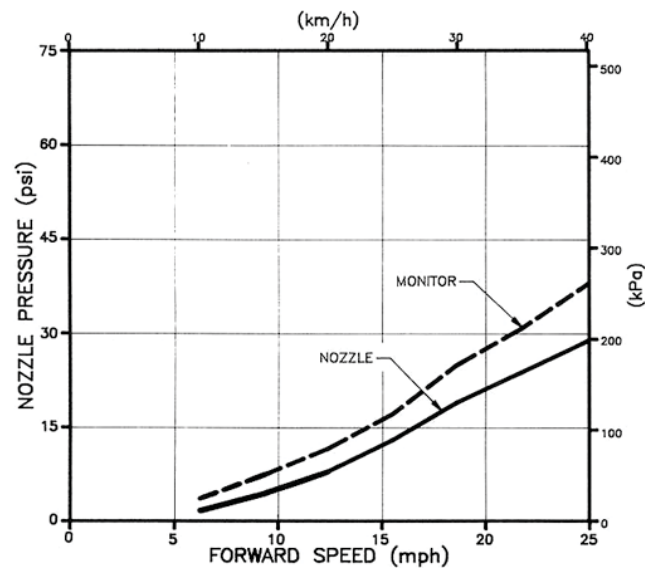
FIGURE 11. Actual Nozzle and Indicated Pressure Using Albus Red Nozzles at 4.5 gal/ac (50 L/ha).

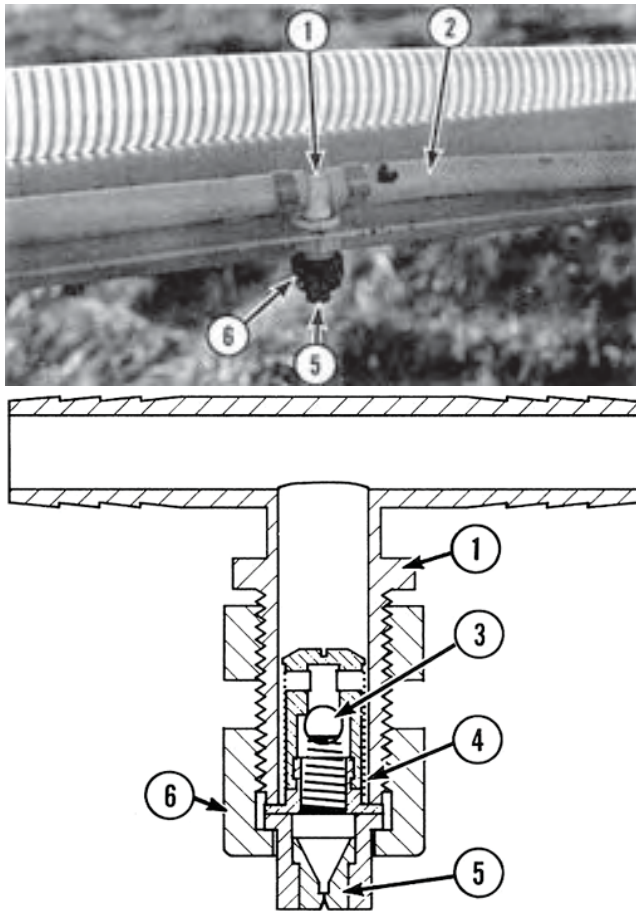
FIGURE 13. Hose Shank Nozzle Assembly: (1) Double Hose Connection (2) Spray Boom, (3) Check Valve, (4) Strainer, (5) Nozzle Tip, and (6) Threaded Nozzle Cap.

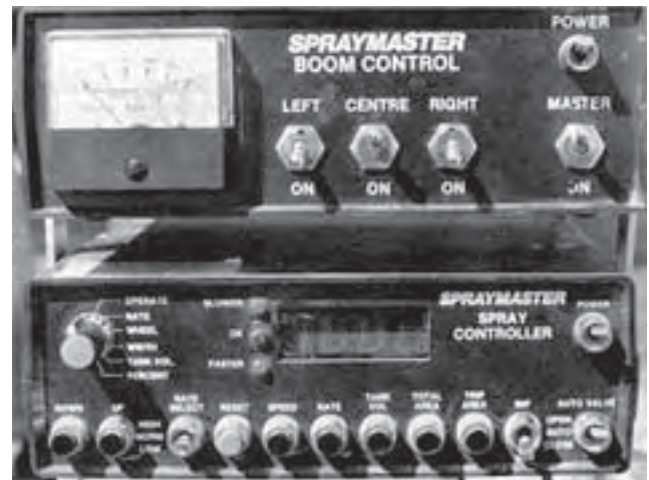
**Controls:** Ease of operating the controls was good. The Computronics International remote control and automatic rate controller consoles (FIGURE 14) were designed to operate from the truck seat. The remote control console included a pressure indicator to monitor nozzle pressure and boom solenoid valve switches to control flow to the booms.

FIGURE 14. Computronics International Remote Control (upper) and Automatic Application Rate Controller Consoles (lower).

The Computronic controller was easy to use following the instructions in the operator's manual. The controller displayed application rate, forward speed, tank volume, total area sprayed, trip area and stored five calibration numbers to automatically control application rate. The wheel calibration number was the sprayer wheel circumference. The wheel circumference measurement required another operator to count the wheel revolutions. Once the calibration numbers were entered in the metric mode, readout could be either metric or imperial.

The Computronic controller 4-digit LED display screen was easy to read unless it faced direct sunlight. The push buttons, dials and switches were small and difficult to use in rough field conditions.

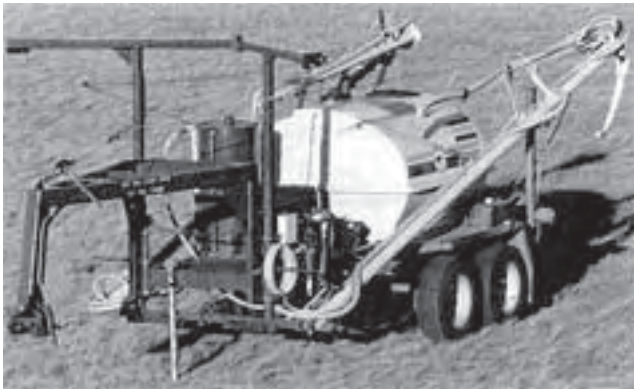
**Boom Positioning:** Ease of boom positioning was good. The Spraymaster booms were folded into transport (FIGURE 15) or placed into field position in about three minutes. Care had to be exercised to prevent getting tangled in the ropes while placing the booms into field position. One boom had to be secured on the boom rest pad before folding or unfolding while placing the other boom. The boom had to be completely lifted off the rest pad to prevent nozzle body damage (FIGURE 16).

FIGURE 15. Spraymaster in Transport Position.

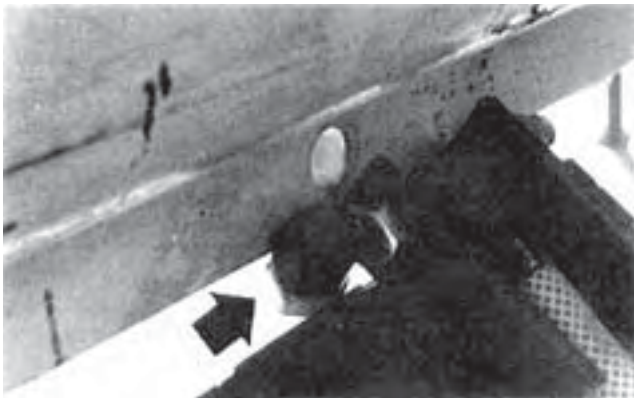
FIGURE 16. Damaged Nozzle Assembly.

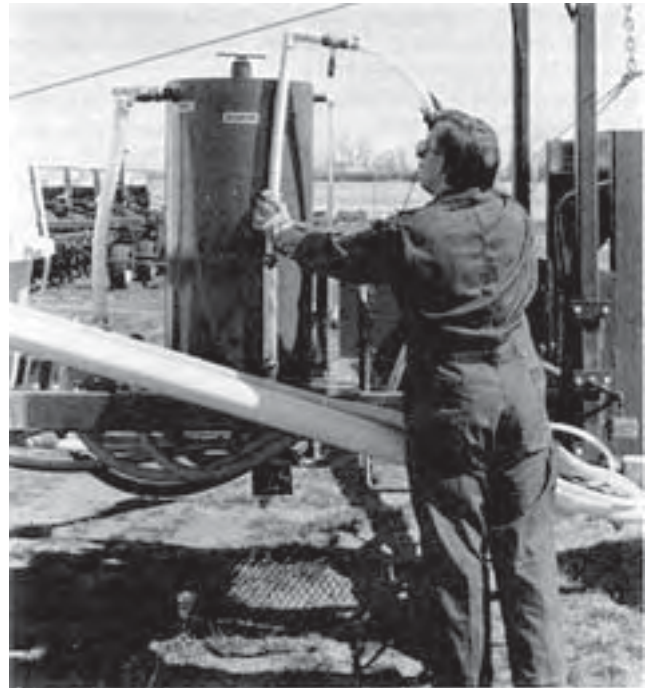
The chemical induction wand stored high on the foam marker tank and was difficult to remove and insert. In addition, the bottom portion of the wand was handled when removing or inserting the wand, exposing the operator to the chemical residue (FIGURE 17).

FIGURE 17. Operator Using Chemical Inductor Wand.

The chemical inductor wand elbow failed. The chemical inductor wand was difficult to manoeuvre into a chemical container since the hose restricted movement, causing the PVC elbow to fail. It is recommended the manufacturer modify the chemical inductor wand for easier handling and better durability.
