Evaluation Report

736

Spracoupe Model 3630 High Clearance Field Sprayer

Spra-Coupe Model 3630 High Clearance Field Sprayer

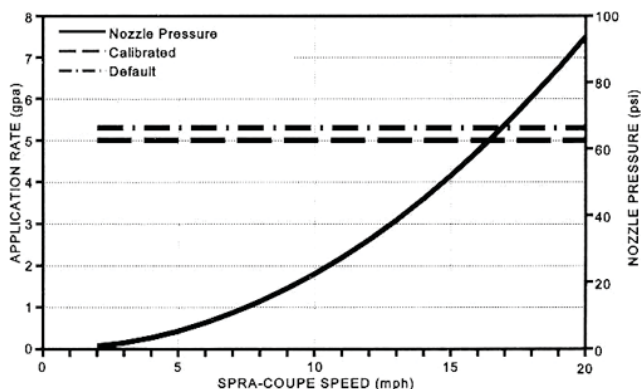
Figure 2 shows application rates with the controller programmed to apply 5 gpa (55 L/ha) with the original flow sensor number and after calibrating the flow sensor. With the original flow sensor number, application rate remained constant over a wide range of forward speeds, but was 6% greater than the actual rate. For example, at 14.4 mph (23 km/h), the actual application rate was 5.3 gpa (59.6 L/ha), compared to 5.0 gpa (55.0 L/ha) displayed on the monitor. Calibrating the flow sensor improved accuracy to within 1% of the desired rate, **Figure 2**. For example, changing the flow sensor number to 199 from 188, the application rate displayed on the monitor matched the desired rate of 5 gpa (55 L/ha).

Figure 2. Application Rate and Nozzle Pressure at Various Speeds with the Spra Controller Programmed to Apply 5 gpa (56L/ha).

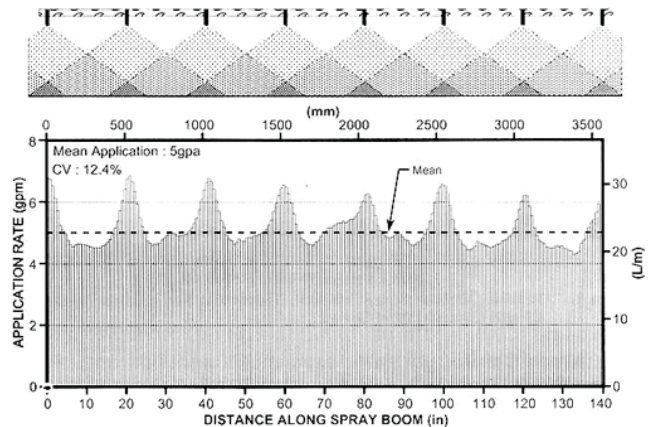
spray distribution pattern coefficient of variation (CV)² was 2.3%. Application rates along the boom varied from 4.1 to 6.6 gpa (47 to 74 L/ha) at 15 mph (24 km/h) with standard 03-F110 tips. The spray distribution pattern coefficient of variation (CV) was 12.4%. Patterns from both nozzle types were acceptable; however, the Turbo Tee Jet nozzles eliminated the high concentration of spray below each nozzle tip that are typical of standard fiat fan nozzles.

Figure 5. Spray Distribution Along the Boom at 40 psi (275 kPa) with Lurmark's Standard 03-F110 Plastic Nozzle Tips Operated at 18 in (460mm) Height and 15 mph (24 km/h).

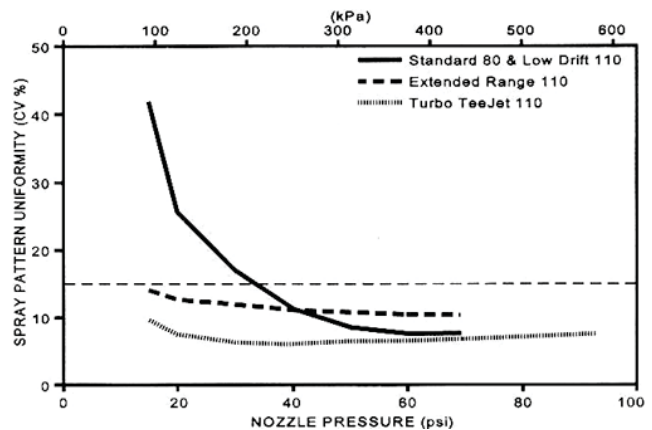
Figures 6 and 7 show how nozzle height and pressure affected spray pattern uniformity for the turbo fiat fan nozzles. The CV results are compared to previously tested fiat fan nozzle tips. The previously tested fiat fan nozzles included standard, extended range and low drift nozzles. As nozzle height and pressure increased, spray patterns improved with all the fiat fan nozzles. The low drift nozzles had similar spray pattern characteristics as standard 800 nozzles. That is, the nozzles produced acceptable spray patterns (CV less than 15%) when operated above 16 in (400 mm) and 35 psi (250 kPa). Like the extended range nozzle, the Turbo Tee Jet nozzle tips produced acceptable spray patterns at all nozzle heights and pressures tested. Both types of nozzles could be operated at pressures as low as 15 psi (100 kPa) and heights as low as 9 in (225 mm). As shown in Figure 2, low pressures frequently occurred operating the automatic rate controller at reduced spraying speeds.

Figure 6. Spray Pattern Uniformity for Spraying Systems Turbo Tee Jet (TT) and Extended Range (XR) Nozzles and Lurmark's Standard and Low Drift (SD) Nozzles Operating at Various Pressures.

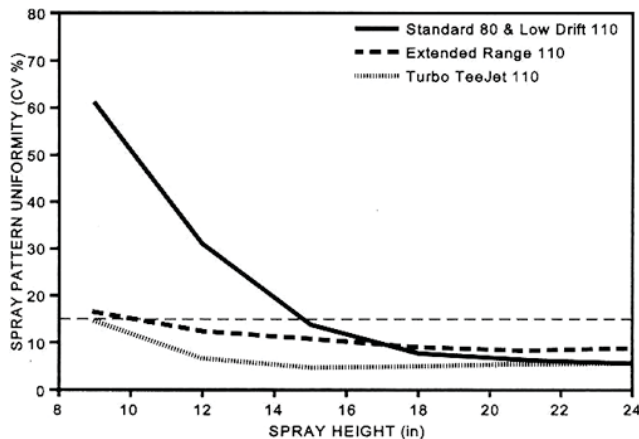
Figure 7. Spray Pattern Uniformity for Spraying Systems Turbo Tee Jet (TT) and Extended Range (XR) Nozzles and Lurmark's Standard and Low Drift (SD) Nozzles Operating at Various Heights.

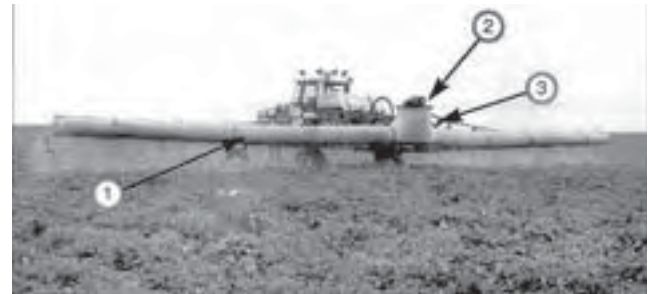
An air-assist system, Figure 8, was installed on the Spra-Coupe 3630 to decide the air system's potential as a drift reduction system when spraying at high speeds and spray heights. As shown in Table 4, the air system increased spray drift by 5%. Spray drift

increased from 15 to 20% in a 20 km/h crosswind. Applicators using air-assist systems strictly for controlling spray drift are cautioned. The air system will be retested at a different set-up to increase its potential as a spray drift reduction device.

Figure 8. Kyndestoft Airbag (1) Airbag (2) Fan Motor and (3) Fan Housing.

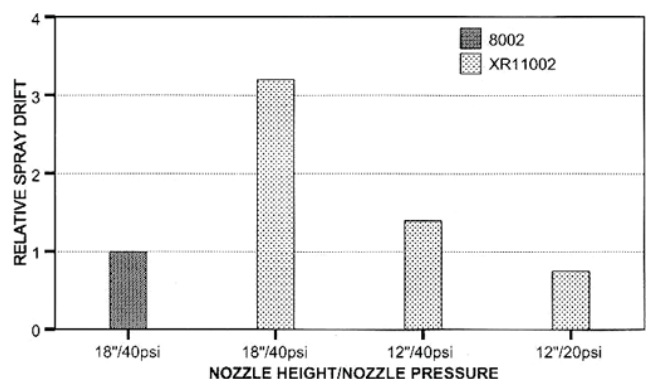
Figure 9 shows spray drift reduced to acceptable levels at low nozzle pressures and heights. Tests were conducted in AFMRC's wind tunnel at a speed of 20 mph (32 km/h). The boom was static and perpendicular to the wind. At 40 psi (275 kPa) and 18 in (460 mm) spray drift from the 1100 Extended Range XR11002 nozzles was 3 times higher than standard 8008002 nozzles. Studies show 110° Extended Range nozzles produce a higher percentage of droplets less than 150µ, than 800 nozzles of the same size. Spray droplets less than 150µ, are more susceptible to drift. A lower percentage of susceptible droplets were produced operating the XR11002 nozzles at 20 psi (140 kPa). Operating the XR11002 nozzles at 20 psi (140 kPa) and 12 in (305 mm) reduced spray drift to acceptable levels. As shown in Figures 5 and 6, XR11002 nozzles were operated at low nozzle pressures and heights without adverse effects on spray patterns. Operating the 110° Turbo Tee Jet nozzles at low heights and pressures to reduce spray drift was also possible.

Figure 9. Relative Airborne Spray Drift from Tee Jet Flat Fan Nozzles Operated in 20 mph (32 km/h) Wind Speeds.

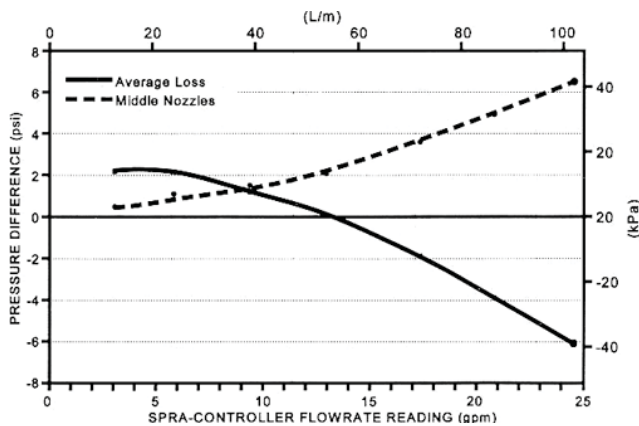
Figure 10. Pressure Difference from Pressure Source and Middle Nozzles.

Pressure in the middle boom nozzles was higher than the left and right boom nozzle pressures. This pressure difference depended on spraying flow rate as shown in **Figure 10**. At spraying flow rates less than 20 gpm (90 L/min), the nozzle pressures at the middle boom were within 3 psi (20 kPa) of the left and right boom nozzle pressures.

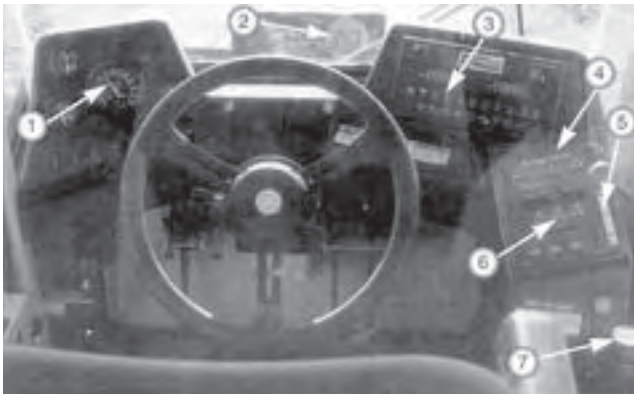
Instruments: Instruments were useful and rated as **good**. All the gauges were easy to see and read. Most instruments were to the right of the operator, **Figure 13**. The instrument panel included gauges for engine oil pressure, coolant temperature, engine hours, engine speed and fuel level, plus warning lights for parking brake, alternator, glow plugs and transmission temperature. The panel was lit by a white or red dome light. The nozzle pressure gauge was on top of the engine hood, just outside the front window, which was lit by a white light.

Figure 13. Spra Coupe's Console Layout (1) Instrumentation Console (2) Pressure Gauge (3)Raven Spra controller Console (4)Foam Marker Controls (5) Hand Throttle Lever (6) Boom Control Console and (7) Shift Lever.

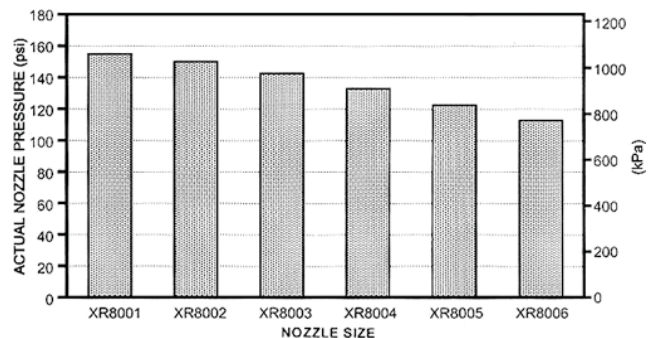
Figure 16 shows the maximum nozzle pressures available for various nozzle sizes. The maximum nozzle pressure available decreased as the nozzle size increased. For example, the maximum nozzle pressure was 155 psi (1070 kPa) for an XRS001 nozzle and 113 psi (780 kPa) for an XRS006 nozzle. The decrease was insignificant because the pressures were still above the standard spraying pressure of 40 psi (275 kPa). With the additional spraying pressures, the automatic rate controller worked better with wide angled nozzle tips. With the wide angle 1100 extended range or turbo nozzles, slowing by gearing down was possible.

Figure 16. Maximum Nozzle Pressures at Maximum Engine Speed.

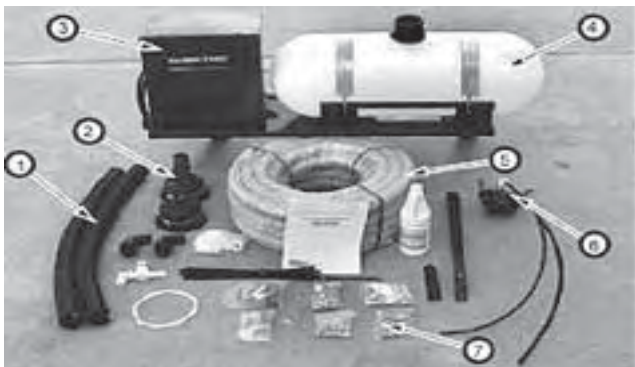
The foam discharge tubes hit the ground frequently during spraying moving the tubes into the spray at the end nozzles. Tightening the foam discharge tube support brackets did not help. Over tightening caused damage to the spray boom ends. **AFMRC recommends the manufacturer modify the foam discharge tubes to prevent them from interfering with the spray.**

Figure 17. Richway Industries Model SG3013 Foam Marker 1) Foam Discharge Tubes, 2) Foam Discharge Boots, 3) Compressor, Filter and Control Valve Housing, 4) Foam Tank, 5) Foam Carrier Hoses, 6) Foam Tank Cap and 7) Hardware.

8. Modify the foam discharge tubes to prevent them from interfering with the spray.
9. Modify the marker system to make it easier to fill and maintain.
10. Modify the Spra-controller to prevent the flow sensor from failing.
