Evaluation Report

198

Massey Ferguson 360 Wide Level Disk Harrow

MASSEY FERGUSON 360 WIDE LEVEL DISK HARROWS

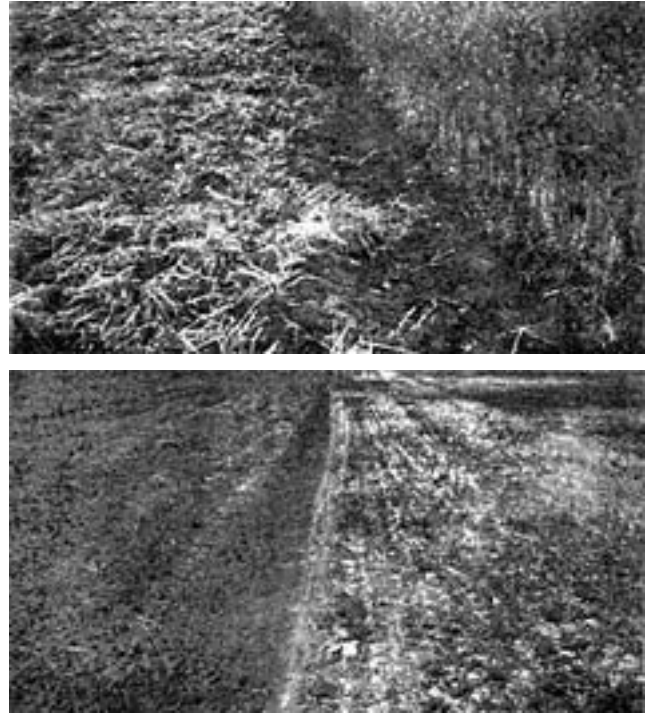
FIGURE 3. Soil Surface after Seeding into Stubble: (Top: Heavy Trash Cover, Bottom: Light Trash Cover).

Seed Placement: Seed placement was good in most field conditions. At speeds up to 8 km/h (5 mph), seeds were placed near the bottom of each furrow and uniformly covered with soil. Higher speeds caused some seed scattering. In very trashy fields, seeds were placed amidst the trash if the disks failed to cut through it. If the trash was cut by the disks, the seeds were placed on the soil at the furrow bottom, and covered by a loose mixture of soil and trash. As is characteristic of all disk harrows, soil was not compacted firmly about the seeds. It is important that packers be used after seeding, especially in dry, loose or trashy soils, to aid seed germination and plant growth. Seed placement in rough, undulating fields was variable. In the bottom of steep ravines or gullies, seed was placed on the soil surface as the disks were unable to follow sharp variations in ground contour.

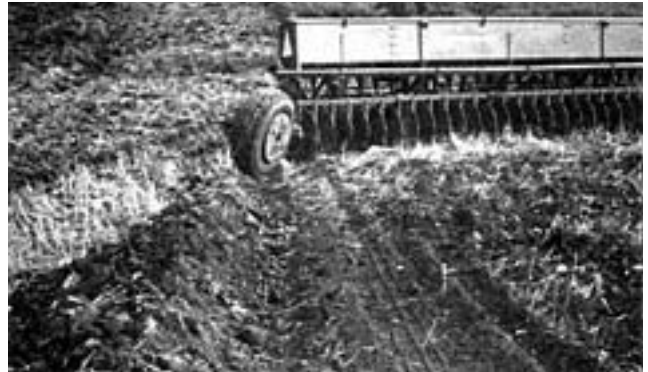
Stability of the Massey Ferguson 360 was good in most field conditions, provided the optional rear furrow wheel weights were used. Stability can be improved by adding calcium chloride to the tires, by operating at reduced speeds, by reducing the tillage depth and by increasing the disk angle. In nonuniform level fields, width of cut varied up to 150 mm (6 in) and sideways movement of up to 250 mm (10 in) occurred due to variations in soil hardness. When operating on side slopes up to 8°, the width of cut varied up to 550 mm (22 in) and sideways movement of up to 600 mm (24 in) occurred. When operating down slopes of 8° to 15°, width of cut varied by as much as 1000 mm (39 in) with the rear wheel leaving

the furrow (FIGURE 4). The disk harrows were much more stable when tilling uphill or on a hillside sloping down to the right than when tilling downhill or on a hillside sloping down to the left.

FIGURE 4. Rear Furrow Wheel Leaving the Furrow when Operating Downhill.

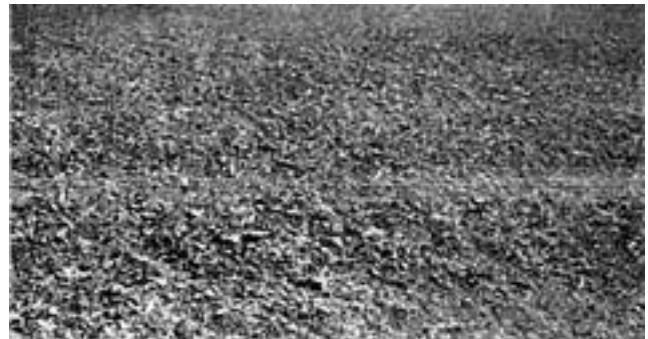
Ridging: The Massey Ferguson 360 usually produced an even seedbed with a uniform soil surface (FIGURE 5), providing it was properly adjusted and the tractor driven at a steady speed and a consistent distance from the furrow. Slight ridging occurred on right turns, or on hillsides.

FIGURE 5. Uniform Soil Surface after Tilling.

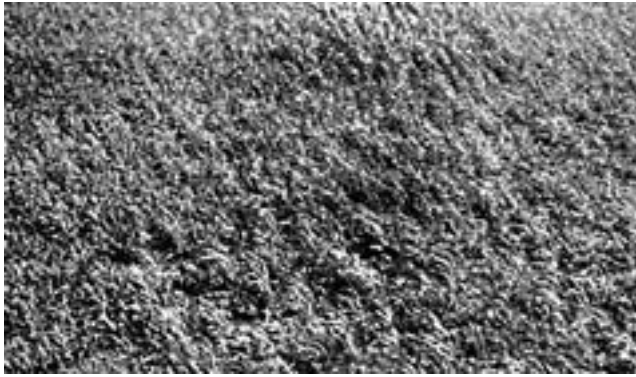
Seed Emergence: Seed emergence was uniform (FIGURES 6 & 7) in all fields with sufficient moisture and nutrient reserves. Emergence was delayed in dry fields. Skips or unseeded strips were evident only on steep hillsides or where the operator had failed to

FIGURE 6. Neepewa Wheat 33 Days after Seeding Into Stubble. Moisture Conditions were Average.

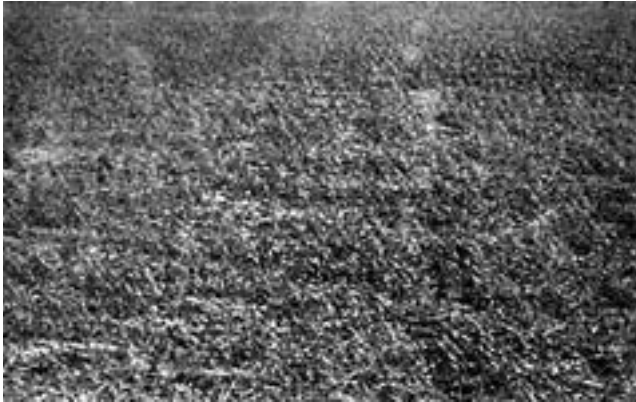
FIGURE 7. Klages Barley 34 Days after Seeding into Stubble. Moisture Conditions were Average.

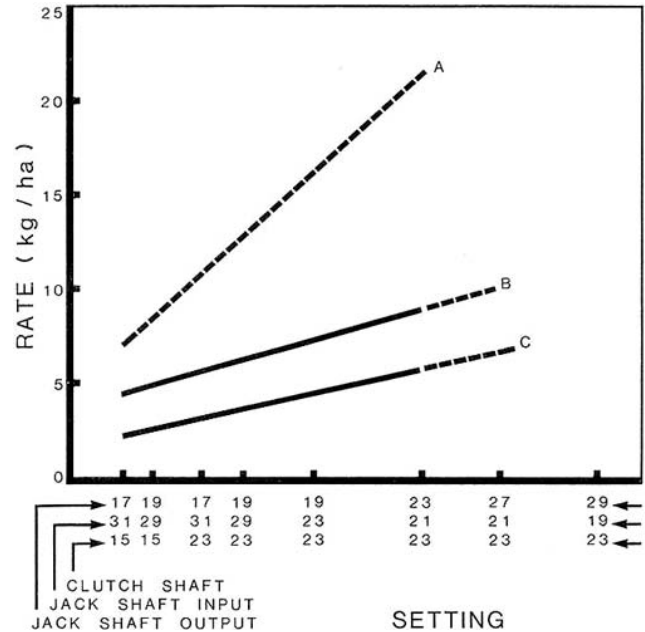
Seed metering system accuracy was very good in wheat, barley and oats and was fair in rapeseed. The manufacturer's calibration charts for wheat, barley and oats were accurate when using standard density seed. The manufacturer's calibration for rapeseed (FIGURE 9) was inaccurate, indicating nearly twice the actual seeding rate. Large differences in the seeding rates also occurred between rapeseed that had been treated with Vitavax and untreated rapeseed. These differences are attributed to the flow properties of seed through the seed cup inserts that are used for all small seeds. It is recommended that the manufacturer consider modifications to the seed cup inserts to reduce the effect of seed properties on the seeding rates of small seeds.

FIGURE 9. Rapeseed Calibration with Normal Speed Grain Drive: (A) Manufacturer's Calibration 625 kg/m³ Seed Density, (B) Untreated Regent Rapeseed 612 kg/m³ Seed Density and (C) Treated Regent Rapeseed 598 kg/m³ Seed Density.

1. Modifying the seed cup inserts to reduce the large variations in the seeding rates obtained when seeding rapeseed with different physical properties.
2. Including in the operator's manual, information on the use and installation of the seed cup inserts and the slow speed grain drive attachment.

1. We will investigate the seed rate variations in rapeseed and will recalibrate and revise the rate charts where required.
2. The additional information will be included in the next printing of the operator's manual.

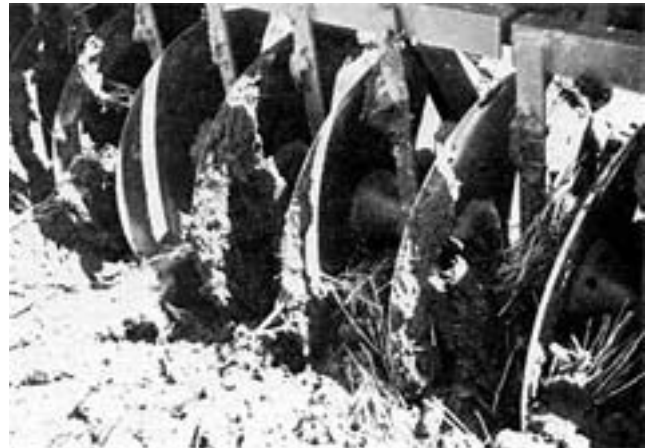
Wet Fields: Mud buildup on the disks and loose trash occasionally caused disk plugging in wet fields. Plugging occurred more readily in heavy trash areas where bunched straw was pushed ahead of the gangs.

The rock deflectors reduced plugging, but did not prevent mud from clinging to the disks (FIGURE 11). Optional disk scrapers reduced the mud buildup in moist soils, but did not completely prevent plugging in wet soils. As is common with most one-way disk harrows, plugging occurred more readily at reduced widths of cut.

FIGURE 11. Mud Buildup on Disks when Operating in Wet Fields.

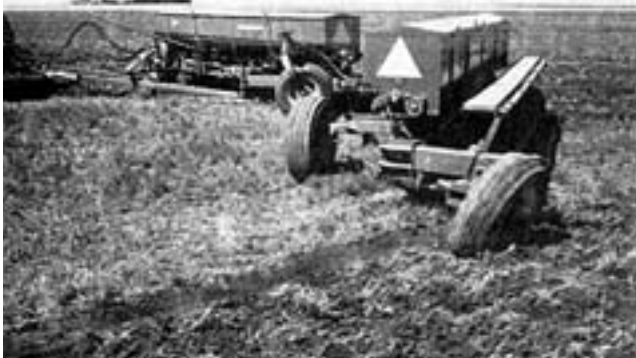
Turning: Sharp left turns were easily made (FIGURE 12). Tilled corners were smooth and could easily be covered by two

passes when finishing the field. When a left turn was being made, the sudden tightening of the hitch cable pulled the front disk harrow about 300 mm (12 in) to the left.

FIGURE 12. Disk Harrows Midway Through a Left Turn.

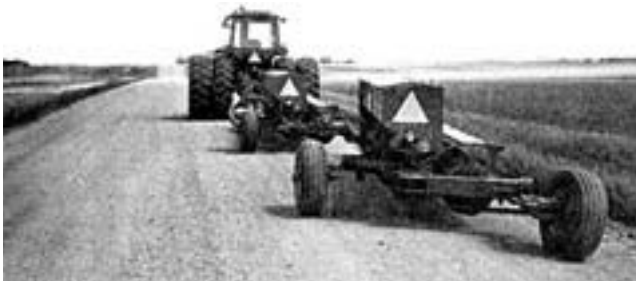
Transporting: The Massey Ferguson 360 could be safely transported at speeds up to 25 km/h (15 mph) when in full transport position, providing the seed and fertilizer boxes were empty. It could be put into full transport position by one man in about 15 minutes. A jack was usually needed to place the front and rear furrow wheels in the upright position. It was very difficult for one man to lift the heavy hitch onto its transport holder. Transport width was narrow enough to allow most vehicles to pass on secondary roads (FIGURE 13).

FIGURE 13. Full Transport Position.

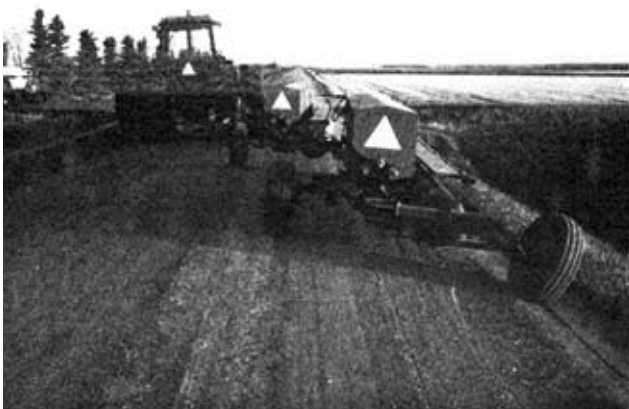
The Massey Ferguson 360 could be placed into semi-transport position by one person in about 5 minutes. It was difficult to transport in this position, because the overall width of the machine and the tractor (FIGURE 14) made travel along some roads very precarious and the passing of vehicles difficult. Interference between the tractor tire and the hitch brace made it difficult to make right turns when in semi-transport position (FIGURE 15). The semi-transport width could be reduced and the tractor tire clearance increased by adjusting the land wheel and the steering link on the lead harrow.

FIGURE 14. Semi-Transport Position.
