# Evaluation Report

# 297

## Leon S-45 Air Seeder

# LEON S-45 AIR SEEDER

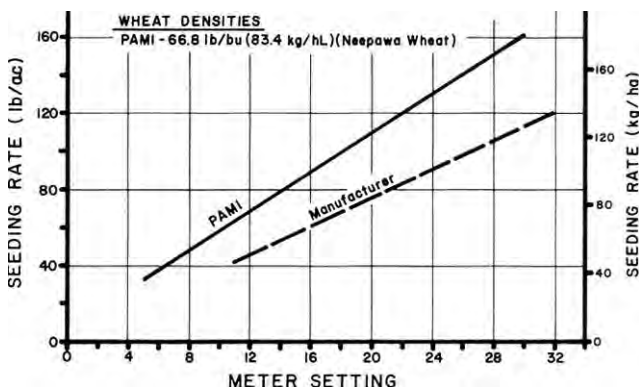
FIGURE 2. Metering Accuracy in Wheat.

**Metering Accuracy:** The grain and fertilizer metering system was calibrated in the laboratory<sup>1</sup> and compared with the manufacturer's calibration. Since actual seeding rates for certain settings depended on things such as seed size, density and moisture content, it is not possible for a manufacturer to present charts to include all the varieties of seed. Field calibration checks may be necessary for seed with properties differing from those used in establishing the manufacturer's charts. Research has, however, shown that small variations in seeding rates will not significantly affect grain crop yields.

The seed densities used by the manufacturer for meter calibration were not given. It is recommended that they be included to permit the operator to compare seed densities to determine if field meter calibrations are necessary. Calibration curves for wheat, barley, oats and fertilizer are given in FIGURES 2 to 5. PAMI's calibration curves are compared to curves based on the manufacturer's calibration charts. Considerable differences were found between the manufacturer's and PAMI's calibrations. For example, at a seeding rate of 60 lb/ac (67 kg/ha), PAMI's measured rates were 50% higher than the manufacturer's calibration in wheat and 95% higher than the manufacturer's calibration in barley. At a seeding rate of 45 lb/ac (50 kg/ha), the measured rate was 100% higher than the manufacturer's indicated rate in oats. At an application rate of 26 lb/ac (29 kg/ha), PAMI's measured rate in 11-51-00 fertilizer was 73% higher than the manufacturer's indicated rate while at an application rate of 103 lb/ac (116 kg/ha) the measured rate was 41% higher than the manufacturer's indicated rate. It is recommended that the manufacturer provide improved metering calibration charts for wheat, barley, oats and fertilizer.

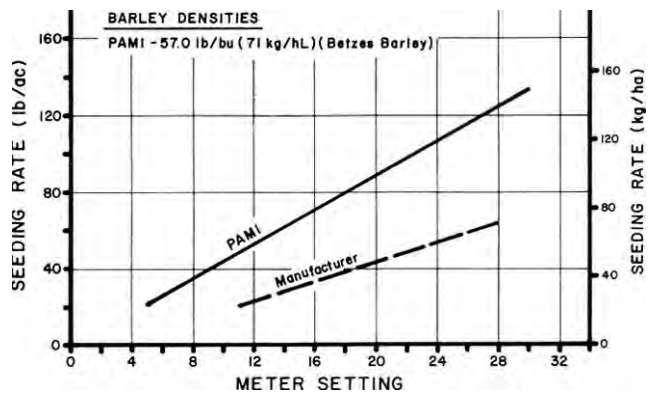
FIGURE 3. Metering Accuracy in Barley.

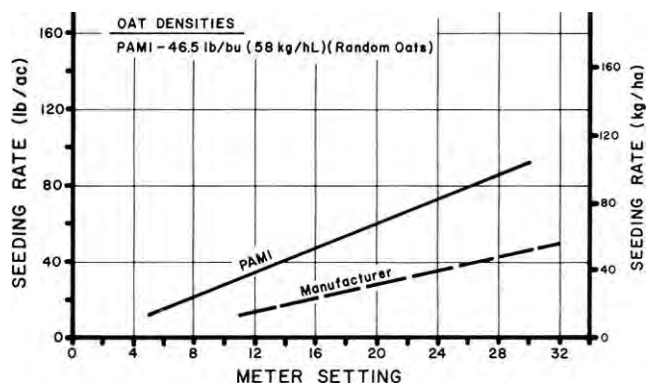
FIGURE 4. Metering Accuracy in Oats.

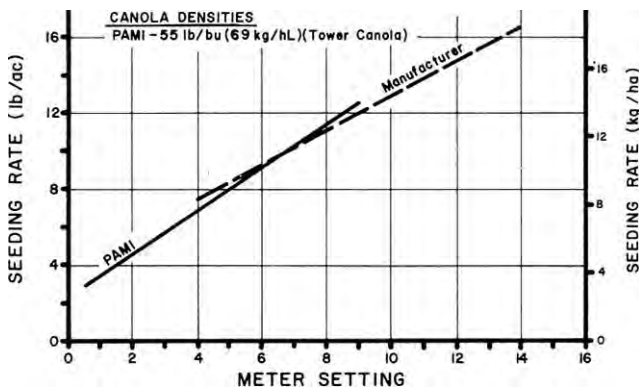
The calibration curves for canola are given in FIGURE 6. The manufacturer's meter calibration chart for canola did not include rates below 7.4 lb/ac (8.3 kg/ha). At application rates from 7.4 to 12.5 lb/ac (8.3 to 14.0 kg/ha) the manufacturer's calibration for canola was fairly accurate. It is recommended that the manufacturer provide an expanded chart for lower application rates in canola.

FIGURE 6. Metering Accuracy in Canola.

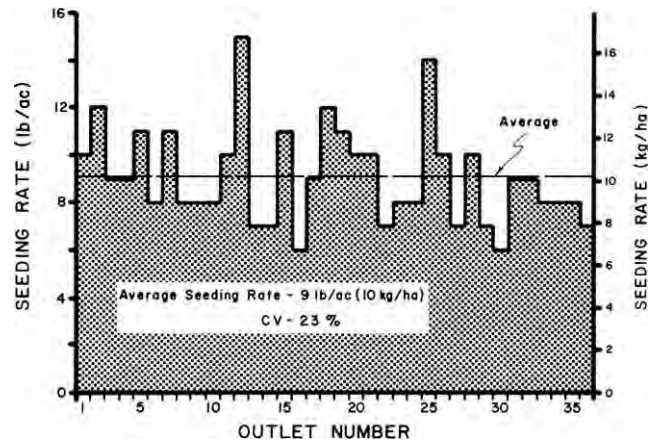
canola at a seeding rate of 9 lb/ac (10 kg/ha) at a fan speed of 2000 rpm. The application rate across the width of the air seeder varied from 6 to 15 lb/ac (7 to 17 kg/ha) which resulted in unacceptable distribution uniformity with a CV of 23%. Although decreasing the fan speed to 1500 rpm resulted in the CV decreasing by about 2%, canola distribution patterns were unacceptable over the full range of fan speeds and metering rates, with CV's ranging from 21 to 26% (FIGURE 10). It is recommended that modifications be made to the distribution system to improve distribution uniformity in canola.

FIGURE 9. Distribution Uniformity Pattern in Canola at 9 lb/ac (10 kg/ha) at a Fan Speed of 2000 rpm.

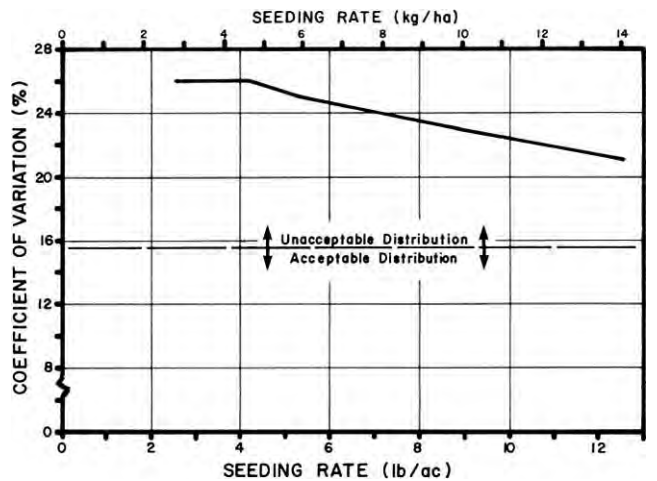
FIGURE 10. Distribution Uniformity in Canola Over a Range of Seeding Rates at 5.5 mph (9 km/h) at a Fan Speed of 2000 rpm.

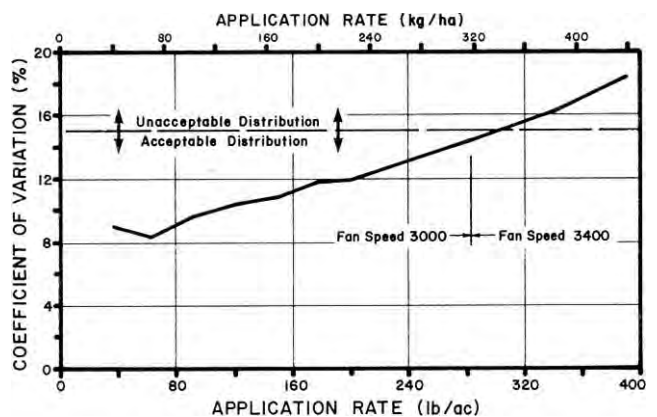
Distribution uniformity in 11-51-00 fertilizer was acceptable at fan speeds of 3000 and 3400 rpm for metering rates up to 300 lb/ac (337 kg/ha), with CV's ranging from 9 to 14% (FIGURE 11). At higher rates uniformity became unacceptable with CV's from 16 to 18%.

FIGURE 11. Distribution Uniformity in Fertilizer Over a Range of Application Rates at 5.5 mph (9 km/h) at Two Fan Speeds.

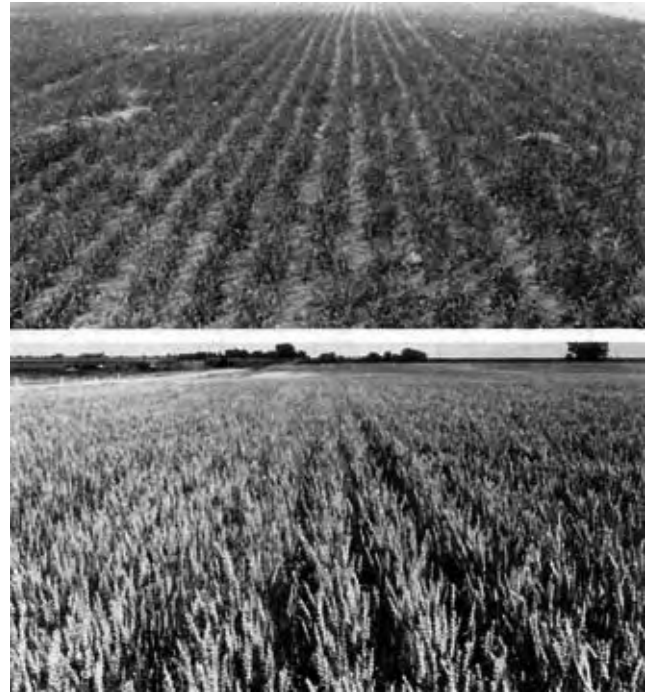
14 shows good wheat emergence when wheat was seeded into a pre-worked stubble field.

FIGURE 14. Uniform Wheat Emergence in Pre-worked Stubble (Upper: 25 Days After Seeding, Lower: At Harvest).

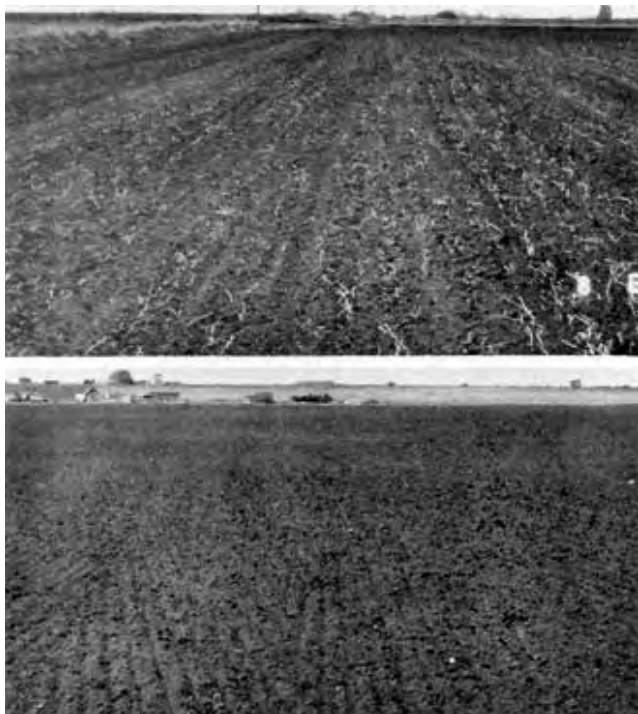
The harrow-packer combination served to further smooth and pack the seedbed, leaving packer ridges from 1.0 to 1.2 in (25 to 30 mm). To obtain a smooth firm seedbed in dry conditions required packer-drawbar operations in two directions. Care had to be used in moist conditions to avoid over packing the seedbed. FIGURE 15 shows a typical seedbed after seeding into stubble, both before and after use of the packer drawbar.

FIGURE 15. Leon Seedbed. (Upper: Before Packing, Lower: After Packing).

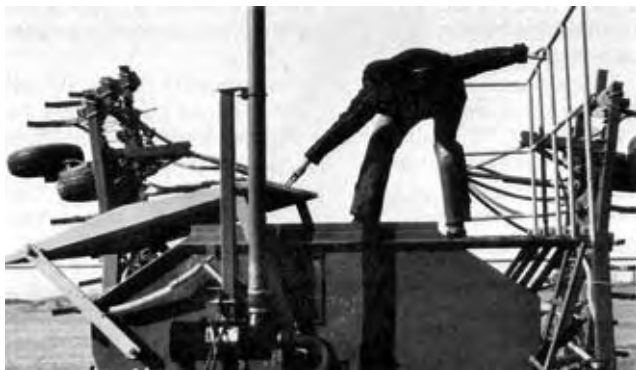
**Filling:** A drill fill or grain auger was needed to fill the applicator tanks. Because the filler openings were located 6.7 ft (2.0 m) above the ground, hand filling was difficult as it necessitated carrying the grain or fertilizer up the access ladder. The large 23 x 43 in (584 x 1092 mm) front tank opening and 71 x 43 in (1800 x 1092 mm) rear tank opening gave ample room for auger filling. The filler lid was mounted on over-centre hinges (FIGURE 18), requiring a force of about 65 lb (290 N) to push the lid open (over centre) and about 135 lb (600 N) to close the lid. The considerable force required to open and close the filler lid was inconvenient for some operators. The lid was not equipped with weather stripping to prevent moisture entry. It is recommended that the manufacturer consider reducing the tank lid opening and closing force requirement.

FIGURE 18. Operator Closing Tank Lid.

6. Modifications to prevent cultivator skewing in heavy conditions.
7. Modifying the tank lid to reduce the force required to open and close the lid.
8. Including a servicing schedule in the operator's manual.

7. We feel that the large lid provided is necessary for easy auger alignment and filling. The lid is spring assisted for opening and closing, and is to some extent adjustable by tightening or loosening the springs. It is necessary, however, for the lid to be closed with enough force to prevent it coming open when the seeder is operating in a rough field. We will investigate the use of a latch to lock the lid shut and allow for easier opening and closing.

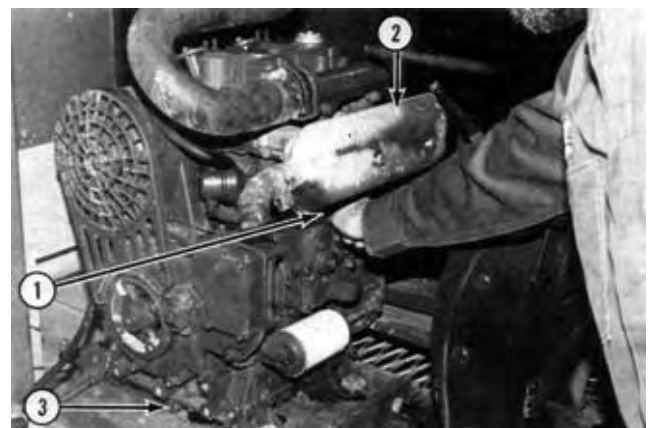
The fan engine fuel shut-off was located on the side of the engine (FIGURE 21). After prolonged periods of use, the shut-off became very hot and difficult to operate without some form of insulation between the operator's hand and the engine. The engine exhaust system was also located so that the operator had to reach under the exhaust to operate the engine throttle and shut-off. It is recommended that modifications be made to provide protection around the engine shut-off, throttle and exhaust for improved operator safety.

FIGURE 21. (1) Engine Throttle and Shut-off, (2) Exhaust, (3) Oil Drain Plug.

11. Providing an improved method of draining engine oil to prevent oil spillage.
12. Modifications to prevent trash build-up on the fan inlet screen.
13. Improving quality control of monitoring system components to prevent failures due to poor assembly.

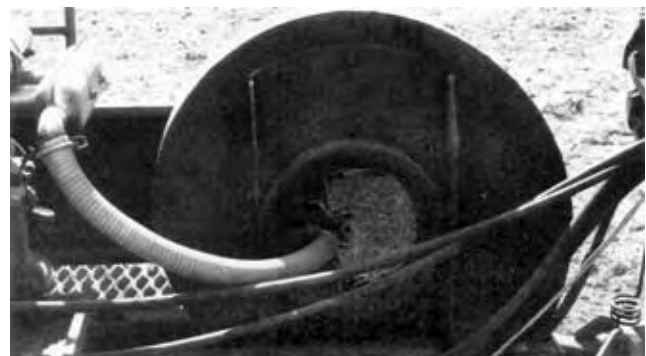
**Fan Inlet:** In field conditions with loose dry trash, the fan inlet frequently required cleaning due to trash build-up on the inlet screen (FIGURE 22). If the inlet was not cleared the distribution system would plug after prolonged use due to restricted air flow. The amount of material build-up on the fan inlet could probably be reduced by installation of a deflector. It is recommended that the manufacturer consider modifications to prevent trash build-up on the fan inlet screen.

FIGURE 22. Fan Inlet Plugged with Trash.
